Publikationen des Deutschen Archäologischen Instituts

Virtual 3D reconstruction of a domestic space in Selinunte (Sicily) from the 5th century BC: opportunities and challenges

Forum for Digital Archaeology and Infrastructure Faszikel 2025 1–45 (§)

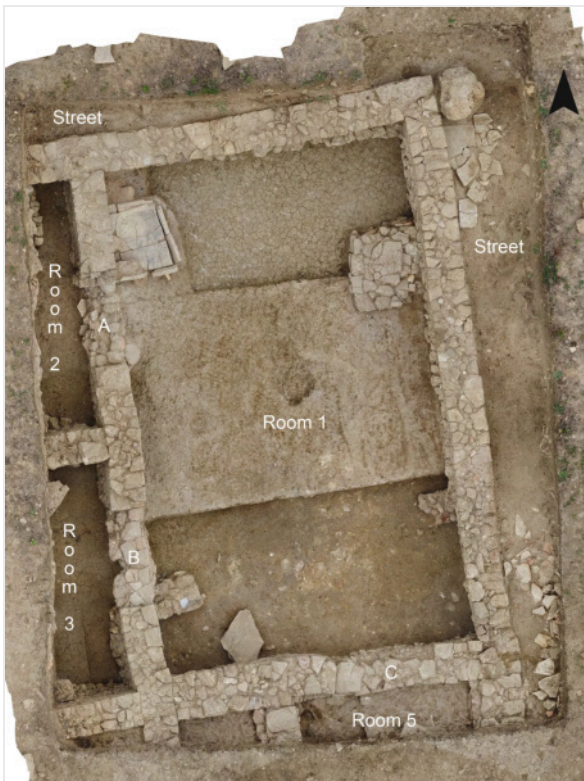
2

Fig. 2: Ortho-image of trench P 2023 in its final state

14 The two hearths were found in situ on opposite sides of the room (see Fig. 2). While the western hearth was made of reused roof tiles and was found completely intact, the eastern hearth was made of a mixture of stones and fragments of roof tiles and had suffered some damage during or after the collapse of the roof. It was only partially covered by roof tiles, as the first row of tiles appears to have largely fallen onto the adjacent road, in line with the pitch of the roof. As a result, the area immediately inside the wall, exposed to various external influences over time, was less well preserved.

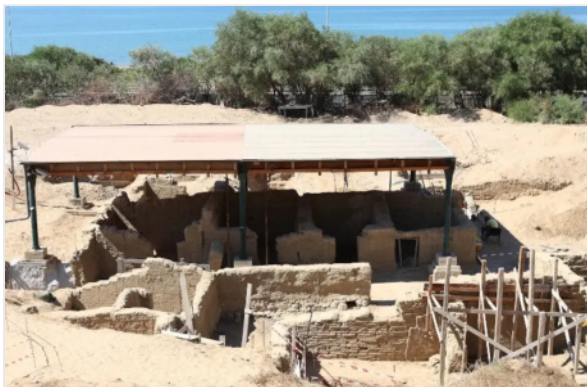
5

Fig. 5: Buildings made from mud brick at Bosco Littorio, Gela.

wood. Similar constructions in Sicily, however, demonstrate that these types of walls perfectly functioned without a wooden reinforcement¹⁰. A good example appears in the *emporion* of Bosco Littorio at Gela, where a series of well-preserved rooms made from rough stone and mud brick was discovered in the 1980s (Fig. 5)¹¹. On short stone foundations of only 20-30 cm, the rising walls, solely made from mudbrick, to this day still reach heights of up to 3 m, testifying to the remarkable structural safety of this simple construction technique. The openings for the roof beams are still present in some of the walls, as are windows and doorways.

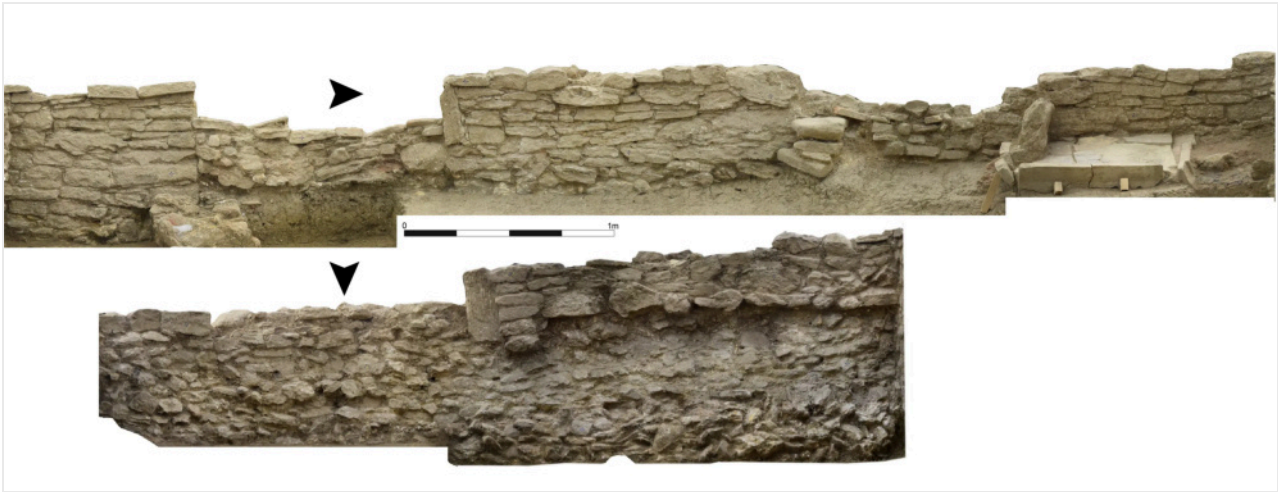
7

Fig. 7: View of the wall bases in the south and west of room 1.

9 An interesting feature preserved in all three doorways is an oblong stone in an upright position that protects the base of the wall on the right side of the passage against damage from wear (Fig. 7)¹⁷. Thus, a possible door hinge was probably attached to the left side (seen from within the room). For attaching a proper door, a wooden frame would have been necessary. In the model, only a wooden board on top of the threshold was added in doorway B, which allows for the mechanical fastening of a door hinge top and bottom.

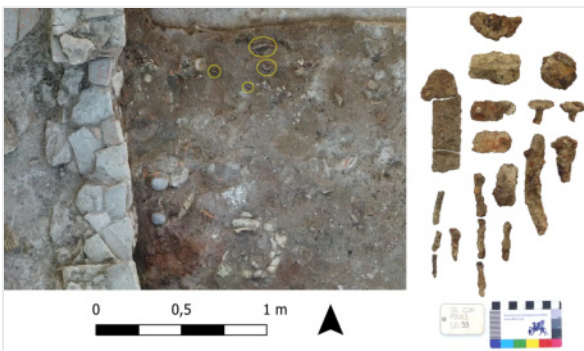
8

Fig. 8: Position of the metal door fittings in front of doorway B.

10 In the ancient Greek house, doors were part of the mobile furniture, not of the building¹⁸. Thus, not every doorway was equipped with a proper door. In the model, a single door was inserted in doorway B, as several iron nails and iron sheets were found nearby, together with traces of ashes and burnt soil (Fig. 8)¹⁹. Although the exact construction and mechanism of the door

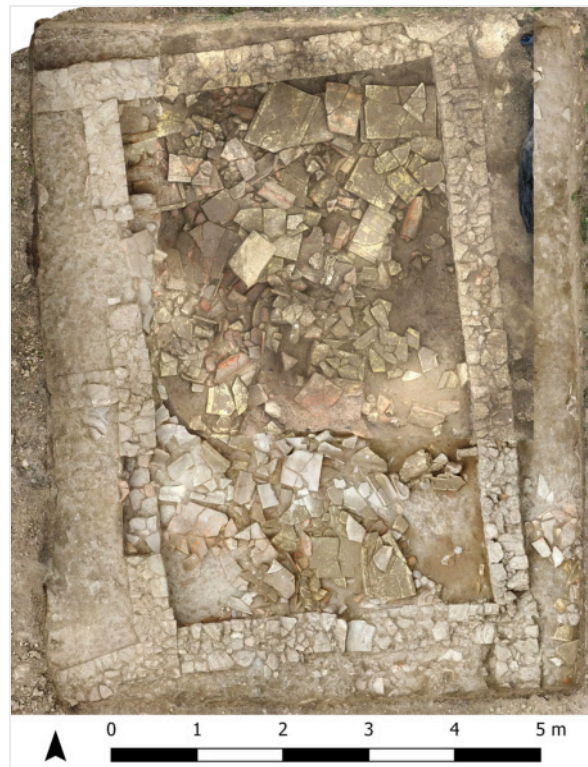
9

Fig. 9: Assembled ortho-image of the collapsed roof in room 1.

11 The room in question undoubtedly was covered by a tiled roof, as many of the roof tiles were found where they had collapsed at the end of the 5th century BC (Fig. 9). They clearly belonged to a single-pitch roof, as there are no ridge tiles among them²². The beams supporting them obviously were aligned along the short side of the room, and the water drainage from the roof most probably was directed eastwards, towards the road. For the model, the pitch of

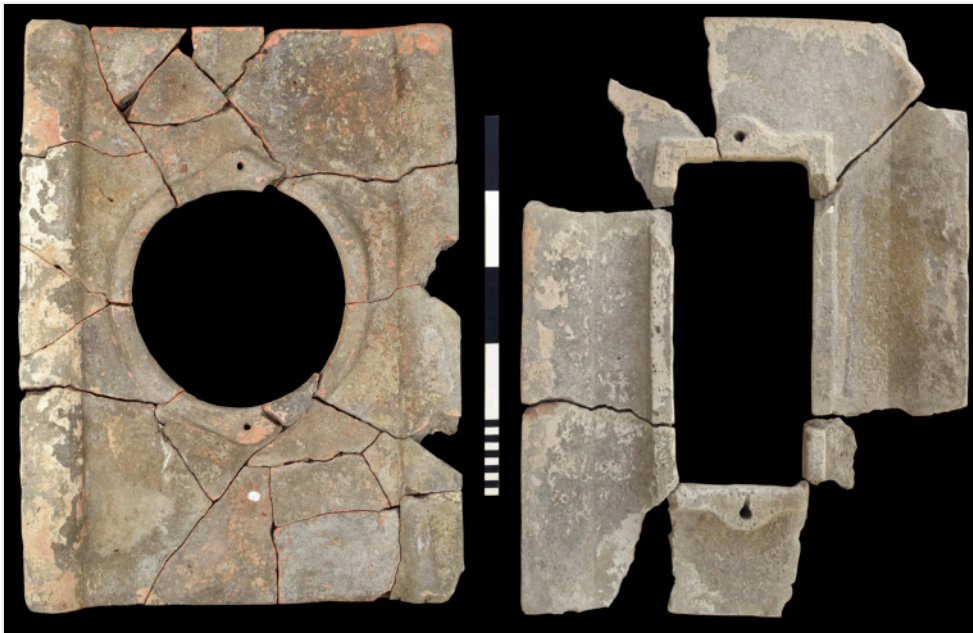
11

Fig. 11: Two opaia from the collapsed roof.

13 Two special tiles were found in the collapse of the roof: a complete *opaion* tile, with a circular opening of about 28 cm in diameter, and a fragmented *opaion* tile, with a rectangular opening of 50 x 16 cm (Fig. 11). In the model, both have been placed according to their place of discovery, although whether their position in the roof was originally linked to the two permanent hearths in the northern part of the room is unclear.

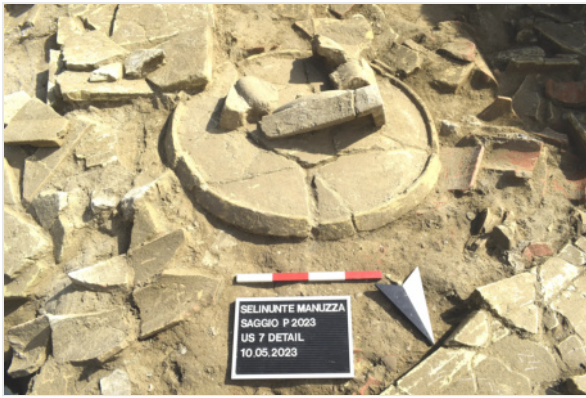
12

Fig. 12: The basin of the louterion in upside-down position among the tiles of the collapsed roof.

16 Not all objects found under the collapsed roof were originally located on the ground. Those that probably were standing on the floor have been placed in the model according to their findspot. This was an easy task for the heavy *louterion*, which was simply lying upside down in the centre of the room (Fig. 12). Positioning the grill on the western hearth, where its four feet were found, was also fairly straightforward. The concentration of cooking pots and other kitchen equipment on the perimeter of the hearth in the northwestern corner is also consistent with the circumstances of their discovery, including the bull horns. More complicated was the arrangement of the amphorae, which required something to lean against, which were found scattered across the entire length of the room. Ultimately, they were arranged rather arbitrarily alongside the walls, especially on the short sides of the room, where most of the necks were found²⁶.

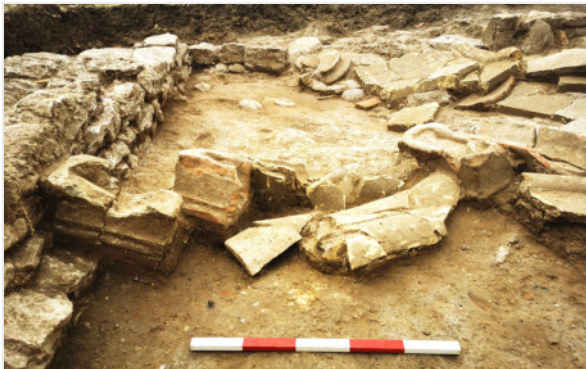
13

Fig. 13: Three miniature altars in fallen position.

17 In the southern part of the room, roughly in line with doorway B, a number of broken vessels were discovered, including several black-glazed vases. On the same line, three miniature altars had apparently fallen from an elevated position and were lying upside down next to the eastern wall (Fig. 13). To accommodate the altars and the other objects found in the same spatial context, an open cupboard with three shelves was modelled. The objects inside were positioned according to their findspot, assuming that the cupboard had fallen to the floor and taken everything inside with it. For example, the altars were placed on the bottom shelf, as they were found closest to the wall.

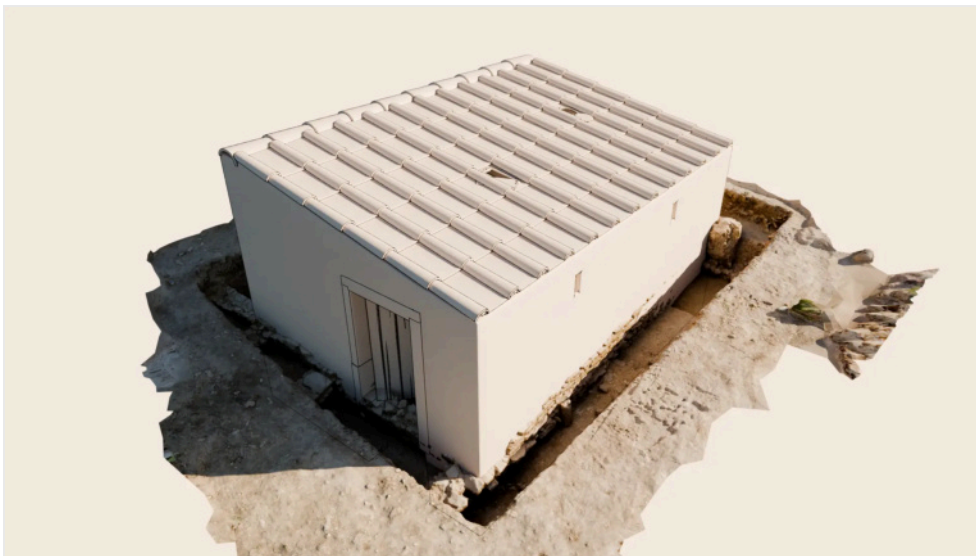
26

Fig. 26: Development of the architectural reconstruction on the basis of a photogrammetric 3D model.

photogrammetric 3D model of the room (Fig. 26). This step is fundamental: starting from a digital twin enables precision in dimensions, proportions, scale and measurements and thus ensures that the virtual reconstruction fully respects the preserved remains. From here, a dynamic iterative workflow ensued, which involved close and ongoing collaboration between the design and excavation teams. This dialogue allowed for proposing alternatives, implementing adjustments and exchanging solutions, which culminated in the finalised graphic hypothesis. Subsequently, materials and textures were carefully designed to provide a photorealistic finish to the scene, always grounded on the in situ remains and the historical-archaeological parallels discussed earlier in the article.

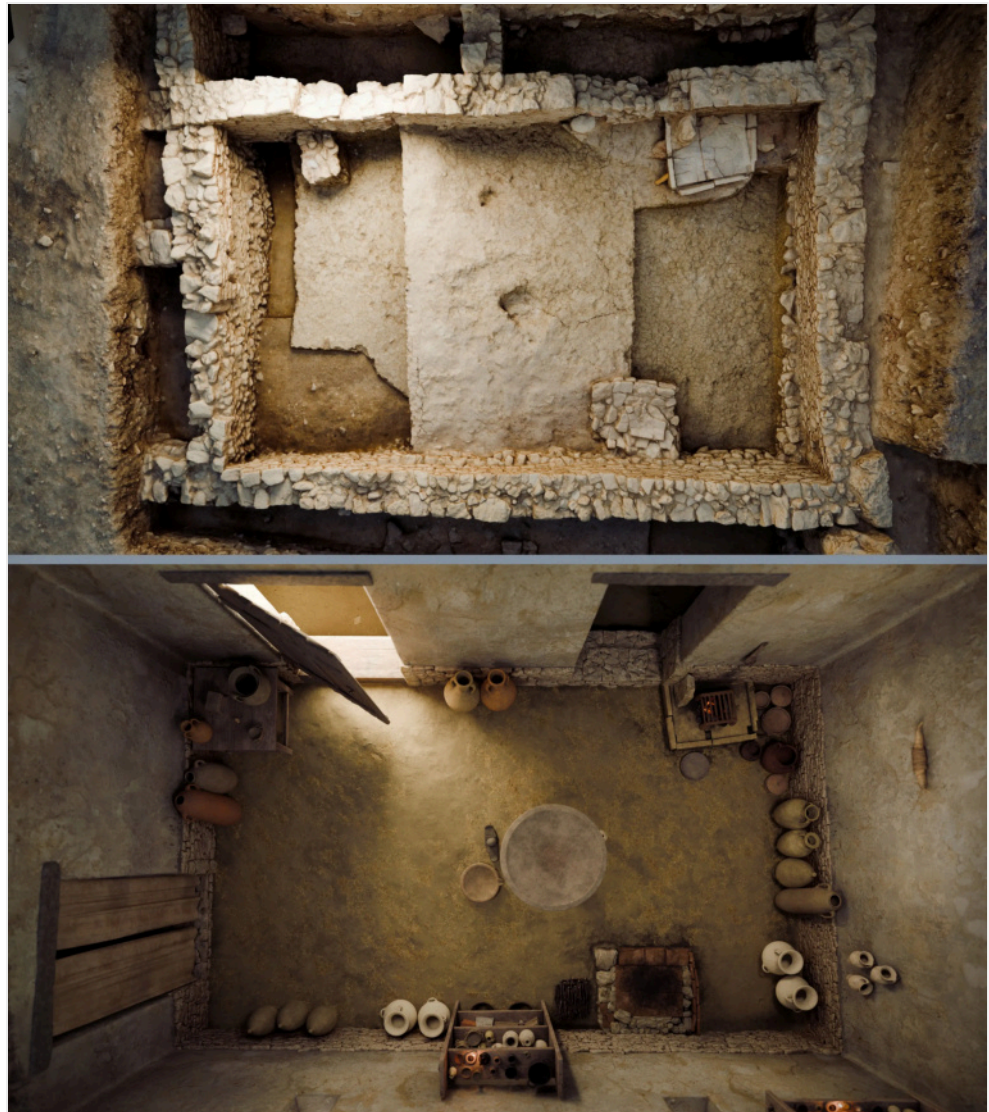
27

Fig. 27: Birds-eye perspective of the excavated room and the reconstruction.

39 A comparable approach was applied to the virtual reconstruction of the various artefacts found within the room. Whenever possible, the photogrammetric models of these objects served as the basis; when unavailable, detailed plans drawn from the original pieces guided their modelling. Advanced digital sculpting techniques, occasionally employed to create precise replicas, thus recovered the original volumetric detail. Following their design, the models were textured and integrated into the complete spatial reconstruction of the room, with placement informed by excavation data (Fig. 27).

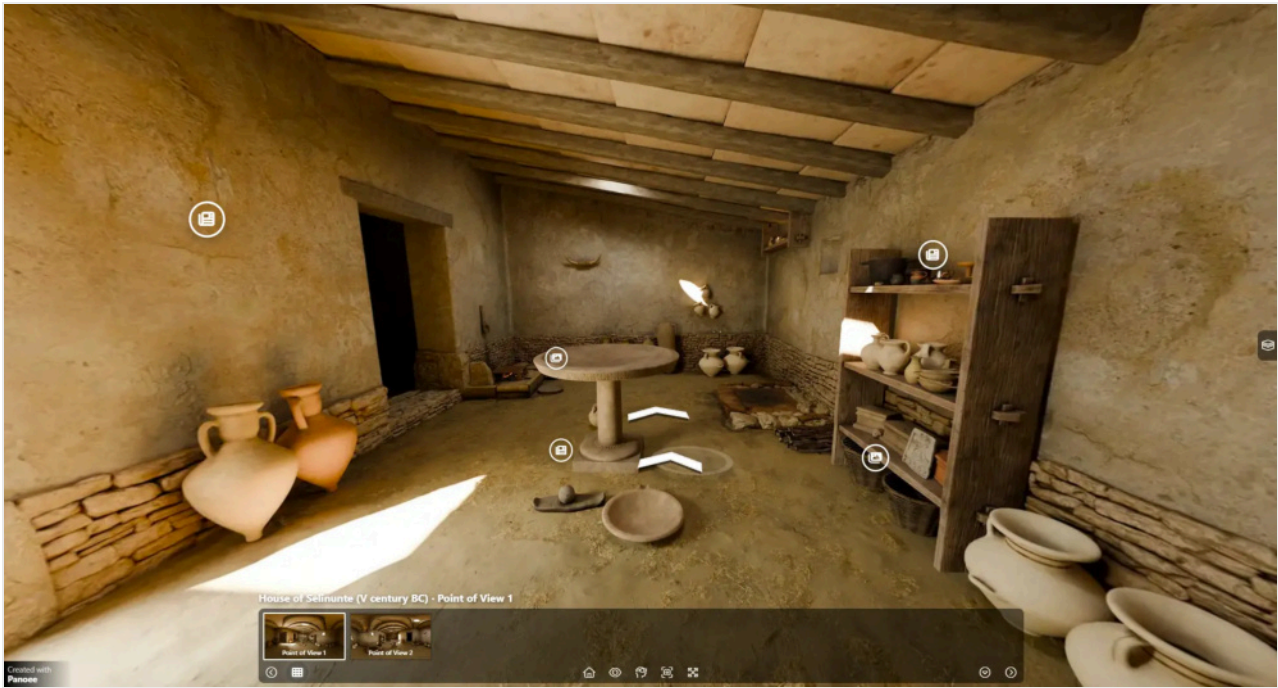
29

Fig. 29: Screenshot of the prototype of a virtual tour through the reconstructed space.

41 The resulting models and infographics allow viewers to explore the reconstructive hypothesis of the room prior to its destruction from multiple perspectives by providing a comprehensive understanding of the space and its contents. Several views are accompanied by corresponding images of the evidence scale, linked to RU tables for readers wishing to investigate the hypothesis formation in greater detail. Additionally, several renderings of the reconstructed objects in 3D and a prototype immersive virtual tour, developed using the Panoee tool⁴⁹, enable interactive 360 exploration of the scene (Fig. 29, Fig. 30, Fig. 31, Fig. 32, Fig. 33).

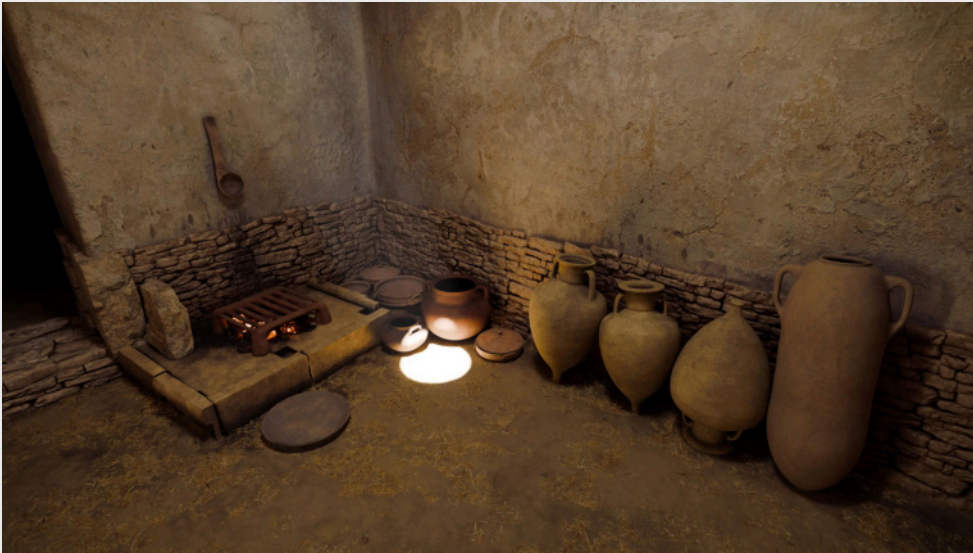
30

Fig. 30: Screenshot of a detail of the model: the western hearth with cooking pots and storage vessels.

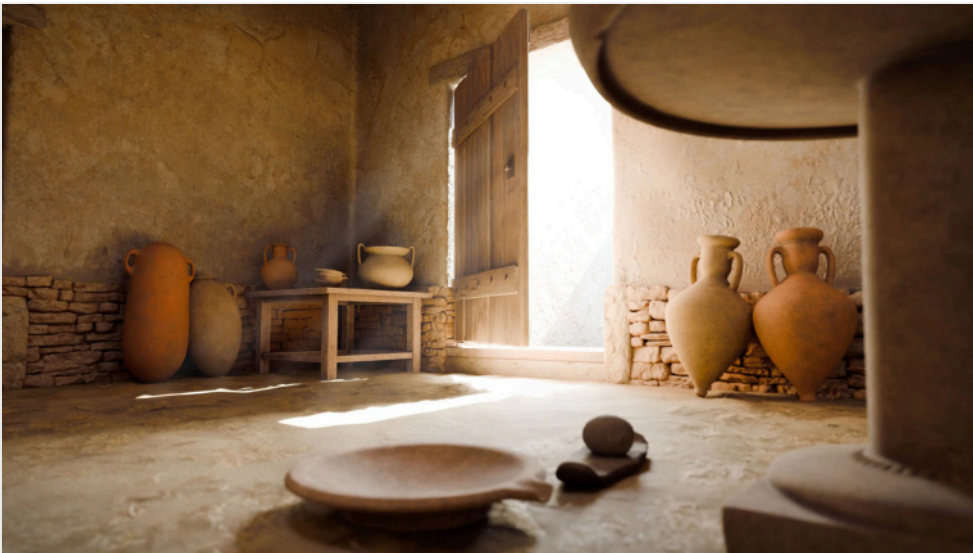
31

Fig. 31: Screenshot of a detail of the model: view from the centre of the room towards the door and the table in the corner.

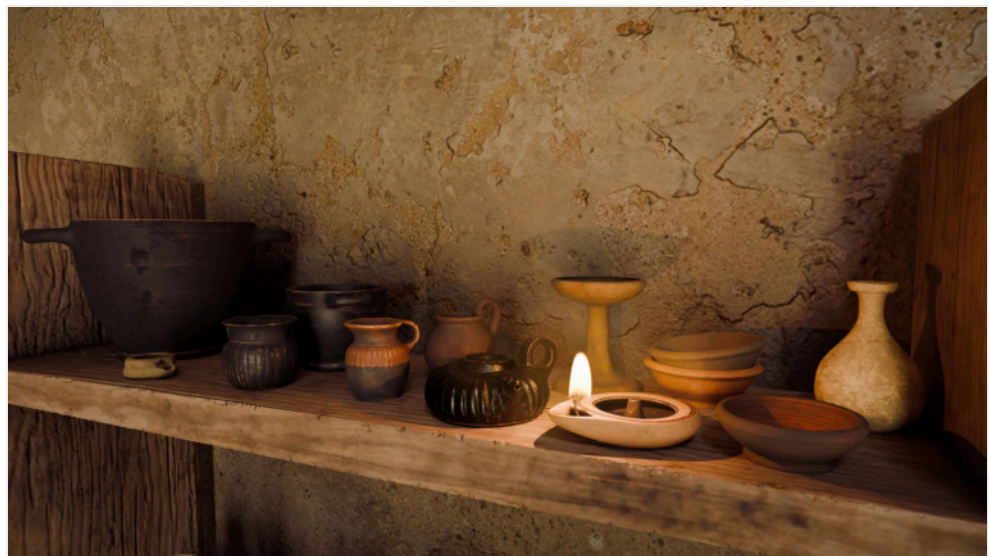
32

Fig. 32: Screenshot of a detail of the model: detail of the uppermost board of the large shelf.

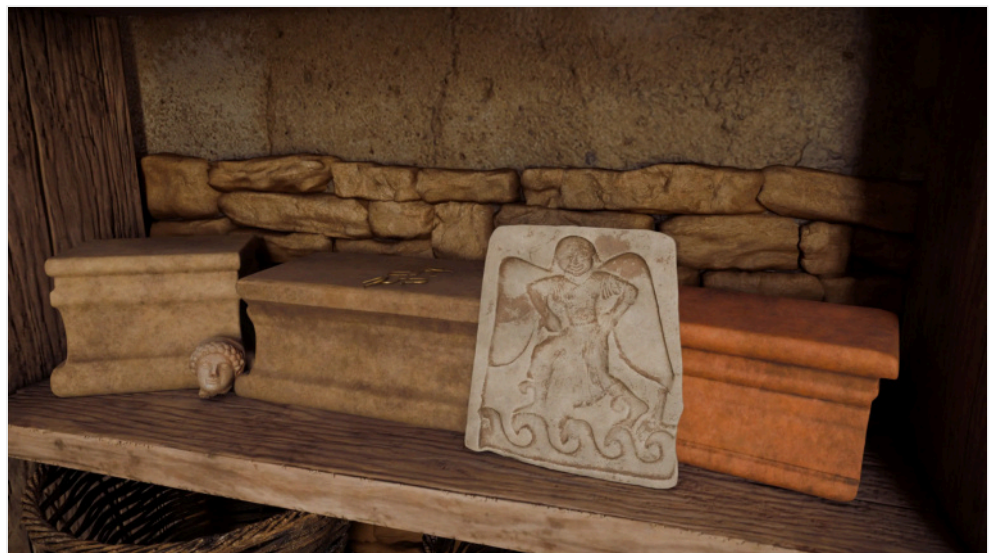
33

Fig. 33: Screenshot of a detail of the model: detail of the undermost board of the large shelf.
