Archaeoseismological Damage Patterns at the Ancient Ruins at Rehovot-ba-Negev, Israel

Archäologischer Anzeiger

Ausgabe / Issue **1 • 2014**

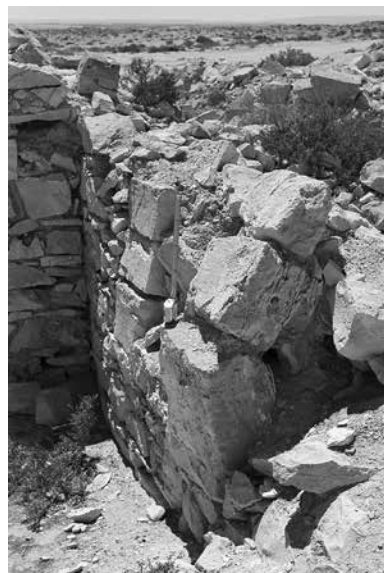
Fig. 4 A tilt southward of the southern wall at the SE premises of the Northern Church (field station 3). The degree of the tilting is increasing with the distance from the abutted perpendicular wall. This phenomenon is the result of maximum freedom of oscillation at the central part of the wall

At Rehovot-ba-Negev, the southern wall of the SE premises of the North Church (field station 3 in fig. 3) tilted southwards (fig. 4). The wall trend is 108°; declination azimuth is 198°; and the angle is up to 75°. Another example can be seen at the same premises (field station 3) where one can observe the same damage pattern in the western wall: the wall trend is 13°, tilted to 81° and collapsed westward – toward azimuth 283°. Only a few fragments are preserved of the western wall, and only one stone high. The wall continues northward. Here it has a tilt and a westward collapse analogous to the SW corner of the western yard in the North Church (field station 4 in fig. 3). The trend of the azimuth of the wall is 18°; it is tilted at an angle up to 72°; and the declination azimuth is 287°; this is also the direction of the wall collapse (fig. 5). The wall continues northward until it meets the opposite wall of the northern premises (field station 5 in fig. 3). It is tilted WNW at a maximum angle of 21° (fig. 6); the trend of the wall is 31°, and the declination azimuth is 301°.

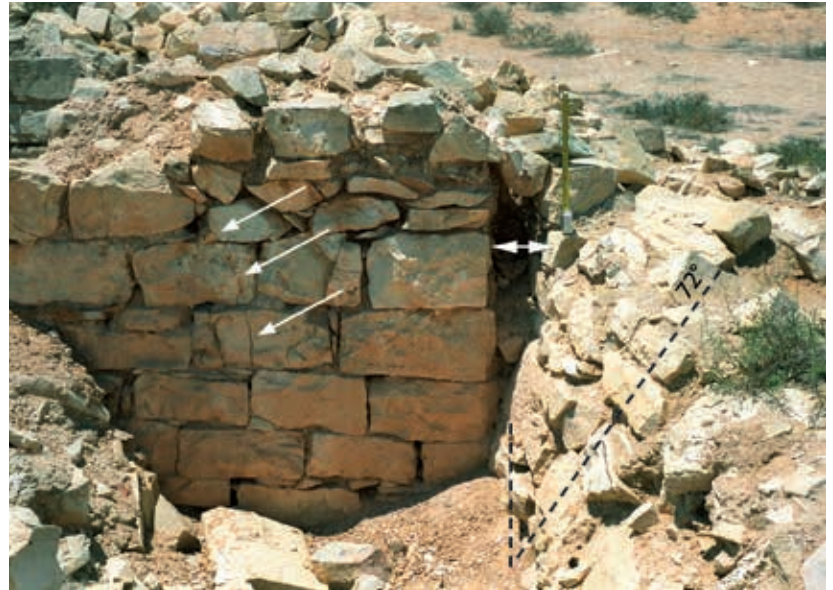
Fig. 5 An 18°-tilt and a collapse of the western wall westward at the SW corner of the western yard (field station 4). Opening between two perpendicular walls is shown by a double arrow, and a through-going fissure (joint) cuts three adjacent stones in succession (shown by three white arrows)

At Rehovot-ba-Negev, the wall standing to the right of the southern entrance into the North Church (field station 1 in fig. 3) is crossed by numerous joints (fig. 17). One of them crosses through three stones. The trend of the deformed wall is 20°, and the length of the joint is 83 cm. Another throughgoing joint can be observed at the western corner of the large yard of the North Church (field station 4 in fig. 3). Here there is a joint cutting three stones in a wall trending of 114° (fig. 5). The length of the throughgoing fissure is 48 cm.

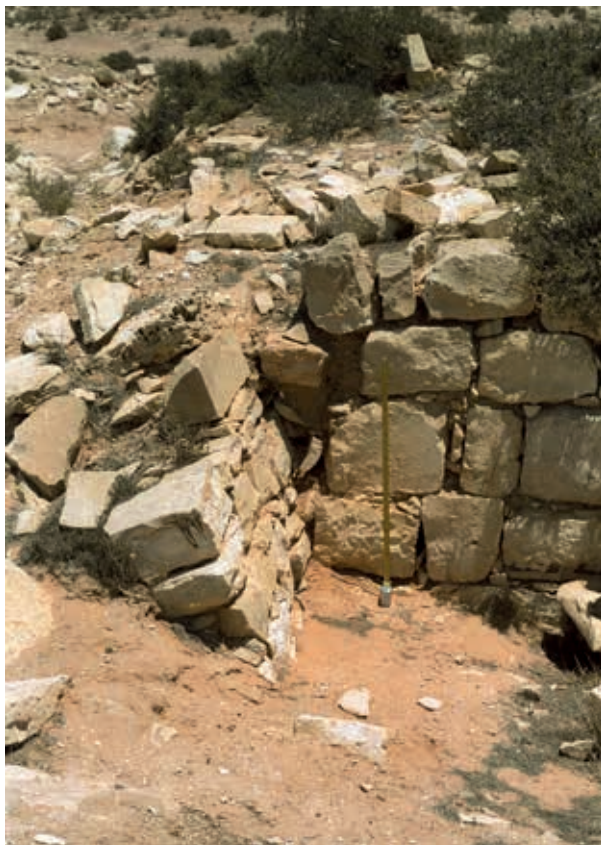
Fig. 6 Tilt of the western wall toward WNW at field station 5. There is an opening between the tilted wall and the perpendicular one

Such a phenomenon can be seen (fig. 15) at the SE premises of the North Church (field station 3 in fig. 3), where one can observe an opening of 20 cm between the northern wall (trend 115°) and the western one (trend 13°). Another example of such an opening can be observed at the SW corner of the large yard of the North Church (field station 4 in fig. 3). Here there is a gap between the southern wall (trend 115°) and the perpendicular western wall, tilted westward (fig. 5). The same pattern can be observed in the same wall, continuing northward (field station 5 in fig. 3). Here the western wall of the church tilted westward and there is a gap between it and the perpendicular wall (fig. 6).

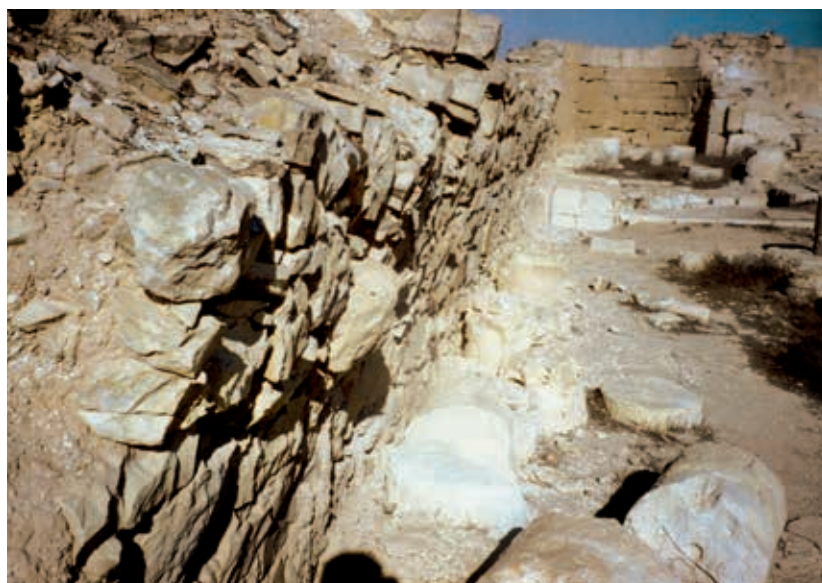
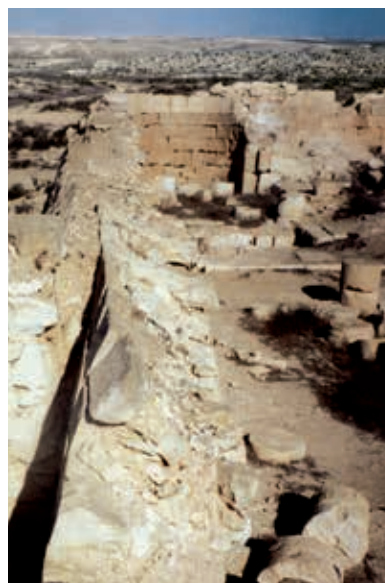
Fig. 8 A southward tilt of the whole wall of the Northern Church, a: view toward east; b: view towards ESE from above. The angle of tilt is increasing up along the wall (a ›skyscraper‹ effect)

southern wall's tilt occurred during the first of the Late Roman earthquakes. It seems that the southern wall began to tilt northward inside the building during the Early Arab earthquakes; additional evidence for this is the shift northwards of the upper part of the revetment wall. Stones of the perpendicular eastern wall are cracked in the small room marked on the plan. Nevertheless, this wall is better preserved (it is much higher) than the main southern wall of the North Church. This indicates that the seismic shocks during both earthquakes acted perpendicular to the main Church wall: it had freedom of oscillation and was significantly destroyed. The small eastern wall, oriented parallel to the effect of the seismic movements, withstood the seismic oscillations better, although many of its stones were significantly damaged. The whole northern wall of the Church (field station 12 in fig. 3) has a significant tilt to the south (figs. 8 a. b).

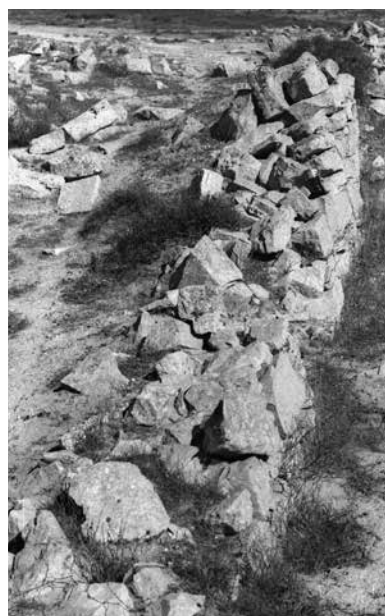
Fig. 9 Tilt and collapse of one of the walls at an unexcavated quarter

There are few measurements of tilted and fallen walls, small remnants of which are still projected above the surface (fig. 9). Generally these walls tilted or collapsed toward ESE (fig. 23).

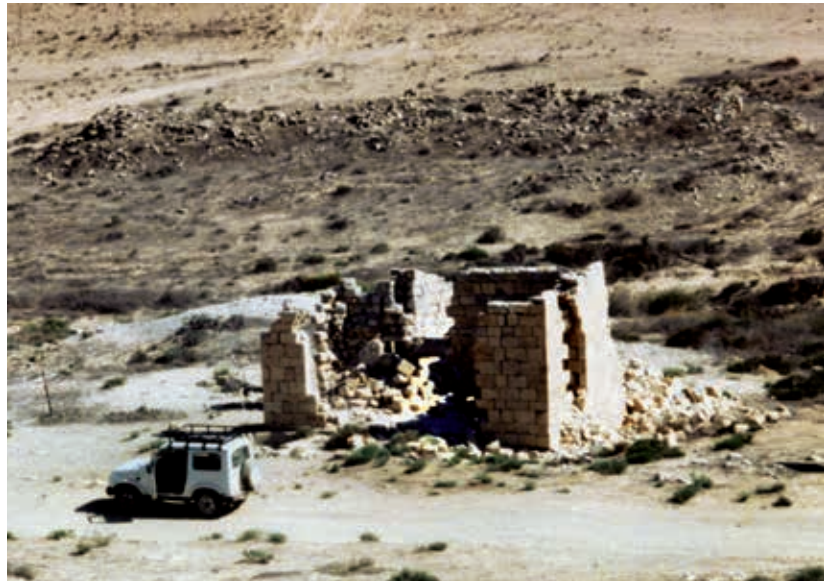
Fig. 10 Destroyed well-house, built under the British Mandate, above the ruins of the Byzantine bath house

An example of the seismic destruction of constructions built during the Turkish and British Empires is a later rebuilt Byzantine bath house located near a well. The bath house was destroyed during the Turkish time⁴⁰. Most probably there was a natural reason for its destruction. The authors of this paper have traced the impact of an earthquake at Turkish-British constructions in the adjacent Bedouin village of Khalsa, built on ruins of ancient Haluza⁴¹, where the deformations cover a large area. The earthquake which affected the Khalsa village would have also left traces in buildings of the same age at Rehovot-ba-Negev. Interestingly, the well-house, which was built during the British Mandate, was also significantly destroyed (fig. 10). This could be the affect of the Jericho 1927 and/or the Aqaba 1995 earthquakes, which caused deformations all over Palestine and modern Israel.

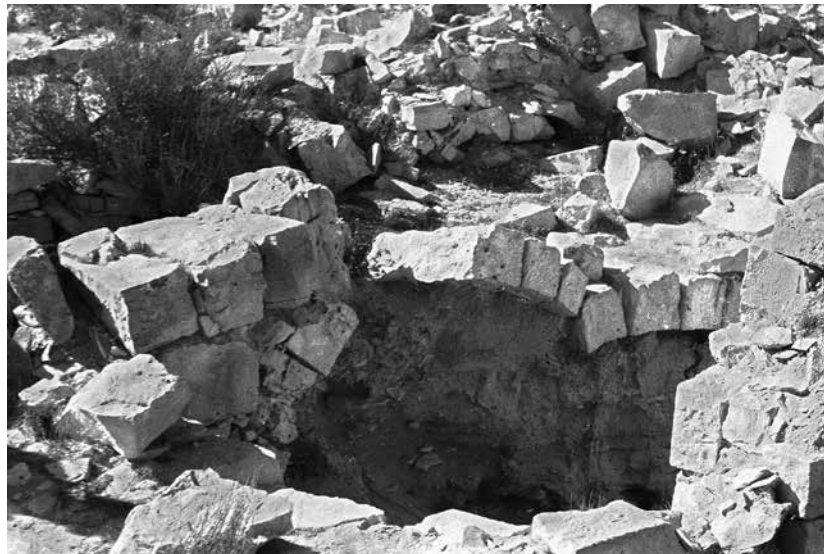
Fig. 11 Collapse of the arch in room L. 207, which has been filled with earth before its complete collapse

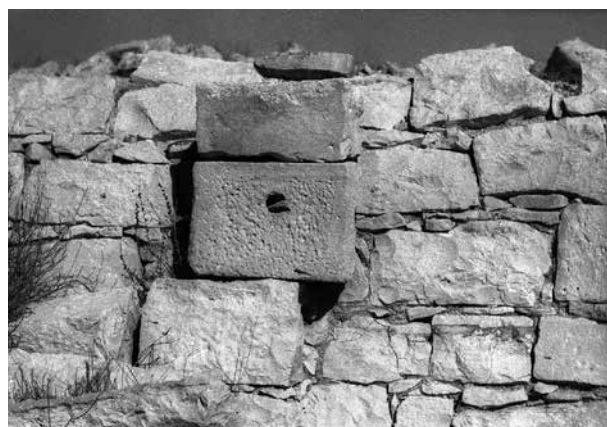
Fig. 13 A horizontal 15 cm shift eastward of the upper part of an arch column in one of the excavated quarters

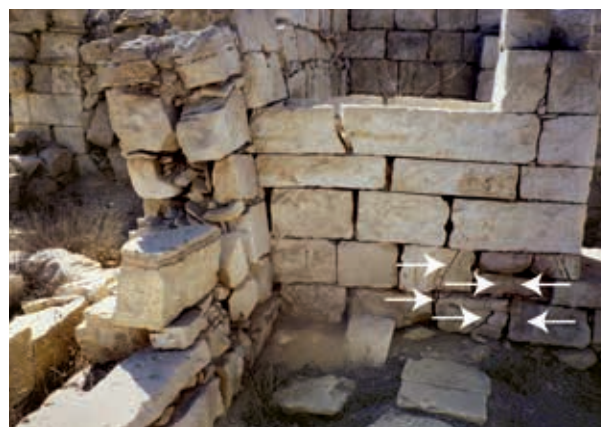
Fig. 14 Deformation of two perpendicular walls at the Caravansary, the ›feeding‹ wall pushed the perpendicular one. The later wall is significantly tilted. The ›Feeding‹ wall is also deformed: there are some openings in its upper part and joints (shown by arrows) crossing two stones are in the wall's lower part

find such an example at the SW corner of the large premises of the North Church (field station 2 in fig. 3), where three stones at the upper part of the wall have been moved, probably due to the push of an adjacent perpendicular wall. The trend of the deformed wall is 110°. The stones were shifted SSW (200°) at a distance of 12 cm. The perpendicular pushing wall has a trend of 24°. Another example can be observed at the SE premises of the North Church (field station 3 in fig. 3). There the northern wall (trend 115°) pushed the perpendicular western wall (trend 13°) westward. A similar picture can be observed at the stables of the Caravansary (fig. 14). Here the ›feeding‹ wall pushed a perpendicular one. Both walls are significantly deformed, tilted (declination angle 22°) and crossed by joints.

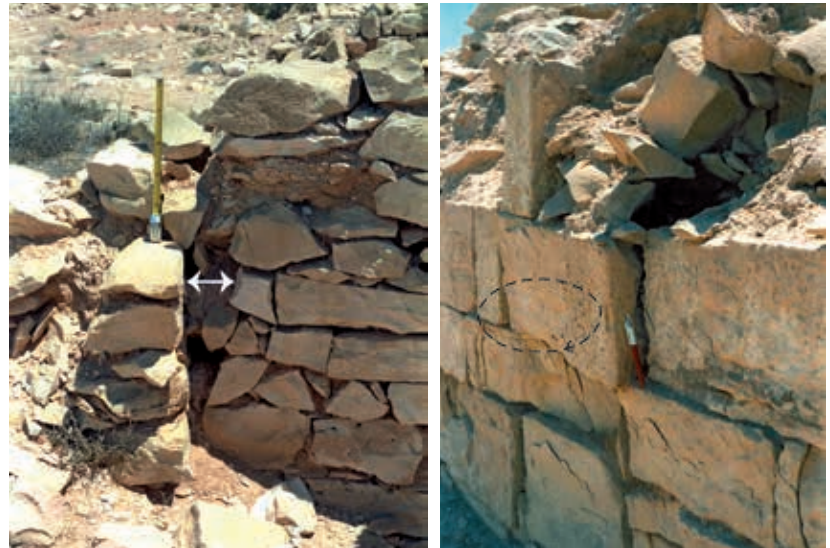
Fig. 15 Opening between two adjacent perpendicular walls at the SE premises (field station 3)

Fig. 16 Clockwise rotation of a stone in an eastern wall (field station 9)

The rotation of wall fragments around a vertical axis is a common phenomenon during strong earthquakes¹⁸. Foundation stones are pulled out and rotated, indicating dynamic beating in the process of sharp horizontal oscillations of the whole wall (and not only its upper part). A seismic ground motion is the only mechanism that can cause rotation of building elements. A large number of observed rotations, and the obvious directional systematics, support this conclusion¹⁹. An example of rotation (fig. 16) can be observed outside the eastern wall of the North Church (field station 9 in fig. 3). Here one stone in the upper preserved row was rotated clockwise. The general trend of the wall is 24°; and the trend of the rotated block is 26°.

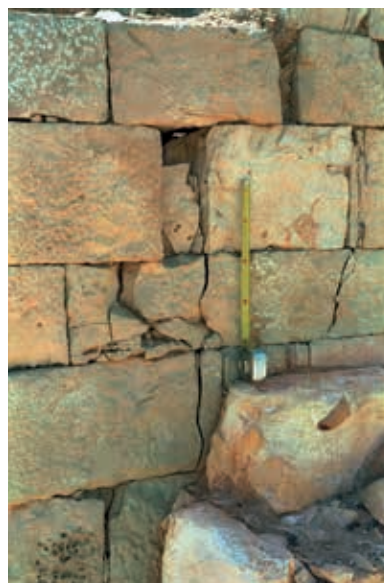
Fig. 17 Rehovot-ba-Negev, joints at the wall at the southern entrance into the Northern Church (field station 1) cut through three stones

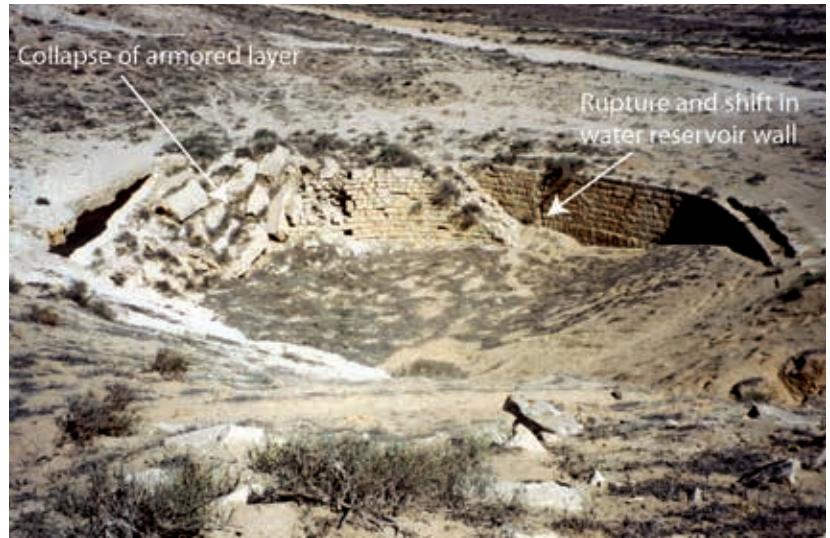
Fig. 18 Rehovot-ba-Negev, seismogenic (?) rupture at the SE wall of the water reservoir. The reservoir was partly cut out of the bedrock and is partly brick-built. Also note the collapse of a significant part of the armored layer which partly covered the reservoir from SW

A through-the-wall crack was observed at the Rehovot-ba-Negev water reservoir. The whole wall is cut by this rupture (fig. 18), resembling a ›pure‹ seismic rupture with a horizontal displacement (left-lateral shift) on the first ten centimeters. However, this rupture does not continue in either the adjacent ancient building constructions, or in the relief features. Additional study, and palaeoseismological trenching of the rupture is necessary. The described rupture could be the reason for the disappearance of the water resource in the town, and its subsequent abandonment.

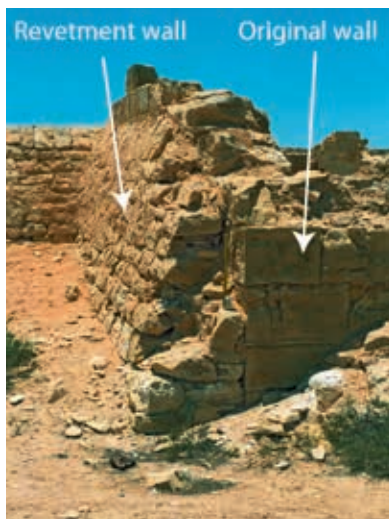
Fig. 20 Continuation of the revetment wall (field station 7)

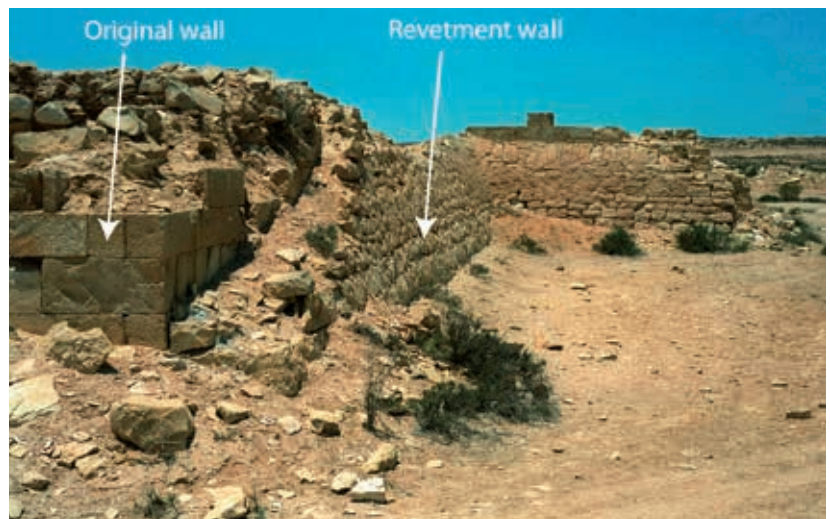
Fig. 21 Revetment wall at the NE corner

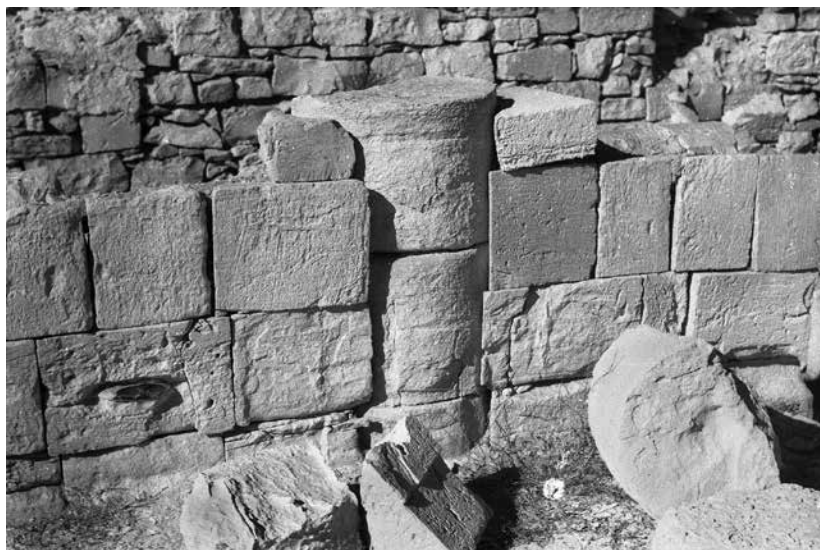
Fig. 22 Rehovot-ba-Negev, Northern Church. An ancient column within a wall that was built in order to protect it from possible future destruction

Columns at ancient and modern buildings cause the redistribution of the static load of the whole building construction, and serve as art decoration of the internal and external parts of the building. When a researcher finds a column supported by a later wall, he can be sure that the column was severely deformed, making the supporting wall necessary. Such an example can be found in the North Church (fig. 22).
