## Western and Central Asia. Satellite Imagery for the Study of Conservation and Restoration of Earthen Architecture. Research Carried Out between July and September 2022

## WESTERN AND CENTRAL ASIA

### Satellite Imagery for the Study of Conservation and Restoration of Earthen Architecture

Research Carried Out between July and September 2022

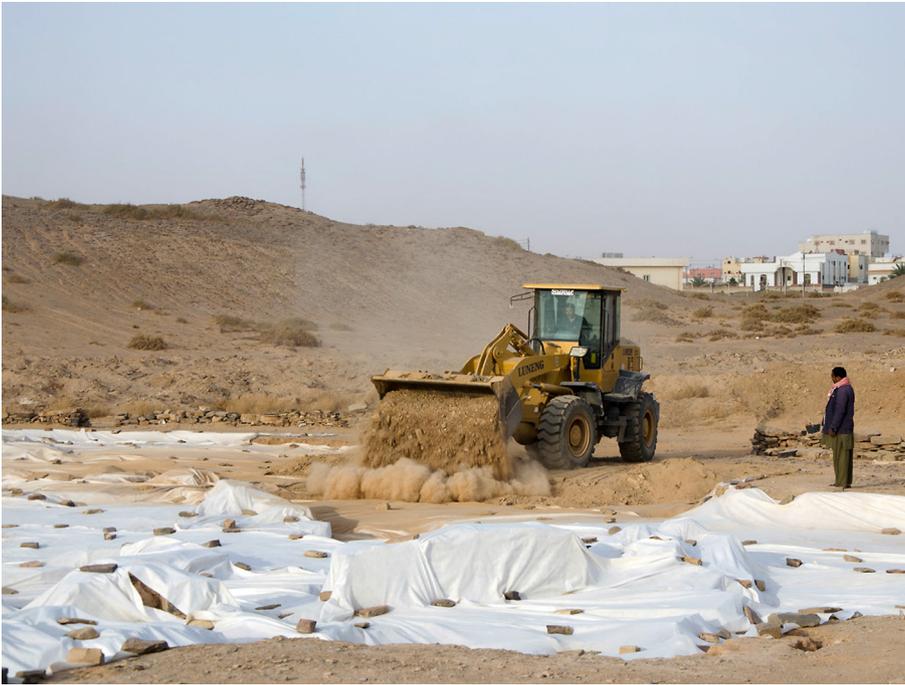
2 Tayma, Saudi Arabia. Examples of conservation and restoration techniques: Backfilling. (Photo: Hausleiter 2018, Fig. 8)

- 4 Archaeologists working in Western and Central Asia have a major responsibility for the management of archaeological remains. Once excavated, the remains of earthen walls are re-exposed to decay agents. How to preserve these remains? Should they be made accessible to the public? Or is the alternative to backfill (Fig. 2) or even let them decay?

4. Interventions on the structures using stabilising materials as a hardener against weathering and other decay agents (Fig. 5).
- 10 The first two approaches consist of indirect, passive interventions that do not directly impact the earthen structure. Backfilling is a preservative method consisting of re-covering the excavated archaeological structure with soil, and it is commonly used in ongoing excavation for protecting the structures from one campaign to another. However, it has its disadvantages in terms of the fruition of the archaeological property. The construction of temporary or permanent protective shelters is another passive, preservative method that does not directly impact the earthen structures but helps in their preservation, especially against weathering. Disadvantages are the following: impact on the landscape from both a structural and a visual point of view; the choice and availability of materials that should be (by preference) local, low-cost, of low impact, and durable; the decay of materials in time; the construction works that can seriously affect and endanger the archaeological structure; the placement of posts that should not affect the archaeological structure or even the underlying stratigraphy.

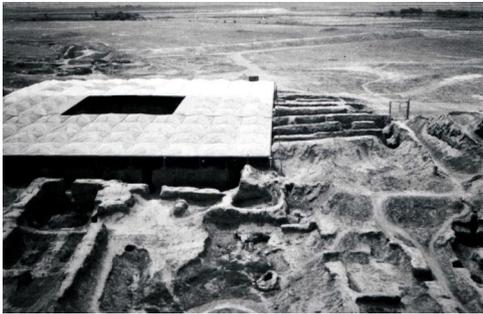
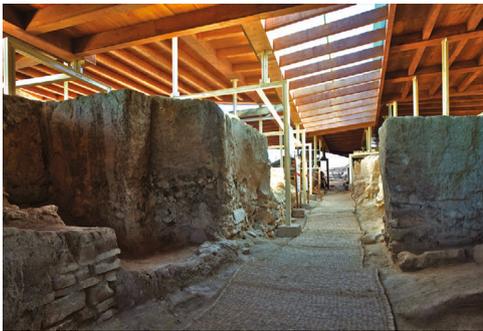
3 a. Mari, Syria/b. Arslantepe, Türkiye. Examples of conservation and restoration techniques: Protective shelters. (Photo a: Bendakir et al. 2003, Fig. 1; Photo b: Frangipane 2022, Fig. 19)

2. The construction of temporary or permanent protective shelters (Fig. 3a. b).
  3. Limited interventions on the structures without using stabilising materials (e. g. encapsulation, capping, filling voids and cracks with mortar, and covering the mudbricks with a plaster made of a lime-clay-straw mixture, Fig. 4a. b).

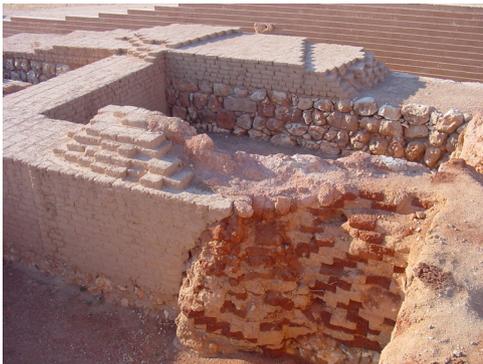
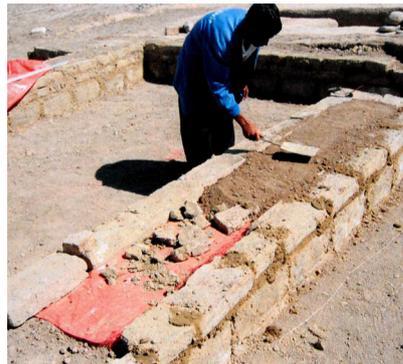
4 a. Konar Sandal, Iran/b. Area Q of the Western Palace, Ebla, Syria. Examples of conservation and restoration techniques: Interventions without the use of stabilising materials. (Photo a: Dehkordi et al. 2011, Fig. 6; Photo b: Nadali 2023, Fig. 8)

11 The last two approaches consist of direct interventions on the structure. The most widely used procedure to date is the one based on limited interventions without the use of stabilising materials. It is carried out by using local earthen materials, and the new mudbricks are manufactured from the same clay found in the vicinity of the site to be preserved. These interventions appear useful and cost-effective. Maintenance is essential because they require continuous interventions to be effective, i.e. against weathering. These techniques also have the disadvantage of not being applicable when access to the site in question is no longer possible due to external factors. As for the use of stabilising materials, there is debate about the appropriateness of the use of chemical components in earthen architecture. On the one hand, their use as a hardener can be beneficial against weathering and other decay agents; on the other hand, their usage fosters change in the structural composition and stability of the architecture and poses issues related to sustainability and reversibility of interventions. Moreover, chemical components have the risk of being high-cost, hard to find locally, and environmentally unfriendly.

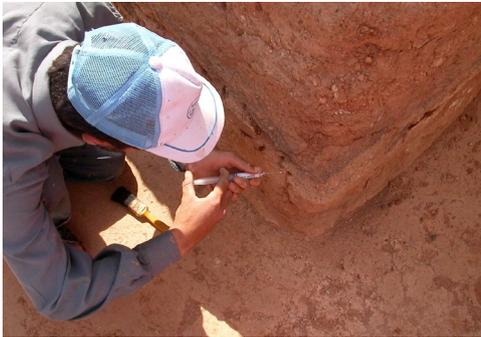
5 Area Q of the Western Palace, Ebla, Syria. Examples of conservation and restoration techniques: Interventions with the use of stabilising materials. (Photo: Nadali 2023, Fig. 6)

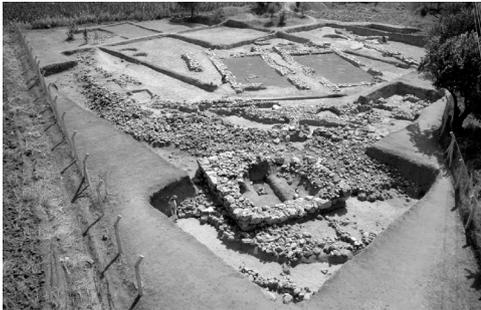
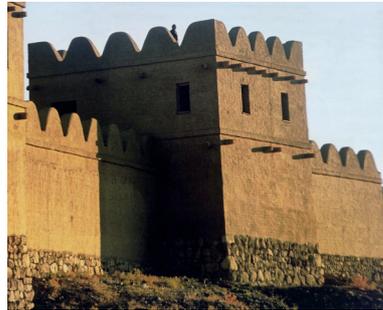
6 a. Kanlıgeçit, Türkiye/b. Hattuša, Türkiye. Examples of conservation and restoration techniques: Integrative reconstruction. (Photo a: Özdoğan 2016, Fig. 2; Photo b: Seeher – Schachner 2014, Fig. 10)

12 There are also two other possibilities, more restricted in terms of use and with several disadvantages, consisting of integrative reconstructions after backfilling (Fig. 6a. b) and encapsulation and capping interventions made with the use of backed bricks (Fig. 7).

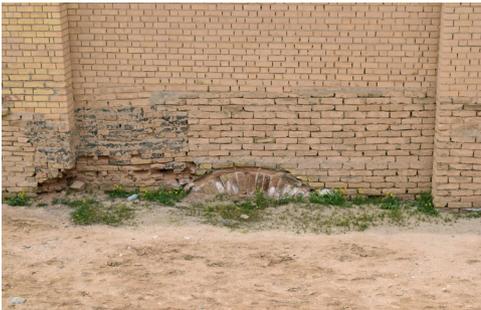
7 Babylon, Iraq. Examples of conservation and restoration techniques: Encapsulation and capping with backed bricks. (Photo: Luca Volpi)

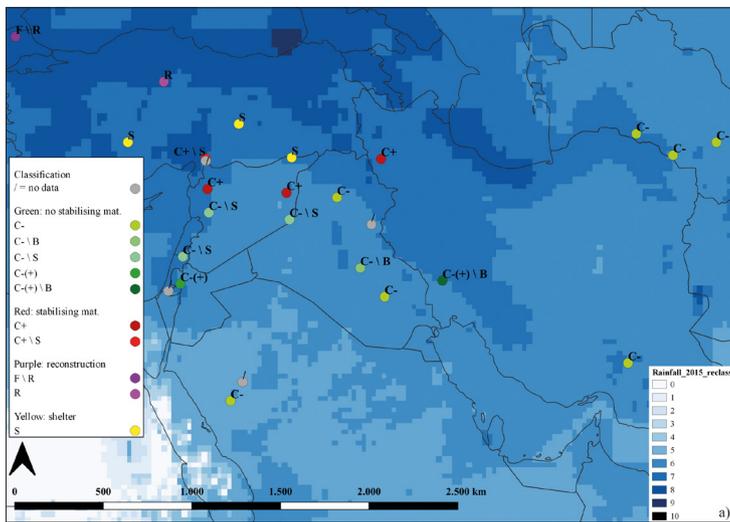
8 Western and Central Asia. Reclassified rainfall map with site classification. (Data: [https://neo.gsfc.nasa.gov/view.php?datasetId=TRMM\\_3B43M&year=2015](https://neo.gsfc.nasa.gov/view.php?datasetId=TRMM_3B43M&year=2015) <sup>↗</sup>, Reclassified map: Luca Volpi)

15 Water erosion is one of the most dangerous for earthen structures. The amount and frequency of rainfall during a year is one of the main climatic parameters to be considered (Fig. 8). The selected sites are included in four classes (classes 5–8). The conservation and restoration procedures performed have considered this parameter, considering that where rainfall precipitation is more abundant, various approaches have been used to protect earthen architectures, from backfilling with reconstruction in **Kanlıgeçit** <sup>↗</sup> (KLG) to the use of shelters in **Arslantepe** <sup>↗</sup> (ARS), **Çatalhöyük** <sup>↗</sup> (ÇAT), and Tell Mozan (MOZ), and to the use of stabilising materials, as for example at **Hasanlu** <sup>↗</sup> (HAS), **Tilmen Höyük** <sup>↗</sup> (TLH), and **Ebla** <sup>↗</sup> (EBL). Sites where rainfall precipitation is less frequent, there is a more widespread use of the conservation technique without the use of stabilising materials, as we can see, e. g., in **Mari** <sup>↗</sup> (MAR) and **Uruk** <sup>↗</sup> (URK).

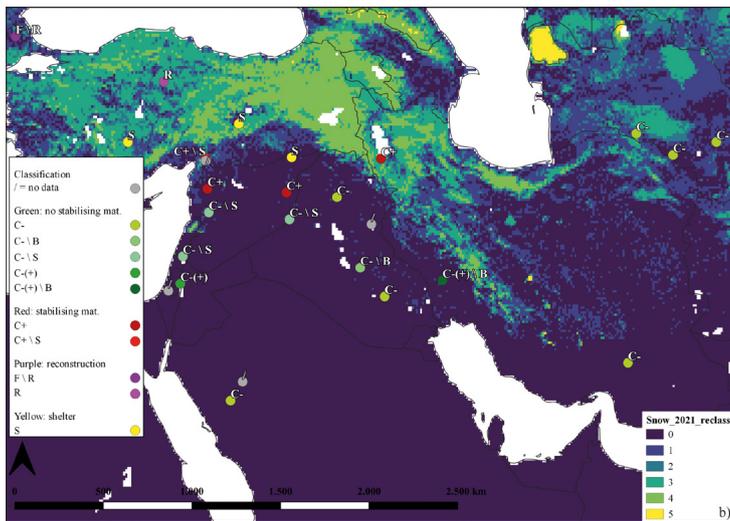
9 Western and Central Asia. Reclassified snow-ice map with site classification. (Data: [https://neo.gsfc.nasa.gov/view.php?datasetId=MOD10C1\\_M\\_SNOW&year=2021](https://neo.gsfc.nasa.gov/view.php?datasetId=MOD10C1_M_SNOW&year=2021) <sup>↗</sup>, Reclassified map: Luca Volpi)

16 Snow is another important parameter among weathering agents (Fig. 9). In most of the selected sites in Western and Central Asia, snow is never attested. However, in the sites where snow is present for one or more months of the year (classes 2 and 3), its presence is dangerous for earthen

architecture and has to be handled. In those cases, several solutions have been attempted: sheltering for Arslantepe (ARS) and Çatalhöyük (ÇAT) and using stabilising materials for Hasanlu (HAS). Where snow is rare or not present, there is a higher percentage of cases where it was preferred to proceed without using stabilising materials.

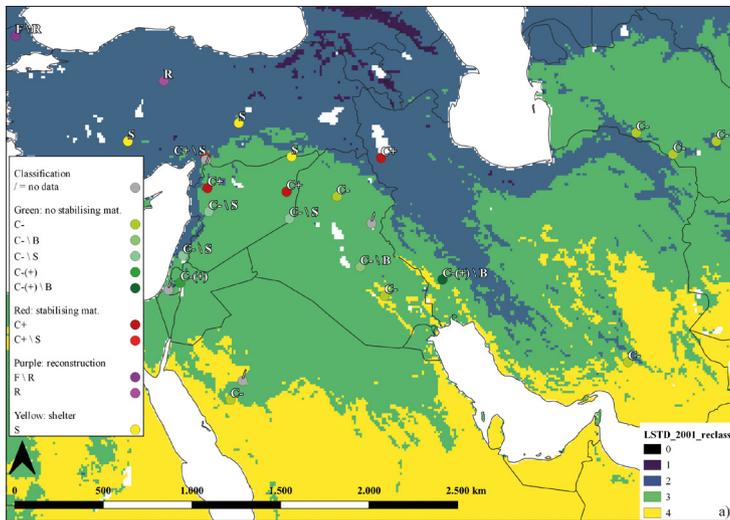
10 Western and Central Asia. Reclassified daily land surface temperature map (LSTD) with site classification. (Data: [https://neo.gsfc.nasa.gov/view.php?datasetId=MOD\\_LSTD\\_CLIM\\_M](https://neo.gsfc.nasa.gov/view.php?datasetId=MOD_LSTD_CLIM_M) <sup>?</sup>, Reclassified map: Luca Volpi)

17 In order to parameterise the dry-wet cycle, average land surface temperature data during the day and the night have been used. As for daily land surface temperature (LSTD; Fig. 10), a clear prevalence for interventions without the use of stabilising materials is noted in hotter and dryer places (classes 3 and 4). This is the case with sites like [Hegra](#) <sup>?</sup> (HGR), Uruk (URK), and Konar Sandal (KON). On the contrary, sites where the temperature is colder have been preserved using other approaches, as attested for class 2 sites such as Kanlıgeçit (KLG), [Hattusa](#) <sup>?</sup> (HTS), and Hasanlu (HAS).

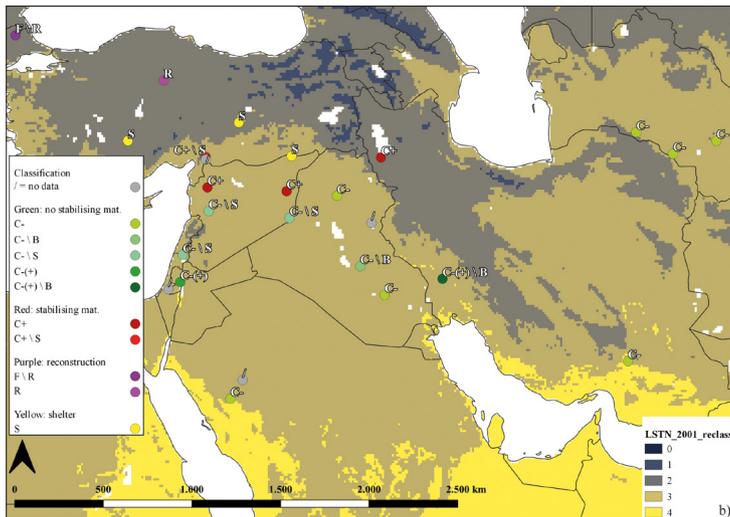
11 Western and Central Asia. Reclassified nightly land surface temperature map (LSTN) with site classification. (Data: [https://neo.gsfc.nasa.gov/view.php?datasetId=MOD\\_LSTN\\_CLIM\\_M](https://neo.gsfc.nasa.gov/view.php?datasetId=MOD_LSTN_CLIM_M) <sup>?</sup>, Reclassified map: Luca Volpi)

18 A similar pattern emerges from the analysis of nightly land surface temperature (LSTN; Fig. 11). Sites belonging to class 2 have been variously approached: sheltering, integrative restorations, and conservations with the use of stabilising materials.
