## Madīnat al-Zahrā', Spain. Conservation and Investigation of an Iron Gate. Research Carried Out between September 2020 and March 2021

### Conservation and Investigation of an Iron Gate

Research Carried Out between September 2020 and March 2021

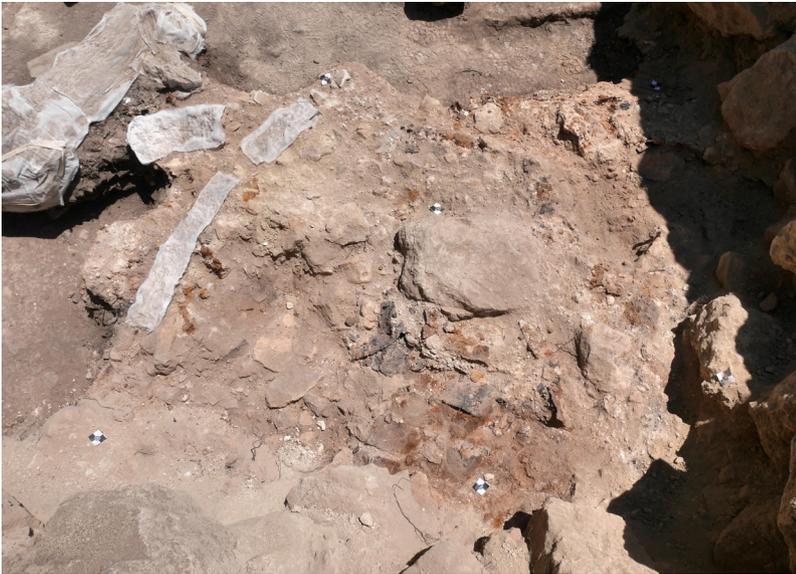
1 General view of the remains of the door at the site. (Photo: D-DAI-MAD-ARN-DG-29-2019-0696, Felix Arnold)

is aimed at the investigation of the forecourt of the palatial complex of [Madīnat al-Zahrā'](#)<sup>1</sup>, a purpose-built capital founded by the caliph Abd al-Rahman III in 936. In 2019 a gate was discovered on the eastern side of the monumental courtyard [1]. Initially the gate had served as the entrance to a building complex located to the east of the courtyard, but in its later stages it may also have functioned as an entrance to the courtyard. The gate was destroyed by a fire, probably as a result of the pillage of the city at the onset of a civil war (*fitna*) in 1010 CE [2]. Within the destruction debris iron elements of at least different door leaves were found, along with a large number of nails from the roof structure of the adjoining portico. Inside the gate itself several rivets were found. They probably had served to fix the wooden boards of one of the door leaves of the gate itself. Directly outside the gate, the remains of a second door leaf were found, completely covered by iron bands (Fig. 1). This second door leaf may originate from a neighboring gate, which remains unexcavated. The remains of this second door is the subject of this present preliminary report.

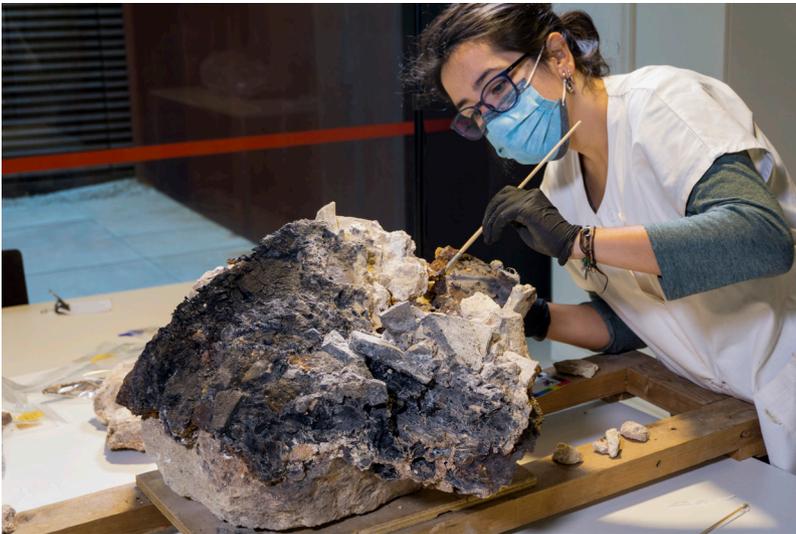
2 Micro-excavation of a segment of the door. (Photo: Alejandro Ugolini Sánchez-Barroso)

2 The remains of the door were recovered as a block, divided into several segments, and transported to the restoration workshop of the museum of Madīnat al-Zahrā'. In total four large segments were recovered, each more than 1 m<sup>2</sup> large, as well as nine smaller segments. The team of restorers at the museum developed a plan for the integral conservation of the recovered material, calling for a micro-excavation, followed by a consolidation and restoration [3]. The design and objectives set out in this document were tested in a short trial phase, followed by an extended campaign in 2020 and 2021 in which the archaeological excavation process of all the blocks was completed (Fig. 2). Throughout the process, the archaeologists worked closely with the conservation team to ensure that the iron remains, which were highly susceptible to corrosion and had been affected by the intense heat of the fire, suffered as little damage as possible.

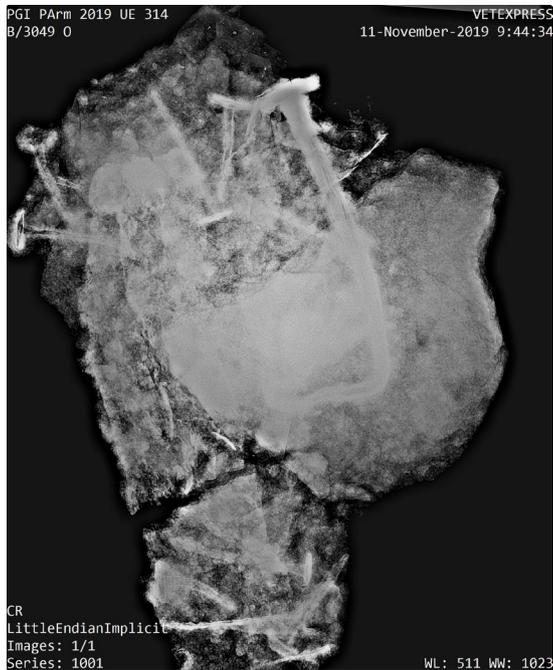
3 Detail of an X-RAY with nails and metal bands. (X-Ray image: Eduardo M. Hernández Robles)

4 Since all the materials came from a level of destruction and fire, the next phase of work consisted of determining the state of conservation and consistency of the remains. To this end, diagnostic radiography was used to determine the degree of metallisation of the iron for restoration treatments, as well as the location of possible nails and other elements inside each segment (Fig. 3).

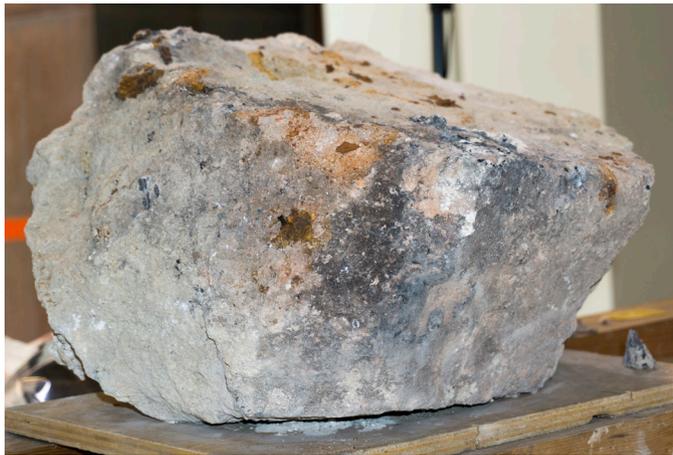
4 Architectonical element with marks of fire and iron. (Photo: Alejandro Ugolini Sánchez-Barroso)

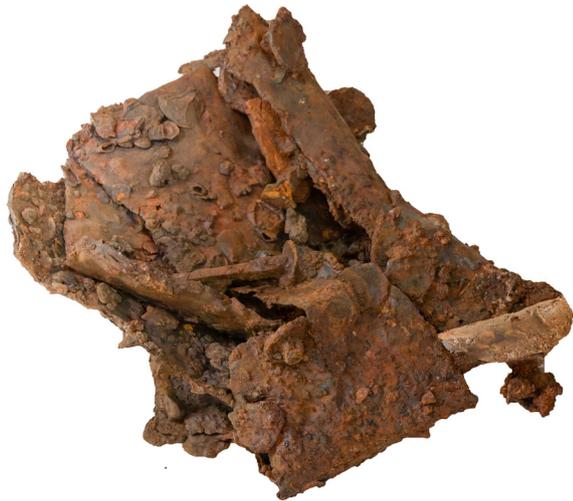
5 Documentation of the work progress in 3D. (3D model: Alejandro Ugolini Sánchez-Barroso)

6 In order to document the evolution during the main phases of the micro-excavation, 3D models of each segment were made to follow the different phases, as well as orthophotos, to study in detail elements difficult to see with the naked eye (Fig. 5).

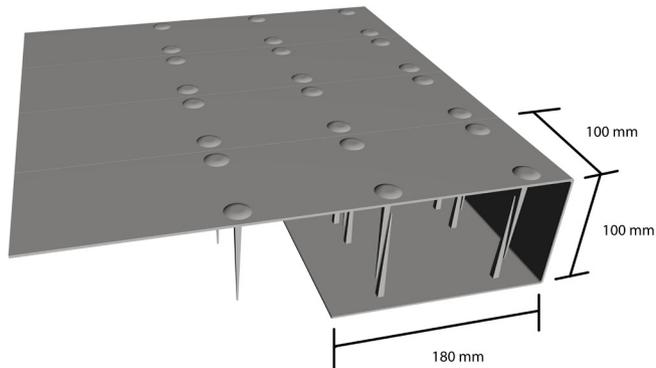
6 Schematic reconstruction of the iron bands covering the door leaf. (Graphic: Alejandro Ugolini Sánchez-Barroso)

- 8 The stratigraphic sequence is consistent in most segments of the door. It is possible to identify a uniform level of iron bands that form the surface of the door and that were the reason for the inverted excavation of the different blocks. At this level there were iron bands between 9.5 and 11 cm wide and 2 mm thick, with a length that encompassed the entire preserved width of the door. These bands were attached to the missing wooden structure of the door with iron nails, each 8 cm long with flat heads, placed in two parallel rows at regular intervals of about 11 cm (Fig. 6).

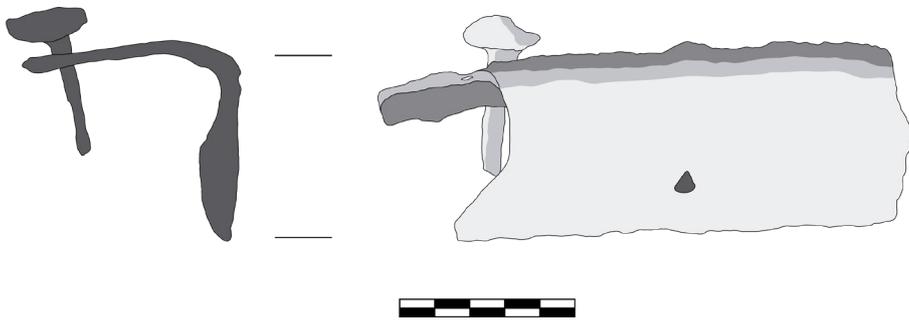
8 Fragment of a metal band bent at a 90° angle to covered the bottom of the door leaf.  
(Drawing: Alejandro Ugolini Sánchez-Barroso)

- 11 The excavation of the door elements has provided detailed information on its morphology. The surface of the door had been covered by parallel iron bands that were 10 cm wide and 2 mm thick, except at the lower end, where the corresponding band was bent longitudinally at 90° to cover the bottom

side of the door leaf (Fig. 8). Unfortunately, it was not possible to identify the basic elements of the door mechanism, such as the locking elements or the axis on which the door had been mounted for its correct rotation. Nevertheless, we can use similar examples from elsewhere to interpret its possible original appearance. The internal structure of the door was made of wood, as evidenced by the remains of charcoal, with a frame composed of wooden beams, as has been the case for large doors since at least Roman times [5]. The cavities of this frame were covered with a wooden board on which the iron bands was applied.

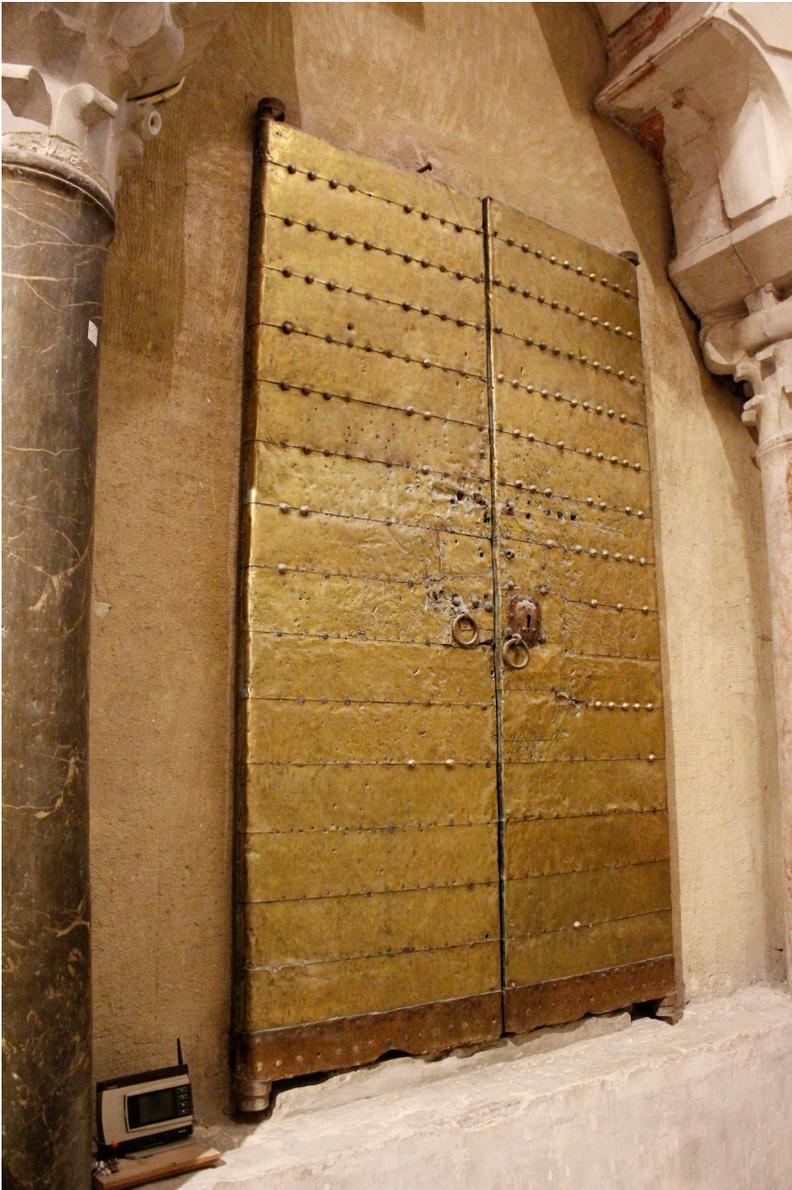
9 Door leaves of the 10<sup>th</sup> century covered by brass bands at the Mosque-Cathedral of Córdoba (Spain). (Photo: Alejandro Ugolini Sánchez-Barroso)
