Bas Beaujean, Johan Claeys, Frans Doperé, Jeroen Poblome

A Chronological and Functional Assessment of the Roman Imperial Bath-Gymnasium of Sagalassos (SW Asia Minor)

Istanbuler Mitteilungen 73, 2023, § 1–141

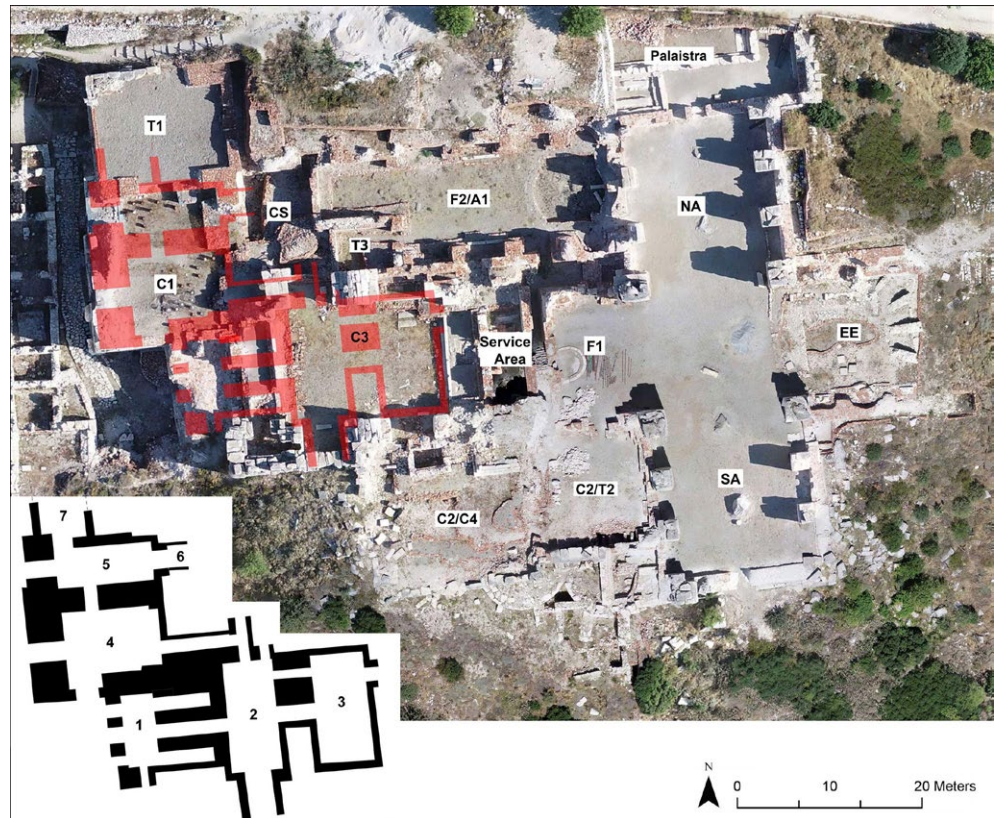
2

Fig. 1: An orthophotographic image of the site of Sagalassos in 2019, indicating the Bath-Gymnasium and other sites which are featured in this paper.

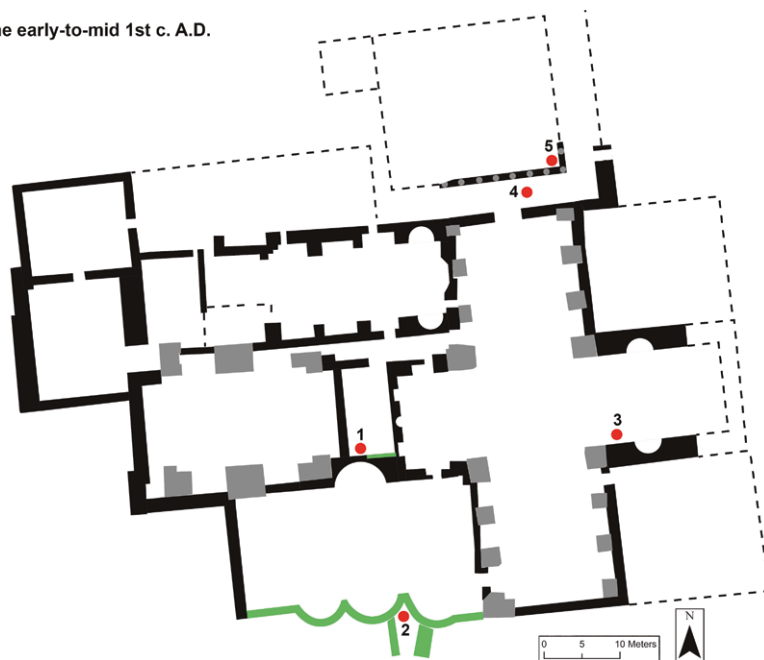
4

Fig. 4: Map depicting the known parts of the Old Baths (green) against the backdrop of the late 1st–2nd c. A.D. complex. The find locations of early-to-mid 1st c. A.D. datasets are indicated (red), respectively being (1) the 1st century *praeefurnium*, (2) in between the central and eastern apse, (3) below the foundations of the cross-shaped hall in EE, and (4) and (5) near and within the later *palaistra*.

12 In addition to apsidal walls and a pool, a mid-to-late 1st c. A.D. *prae-furnium* was documented in the so-called Service Area (fig. 4). The surviving remains consist of a brick feature constructed in front of a now filled-in vaulted passage (fig. 8). Immediately to its east, the three lowest courses of the northernmost remaining wall section of the Old Baths still stand in worked limestone blocks. In front of the channel, the brick-type of the lower courses – which form the lower vaulted passage – clearly differed in size (26 × 26 × 3 cm) from later brick sections on top (40 × 40 × 5 cm). Firmly stuck to the top and in between the brick feature were several deposits containing 50–100 A.D. SRSW. In addition, some remnants of strata associated with the corresponding floor level pro-

15 A control excavation in between the stylobate of the 2nd–early 3rd c. A.D. *palaistra* and the northern wall of the cross-shaped hall exposed earlier contexts, as well as the ophiolitic bedrock (fig. 4. 9). Based on the pottery, the lowest deposit was dated to 50 B.C. – 50 A.D., succeeded by a 10–35 A.D. stratum, which was topped by a 350–400 A.D. layer. As the foundations of the northern wall were present below the

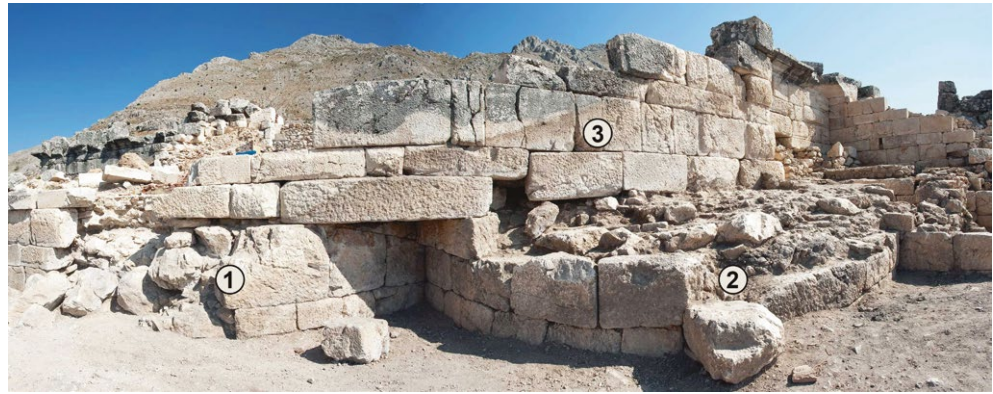
6

Fig. 7: Northern (left) and eastern (right) view of the eastern half of the eastern apse. Originally it included (1 and 3) an apsidal pool, which was incorporated into the Bath-Gymnasium. Eventually, it was turned into a *prae-furnium*, with (2) air flues and a (4) furnace opening towards T2.

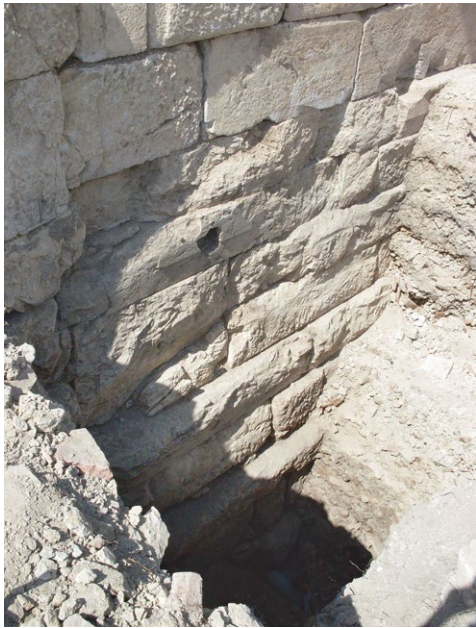
12

Fig. 12: Southwestern view of the control excavation exposing the impressive foundations of the southern wall of the cross-shaped hall.

²⁰ The southern wall of the cross-shaped hall (SA) consisted of an ashlar exterior placed in between the southwestern and -eastern piers, and a later inner face of mortared rubble (fig. 11). A control excavation reached the foundation trench of the outer wall, as well as the southwestern pier, 6.80 m below the floor level (fig. 12). The foundation fill consisted of a mix of reworked ophiolite and building debris, and included late 1st – early 2nd c. A.D. SRSW sherds. The substructure of the wall and pier consisted of 15 ashlar courses, which were more roughly worked in the lower courses. The ashlar of the original visible masonry construction show a clear setting back in contrast with the foundations (fig. 12), likely indicating the first floor of the SA area. Firstly, these results provide a late 1st – early 2nd c. A.D. construction date for the southern wall and southwestern pier. Considering the shared construction technique, and the fact that the piers can only function as a group, we presume the other 15 piers were erected in the same period. Secondly, based on the relationship between the later mosaic floor and the setting back, the floor did not shift significantly during the next five centuries of use.

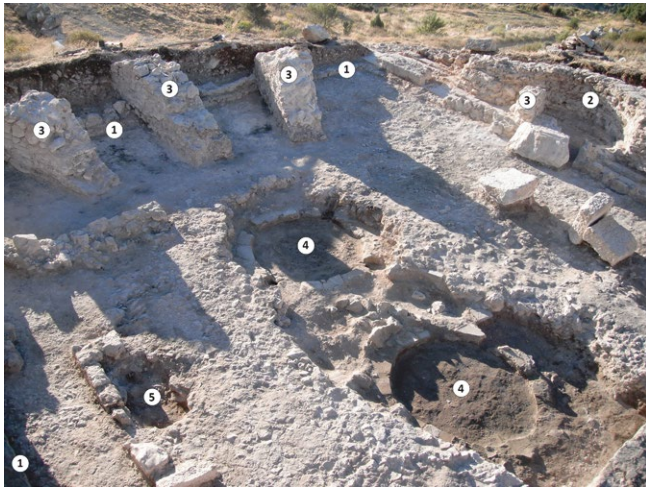
17

Fig. 17: North-western view of the EE area. Visible are (1) the faint traces of the late 1st – early 2nd century foundations, (2) the late 1st – early 2nd century southern wall (cut out in the late 6th – early 7th century), (3) the later radial walls and associated structures, (4) the 6th century lime kilns, and (5) a 6th century metal kiln.

67 The radial structure was partially dismantled to facilitate the construction of a rectangular metal-recycling kiln, four-to-five comparable features, as well as two circular lime kilns (fig. 17). The largest metal-recycling kiln (1.82–1.98 × 0.40 × 0.38 m) was defined by reused bricks and rubble, and a layer of clay – burned to a crisp red – created an impermeable floor (fig. 17). Its function was inferred on the basis of metal production waste. In the vicinity, similar undefined spots of burnt clay suggest additional recycling activities (fig. 3). The eastern (ø: 2.68 m) and western (ø: 2.10 m) lime kiln were delineated by reused bricks set in clay (fig. 17). Additionally, four reused terracotta water pipes provided air circulation to the eastern kiln. Based on the absence of metal waste, and the presence of comparable structures at Sagalassos, these circular kilns likely produced slaked lime. Concerning their use, their relation with a beaten earth walking level which developed around them and on top of the mortar substrate, provides a *terminus ante quem* between 575–600 A.D.⁸⁰. Subsequently, late 6th c. A.D. dumping activities filled-in these kilns, as well as the compartments in between the dismantled radial walls. We consider the activities of these kilns to be in the framework of organized activities directed at recycling useful building materials and/or parts of the decoration programme of the Bath-Gymnasium for other purposes.

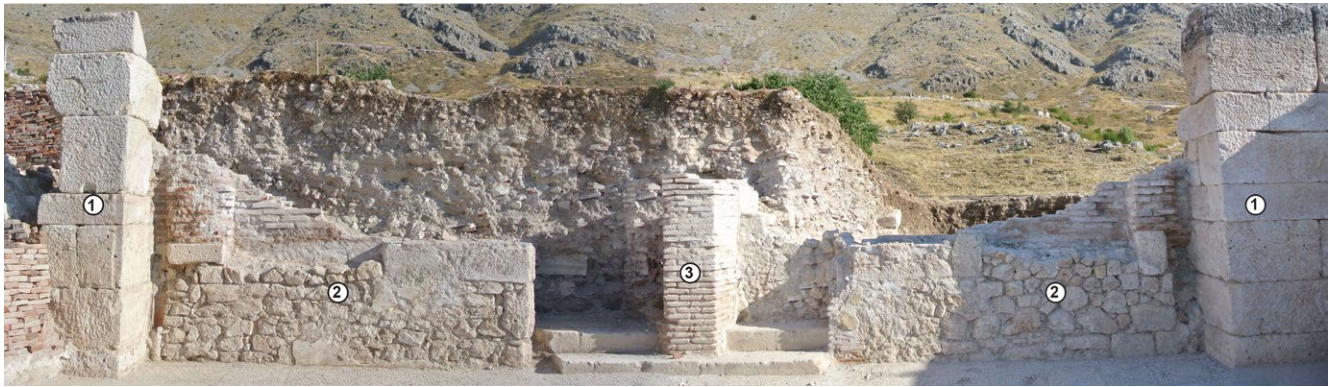
21

Fig. 21: The northern wall of the cross-shaped hall (NA), including the entrance leading to the *palaistra*. Indicated are (1) the late 1st – early 2nd century piers, (2) a later inner face set against the original brickwork, and (3) a later brick structure subdividing the original entrance.

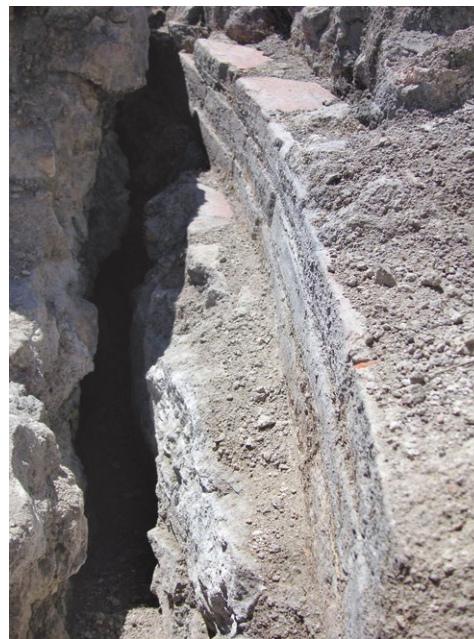
30

Fig. 31: Southern view of (1) the brick division wall subdividing C2 in C4 and T2. Indicated is (2) the location where this division wall bonds with the later southern wall.

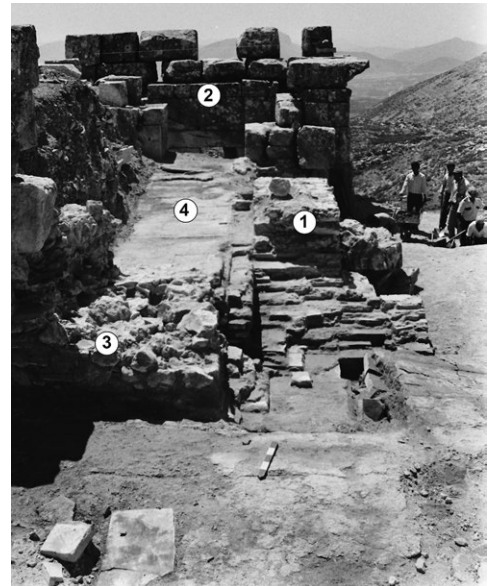
36

Fig. 36: Northern view of (1) the remains of the western wall of C3, (2) the southern wall of C3, (3) the wall defining the north-western corner of C3, and (4) the floor of the western pool.

(fig. 36). Only the southern part is substantially intact and consisted of limestone ashlar. Based on a few preserved parts, the original continuation of this wall is considered to have been built in *opus vittatum*, consisting of alternating bands of mortared rubble and brickwork (fig. 36). It is impossible to determine if it originally abutted an ashlar exterior. Finally, the outer face of the southern wall is composed of limestone ashlar (fig. 28). The inner face in the SE corner consists purely of brickwork, while the part in between the southwestern pier and southern entrance was built in *opus vittatum*. It is possible that the latter was modified when the western wall of C2 was (partially) rebuilt, and blocked the southern entrance.

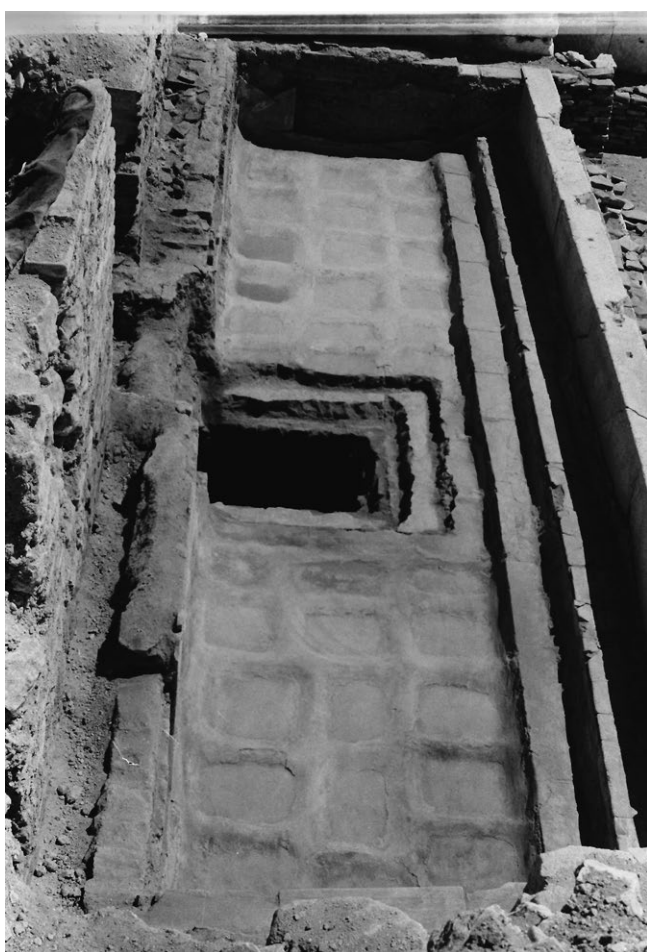
40

Fig. 39: South-eastern view of the western pool of C3. Indicated are (1) the late 1st – early 2nd century piers, (2) the original stairs, (3) the final location of the parapet, (4) the mortar substrate of the pool floor, (5) the remains of a later brick wall, (6) a 6th century smaller SW pool built partially on the steps.

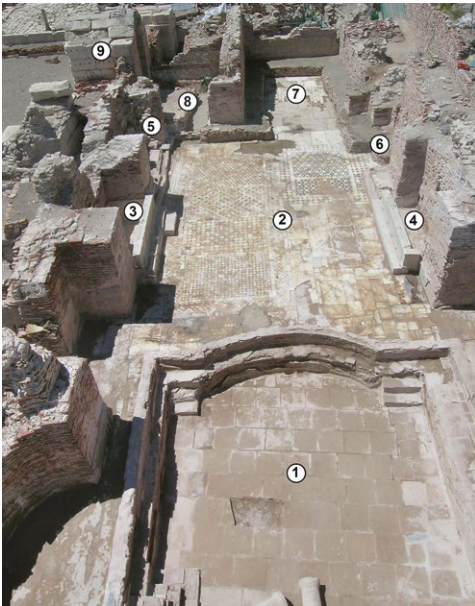
41

Fig. 41: Eastern view of F2/A1, indicated are (1) the late 4th – early 5th century eastern pool, (2) late 4th – early 5th century *opus sectile* floor, the late 4th – early 5th century (3) southern and (4) northern plunge pool, the late 4th – early 5th century (5) southern and (6) northern recesses with seats, (7) the late 4th – early 5th century *apodyterium* area, (8) the later *tepidarium* (T3), and (9) the late 1st – early 2nd century vaulted entrance to C3.

(fig. 41). In contrast to the other walls, the western wall was constructed in *opus vittatum* (fig. 43). We believe a west-east oriented division wall (fig. 43) to be a later modification, which would transform the original 2nd c. A.D. arrangement into one open space. However, it cannot be excluded that it already existed in the 2nd c. A.D. Currently, later modifications make it impossible to confirm the earliest function of this room. As there was no hypocaust system, a function as a *caldarium* or *tepidarium* can be excluded, and the substantial foundations of the eastern pool make a (partial) function as *frigidarium* likely.

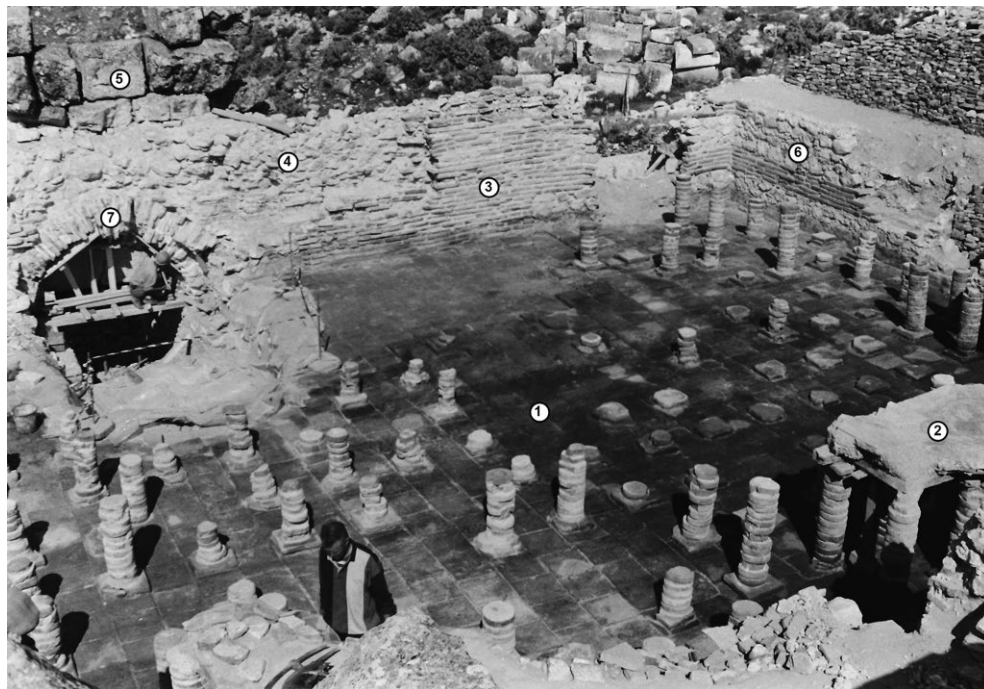
44

Fig. 44: Eastern view of the C1 area. Indicated are (1) the hypocaust, (2) the floor, (3) the brick facing of the western wall, (4) the mortared rubble core of the western wall, (5) the ashlar exterior face of the western wall, (6) the *opus vittatum* northern wall, and (7) the (collapsed) vaulted corridor of the ground floor.

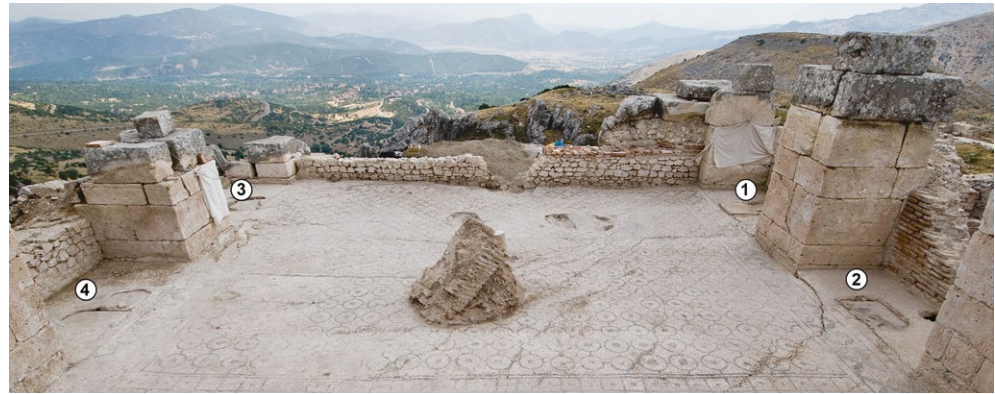
55

Fig. 55: Northern view of SA, and the 5th century mosaic. Indicated are (1) the south-western recess in which a statue of Hadrian stood, and the (2) central western, (3) south-eastern, and (4) central eastern recess where a statue of Faustina the Elder and two unknown empresses were positioned.

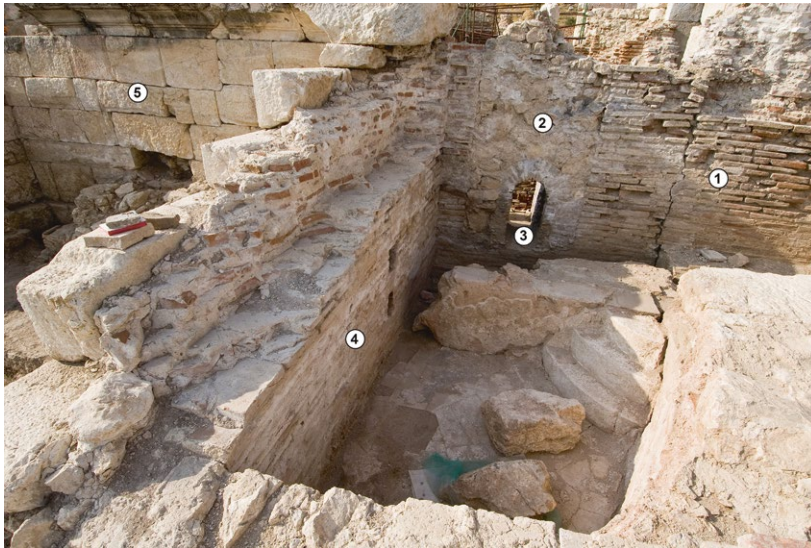
68

Fig. 68: Southern view of the south-eastern *praefurnium* serving T2. Indicated are (1) the later brick southern wall of T2, (2) the mortared rubble segment into which (3) the furnace channel was set, (4) the later brick western wall of the SE *praefurnium*, and (5) the later ashlar outer face of C4.

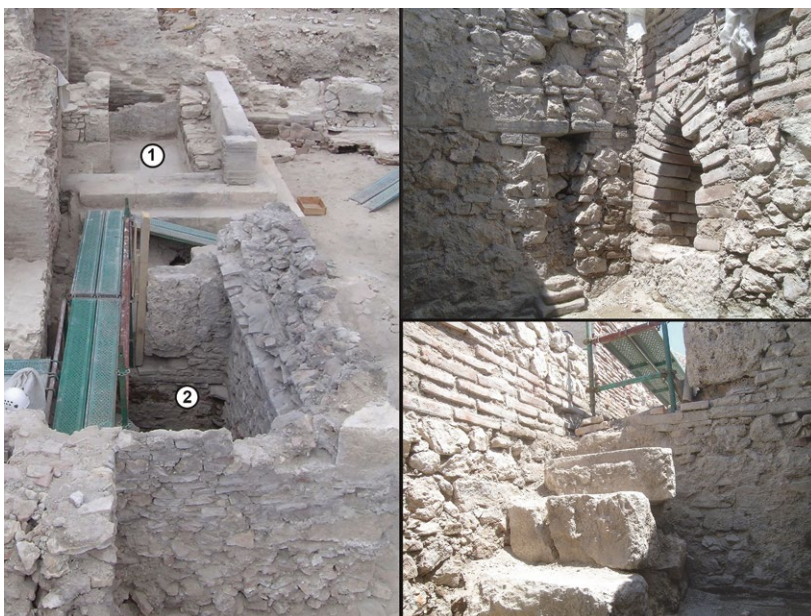
69

Fig. 69: (left) After the western parapet of (1) the C4 pool had been broken out, and the floor removed to install (2) the *praefurnium*, which served C3 via (upper right) an original opening, could be accessed by servants via (lower right) a series of steps.

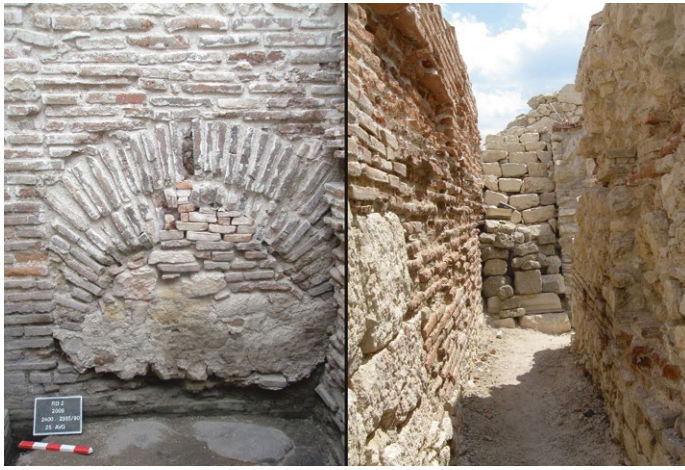
70

Fig. 70: (left) The opening carved into the western wall. (right) The later corridor, which was eventually closed to construct a staircase.

83 The southern segment of the service corridor to T2 was filled-in with mortared rubble (fig. 32), and make-shift stairs of reused blocks were constructed (fig. 70), which led to the roof or possibly a second storey. Remains of a water reservoir were also encountered at this level, positioned against the northern wall of the Service Area. This feature was possibly placed during this modification as well. Stratigraphically, the filling-in of the service corridor and construction of the stairs can be dated to the 6th c. A.D.

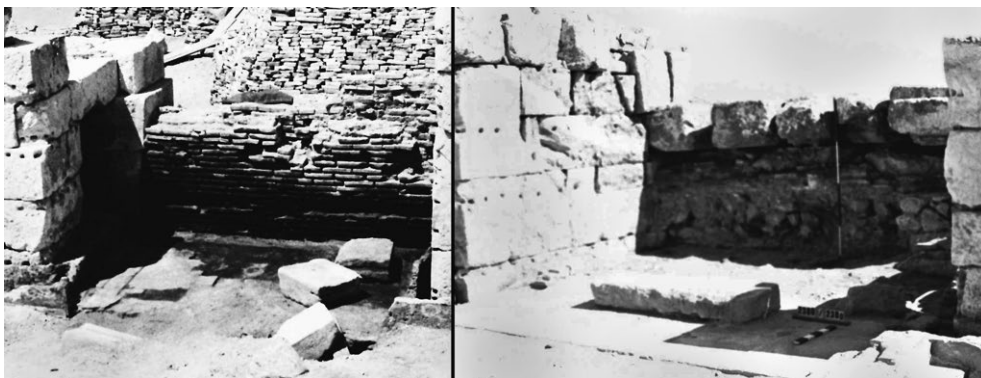
Fig. 74: (left) The north-western recess (in brick). (right) The south-western recess (in *opus vittatum*).

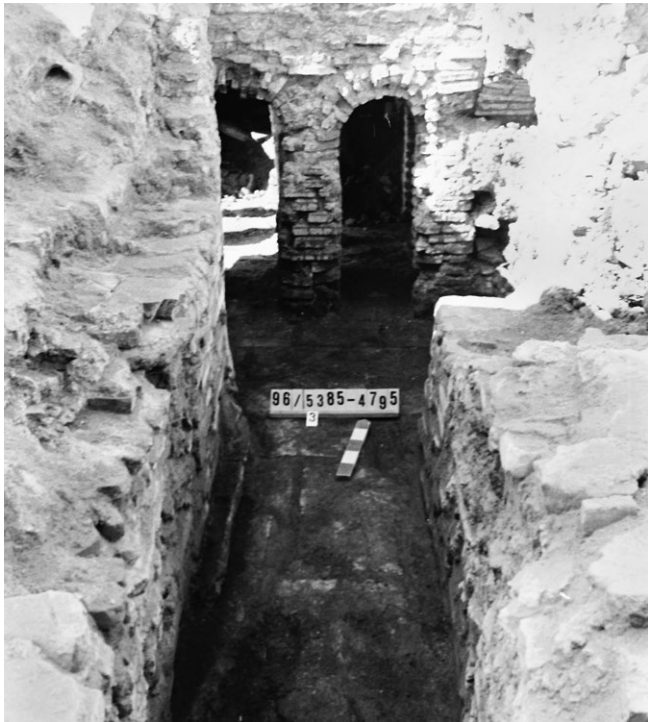
75

Fig. 75: Southern view of the newly cut connection between the later south-western *praefurnium* of C3 and its hypocaust.

to be dismantled. Along the eastern part of this new *praefurnium*, two vertical terracotta water pipes likely facilitated ventilation. A series of openings linked to a vaulted passage (3.60 × 0.80 m), which in turn connected to the hypocaust of C3 (fig. 75). The difference between the floor of the repurposed *praefurnium* (limestone slabs) and the hypocaust (brick) once more emphasizes that this was mostly a later modification⁸⁷. To facilitate entrance to the *praefurnium*, it is possible a small extension was built immediately west of the window (fig. 45), which then became an entranceway. Unfortunately, this extension had completely collapsed, and could not be examined. In all likelihood, it could be reached via a vaulted entrance in Room 1 (ground floor)⁸⁸.

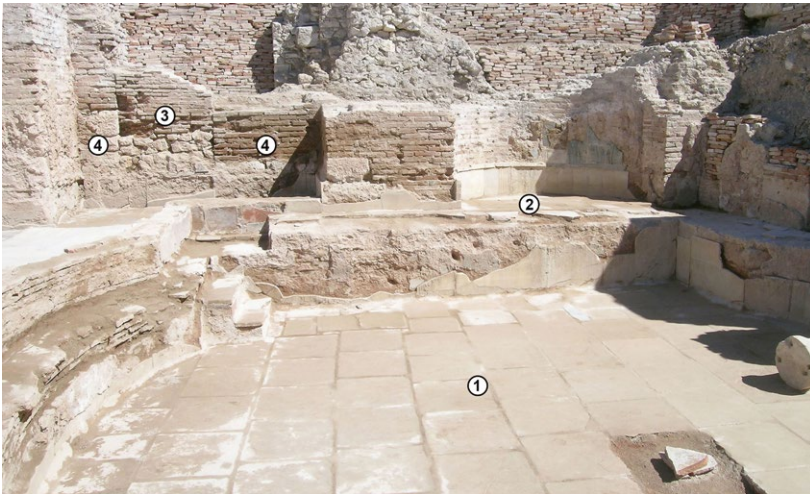
Fig. 77: Southern view of (1) the deep part of the later eastern pool upon (4) the original northern wall of F2/A1. Also indicated are (2) the shallow part of the pool, and (3) the blockage wall of an entrance.

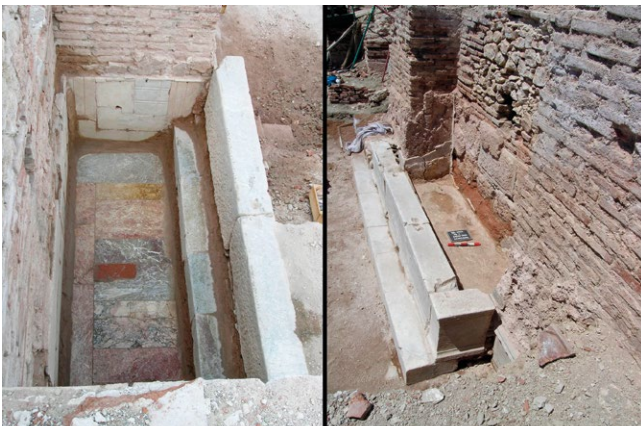
78

Fig. 78: (left) Eastern view of the interior of the southern plunge pool. (right) Eastern view of the northern plunge pool.

98 The southern pool was somewhat more sizeable ($3.85 \times 1.60 \times 1.25$ m), and more elaborately decorated (fig. 78). Like its northern counterpart, the back- and lateral walls were formed by the original wall of the room, and comparably refurbished with reused *crustae* set into a volcanic-based mortar. Two 0.70 m high limestone parapet slabs were installed on top of a brick substructure, akin to the C3 northern plunge pool. As the parapet abutted the veneering, it was placed afterwards (fig. 79). The brick substructure was completely covered in marble veneering, including reused, inscribed *crustae*. This included fragments of a poem, and ›Egyptianizing‹ scenes. Against the eastern and western end of this brick substructure, two limestone blocks were placed. As the western one abutted the gutter of the pool, these blocks were placed last or could even be later additions (fig. 79). The gutter descended westwards along the southern wall.

99 Moving to the interior, a lower step composed of four limestone blocks, was placed against the brick substructure and on top of the pool's floor. The latter consisted of at least four different types of colourful, marbled stone (fig. 78), likely reused. The presence of a rectangular opening – mirroring the repaired section behind the northern pool – seems to be part of the original wall (fig. 79). Currently, it is blocked by a later brick fill-in. Considering that this blockage is associated with the construction of the north-eastern pool of C3, and assuming that the considerable similarities between said pool and the northern and southern pools of F2/A1 imply simultaneous modifications,

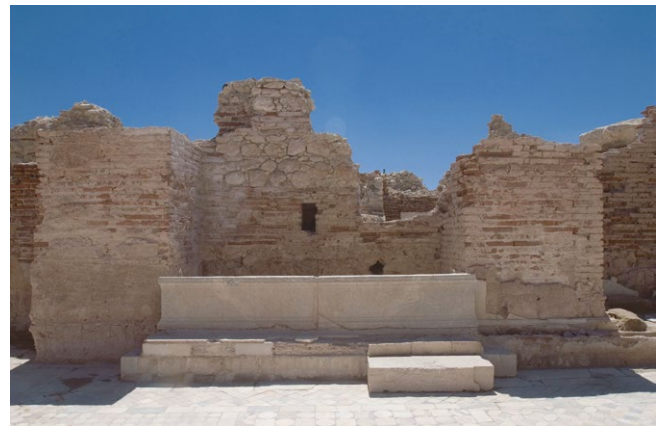
79

Fig. 79: Northern view upon the southern plunge pool. Also visible is the opening constructed in the original backwall.

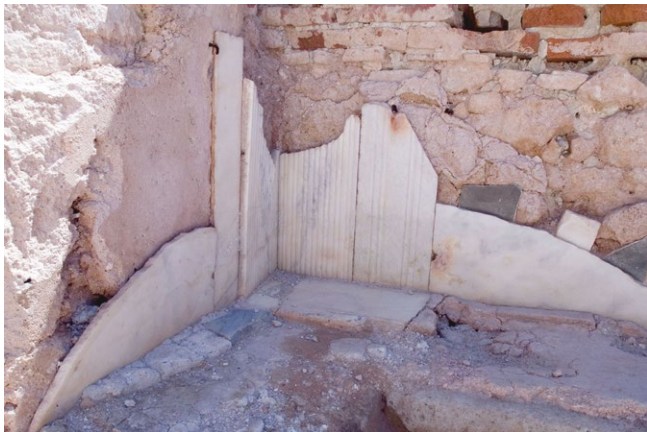
80

Fig. 80: Close-up of the seat in the southern rectangular niche. The reused *crustae* were attached by means of clamps and a pinkish lime-based mortar with hydraulic properties.

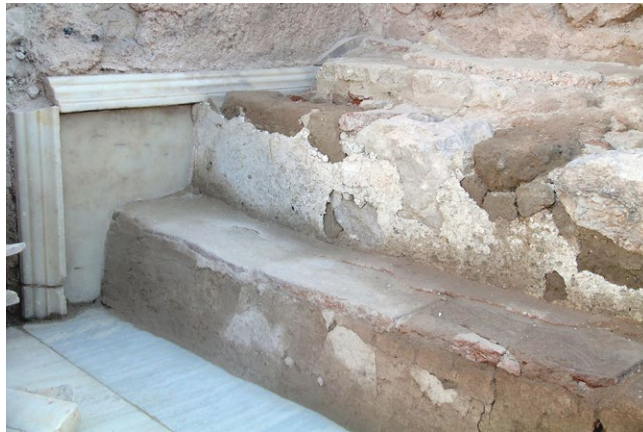
81

Fig. 81: Close-up of the seat in the northern rectangular recess. One can observe how the veneering is in accordance with the extent of these seats.

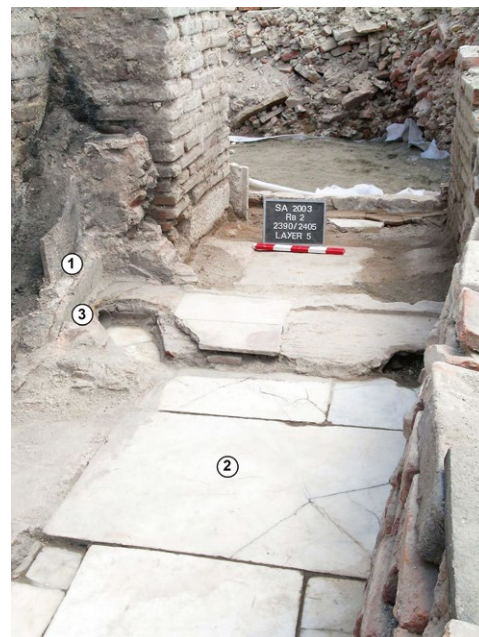
82

Fig. 82: Western view of T3. Visible are (1) a cavity wall, (2) the foot bath and (3) associated water infrastructure.

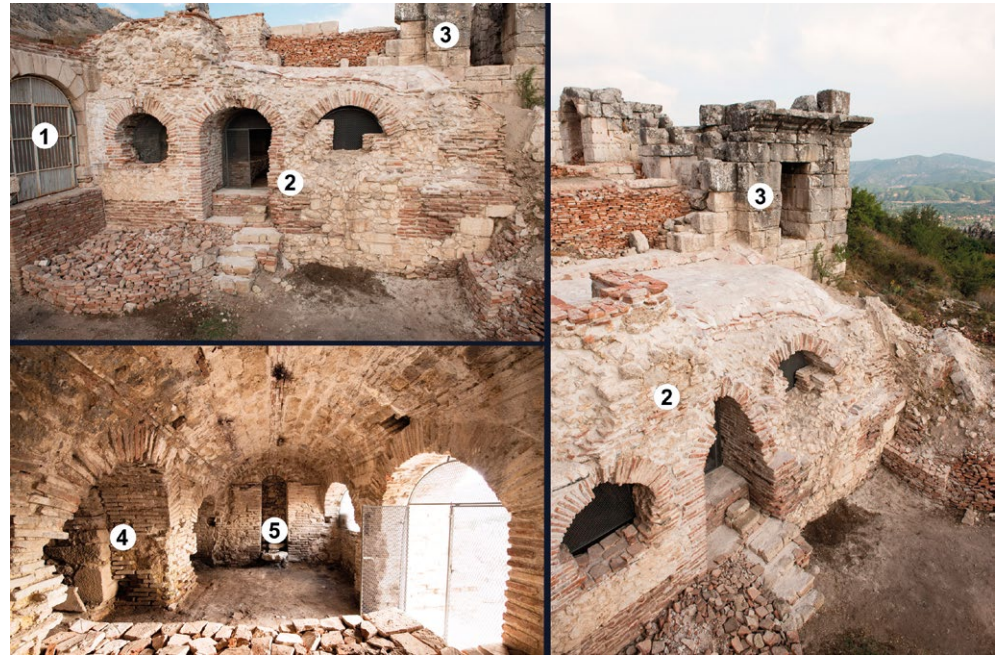
84

Fig. 84: (upper left) Western view of the exterior of Room 1. Indicated are (1) the original ashlar wall of Room 4 including the window/entrance, against which (2) Room 1 was set. (right) North-western view of the same situation, with a better view on (3) the SW corner of C3, against which a small platform was placed, using the window as an entrance. (lower left) Northern view inside Room 1, indicated are (4) the corridor leading to Room 2, and (5) a later entrance with a staircase ascending to the aforementioned platform.

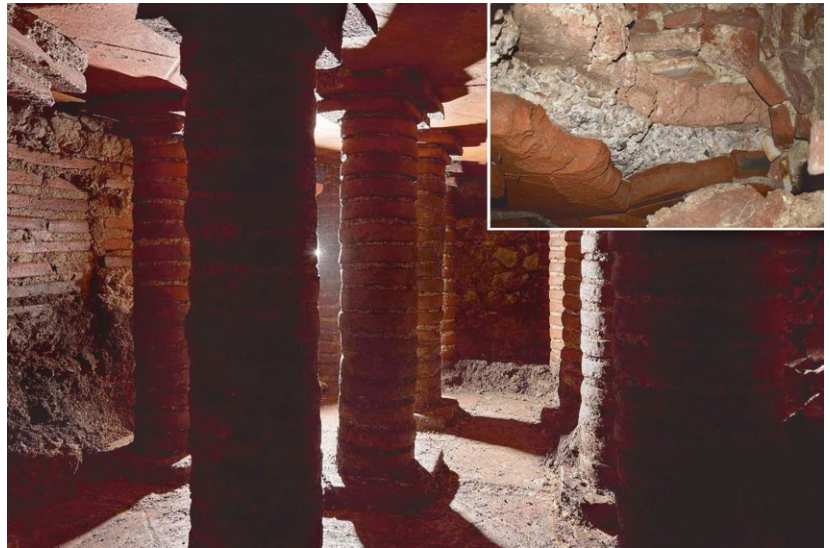
Fig. 86: (centre) Southern view in the hypocaust (immediately east of the service entrance). (upper right) Because of the central collapse, the make-up of the ceiling and first floor is visible: from bottom to top *bipedales*, *opus caementicium*, lime-based mortar with hydraulic properties, floor of marble tiles (buried below the collapse of the vaults).
