Tommaso Ismaelli

## Ancient Architectural Restoration in Asia Minor: Typology, Techniques and Meanings Discussed with Reference to Examples of Large-scale Public Buildings in Hierapolis of Phrygia, a Seismic City in Western Turkey

Istanbuler Mitteilungen 63, 2013, 267–324 (Sonderdruck)

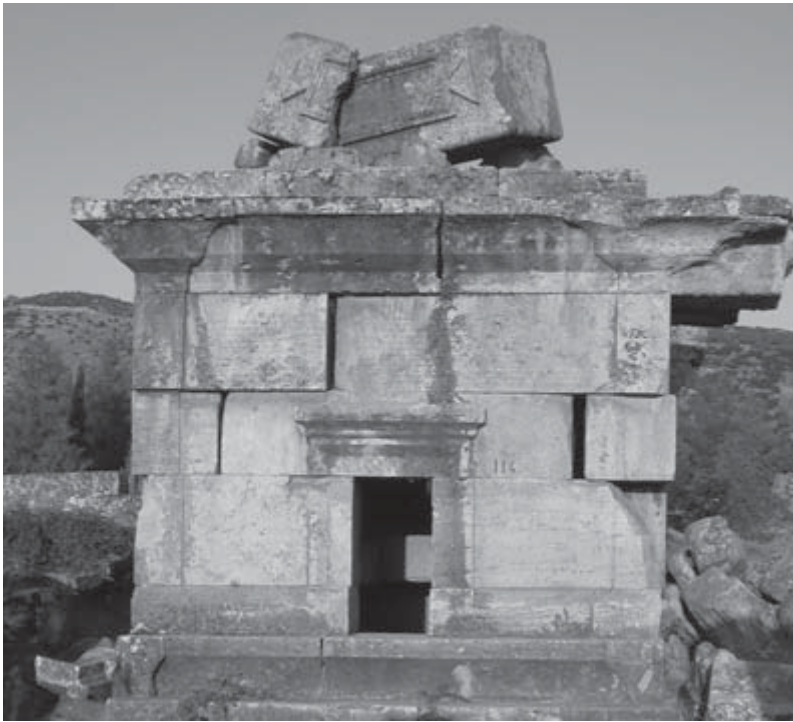
Fig. 2 Hierapolis, North Necropolis. The effects of disastrous earthquakes are visible on the tomb n. 114

In this framework, the geological instability of the site and the periodical recurrence of disastrous events are reflected in ways that differ from building to building depending on chronology (fig. 2). Indeed, analysis of the architectural materials reveals both improvised repairs and expensive rebuilding, carried out by the municipality or private citizens, sometimes with the help of the provincial or imperial authorities. Without attempting to describe the vast post-

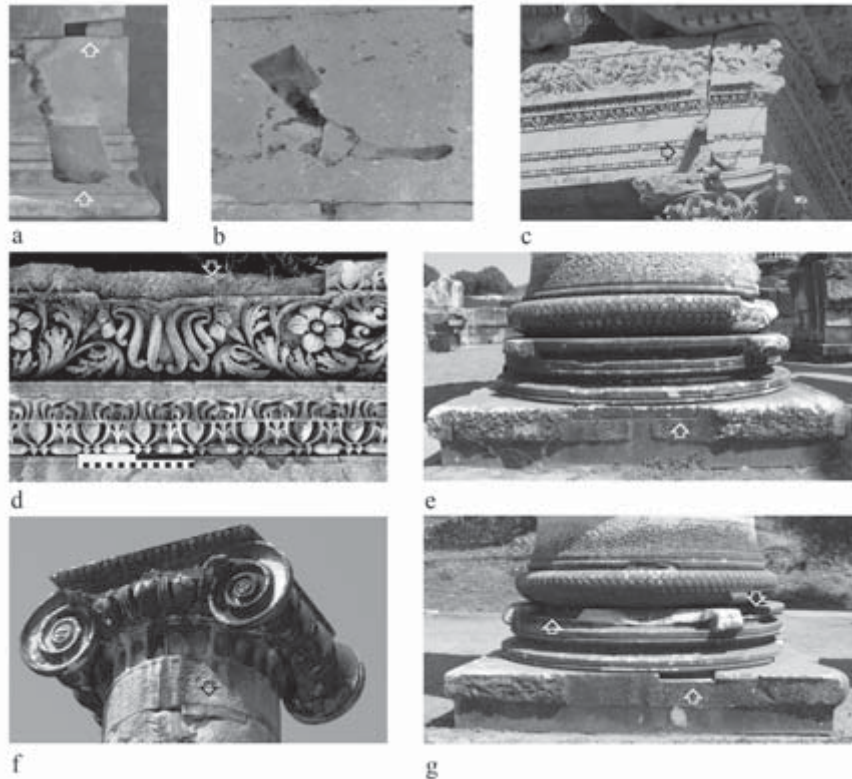
Fig. 13  
Type C restoration  
measure, sub-type  
C-1. a. b: Patara,  
Corinthian Temple;  
c. d: Sagalassos,  
Antonine Nym-  
phaeum, entabla-  
ture; e–g: Sardis,  
*Artemision*, Ionic  
bases and column  
shaft

13). In these cases the *emblema* varies in size, replacing only a small section of a moulding or a substantial part of the main block. Obviously intended to replace the limestone where it was characterized by small and irregular natural cavities are the *emblemata* used in the ashlar of the Corinthian Temple in Patara<sup>62</sup> (fig. 13 a. b).

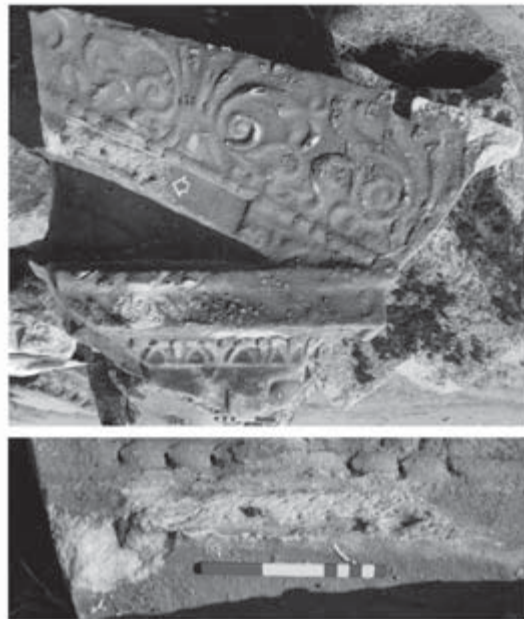
Fig. 18 Type D restoration  
measure, sub-type D-1 in  
Hierapolis. Ranking cornice  
of Temple A with iron  
dowel-rods still in place

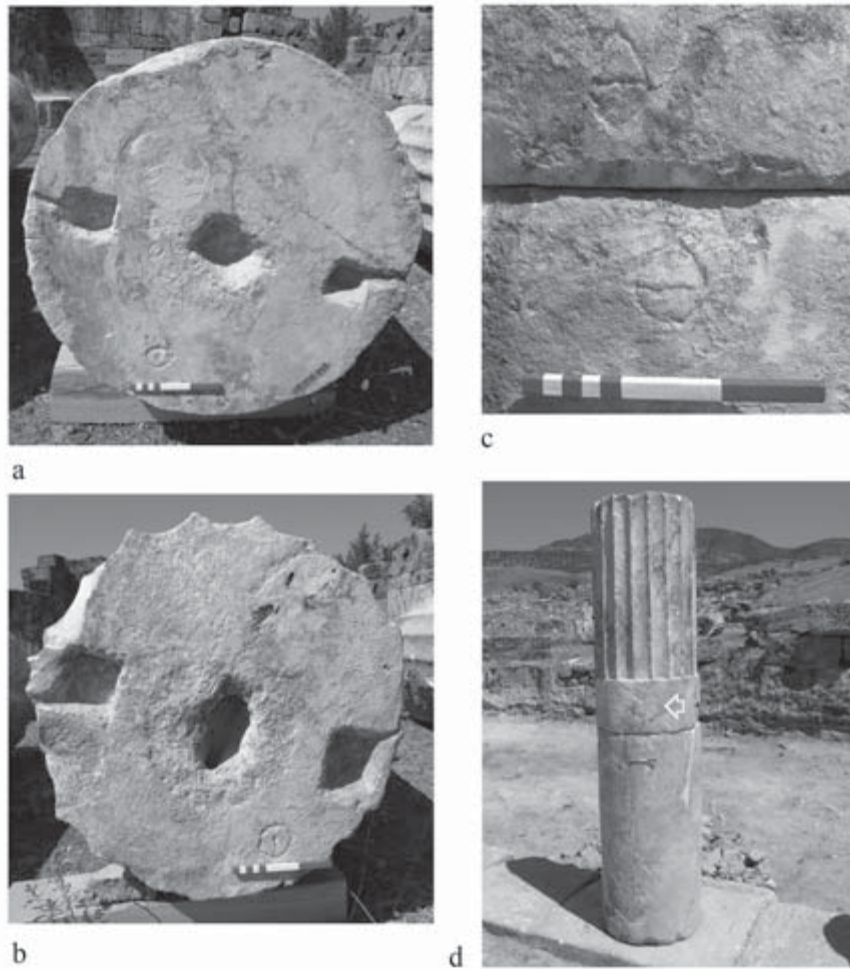
Fig. 27  
 Markings carved both on the two upper surfaces of the drums HSTM113+ HSTM114 (a. b) and the external face (c. d) in order to indicate the angle of rotation necessary to line up the holes for the internal dowel-rod

were carved only after the drums and the capital had been assembled, the markings inside the flutes cannot belong to the original phase of construction but must have been engraved on the occasion of some dismantling, in order to facilitate the subsequent reconstruction. Examples of this are seen on some columns of the Gymnasium and Marble Portico of Hierapolis<sup>98</sup> (fig. 26 c–i). Similar examples in Asia Minor can be found in the so-called *Prophethaus* in Didyma<sup>99</sup> and in the Doric portico enclosing the sanctuary of Dionysus in Teos<sup>100</sup>, which is known to have undergone extensive restoration in the early imperial epoch (fig. 26 l). Specifically, two drums of the Marble Portico in Hierapolis (HSTM113 and HSTM114) constitute an interesting case, in which the mason's marks used during the restoration, namely a *theta*, are carved both on the upper contact surfaces of the blocks and the external face, showing not only that the drums belonged to the same column but also indicating the angle of rotation necessary to line up the holes for the internal dowel-rods (fig. 27).

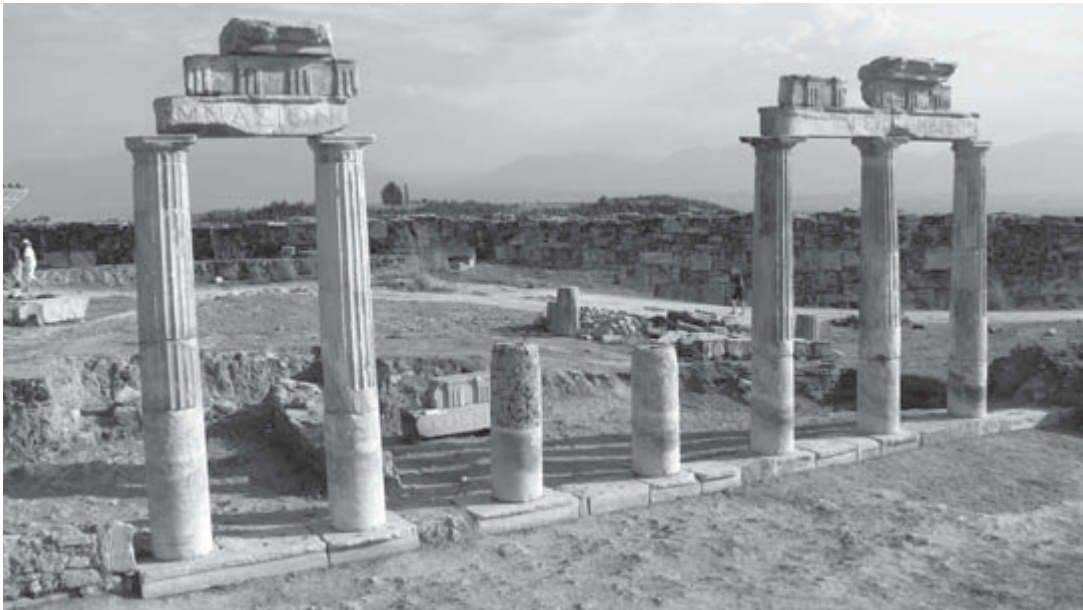
Fig. 31 Hierapolis, Gymnasium, the south colonnade of the palaestra after the recent anastylosis (2010)

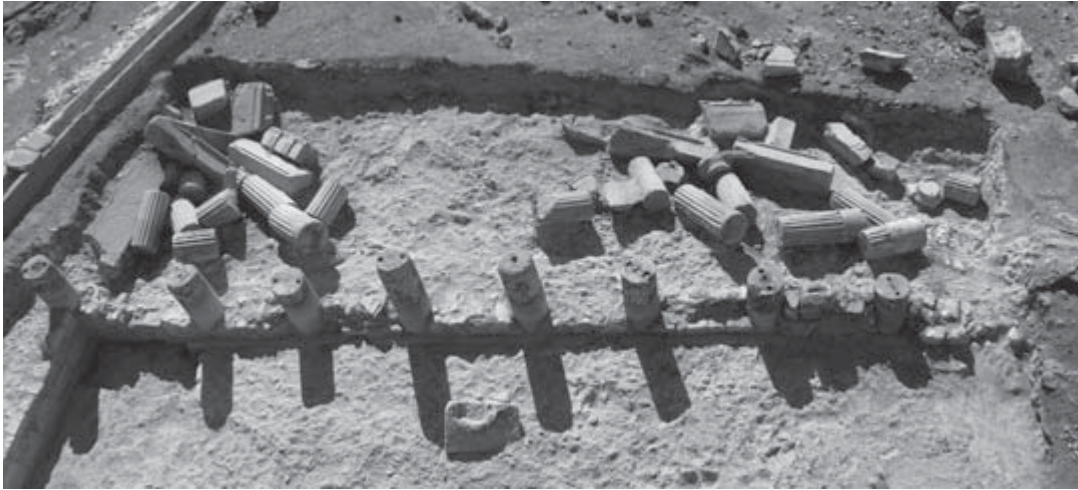
Fig. 32 Hierapolis, Gymnasium, the blocks of the south colonnade found in a collapsed position after the earthquake of the second half of the 7<sup>th</sup> century A.D. (2007)

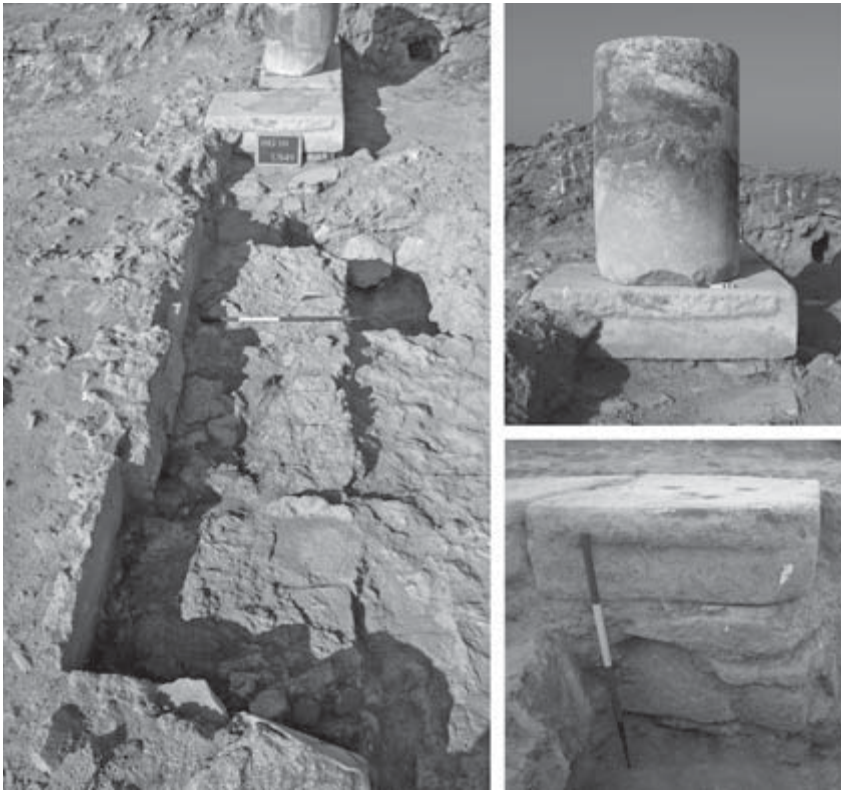
Fig. 36  
Hierapolis,  
Gymnasium,  
the Byzantine  
foundations of the  
portico made of  
blocks of varying  
dimensions, reused  
materials and lay-  
ers of bricks

were built, after the dismantling of the damaged ones. The excavation has shown that the new foundations were made of blocks of varying dimensions and reused materials (breccia column shafts, limestone blocks . . .), with layers of brick laid in such a way as to compensate for the differing levels of the stones (*fig. 36*). Above these foundations, which were quite different from the solid bases of large blocks used in the Roman phase, were laid the slabs of the stylobate, using elements of the original building. However the deployment of the blocks only partially replicated their original orientation: many of them appear to be rotated 90° or 180° with respect to their previous position.
