Olof Pedersén, Ammar Al-Tae, Thierry Grandin

The Processional Street at the Ishtar Gate in Babylon: The Construction of the Middle Levels during Nebuchadnezzar II

Zeitschrift für Orient-Archäologie Bd. 16 (2023), 320–355

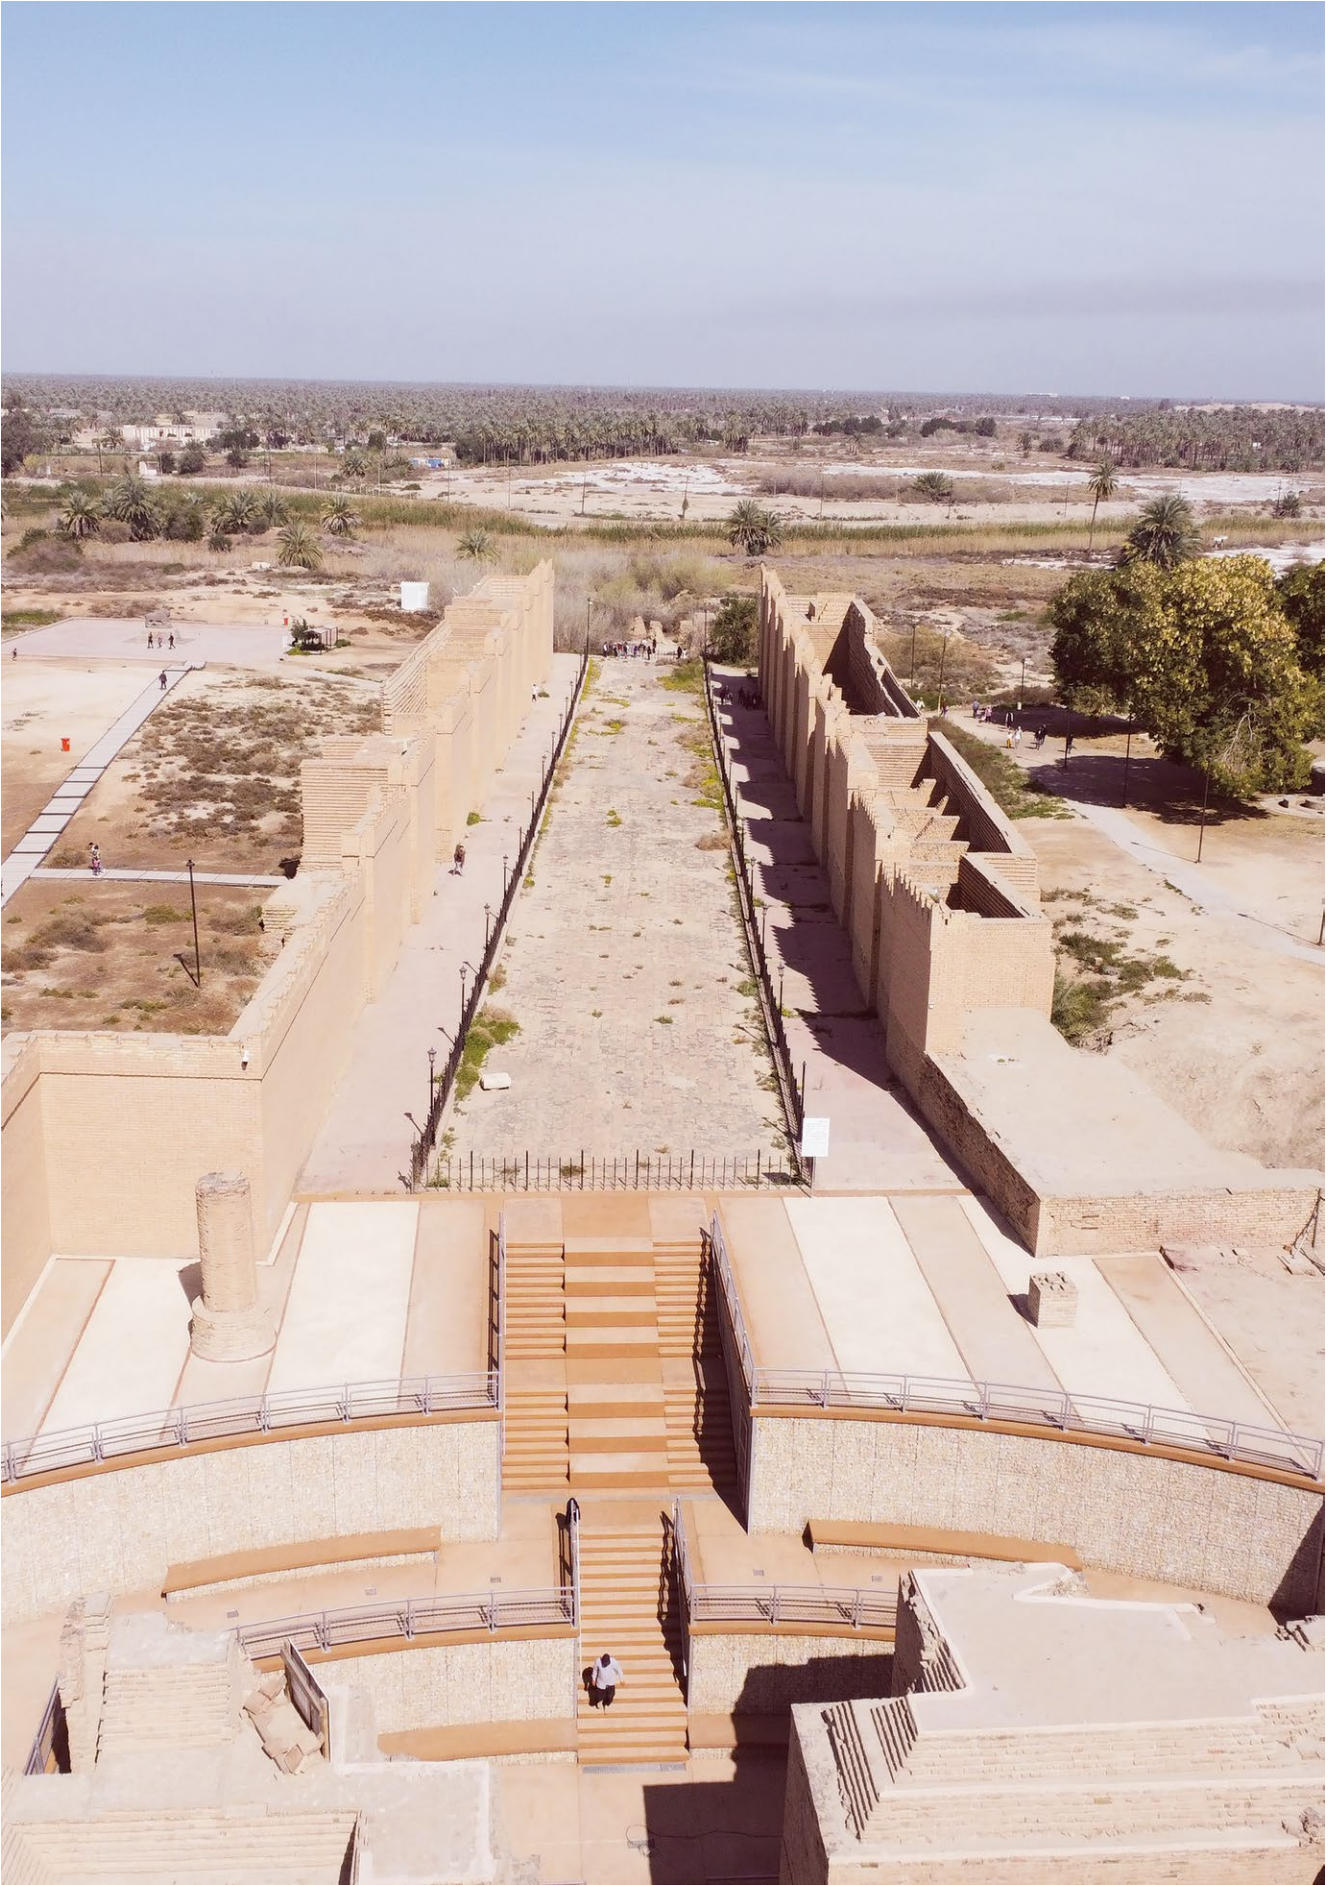
1

Fig. 1: The area in front of the northern entrance to the Ishtar Gate, shown as tourists will see it after completion of the construction work with the removal of the old retaining walls and staircase and construction of new retaining walls and staircase. The middle platform is at the height of the street level discussed here. December 2023

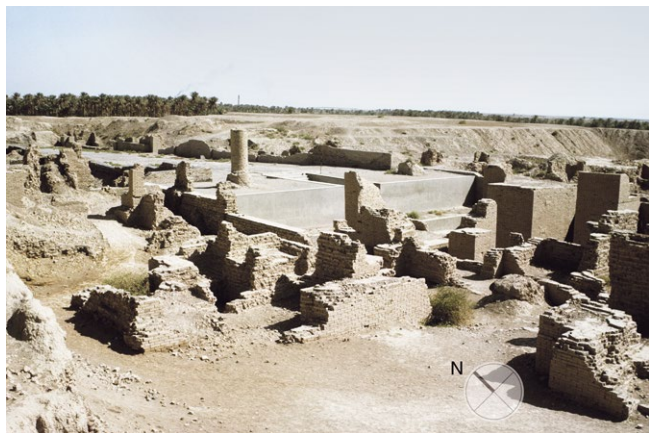
3

Fig. 3: The area north of the Ishtar Gate seen from southwest on a photo taken around 1970 before the reconstructions taking place around 1980 and the reshaping of the German dump in the background. The 1959–2022 grey retaining wall north of the Ishtar Gate. Above it is the round pedestal to the left and corresponding to it on the right side the remains of the square pedestal

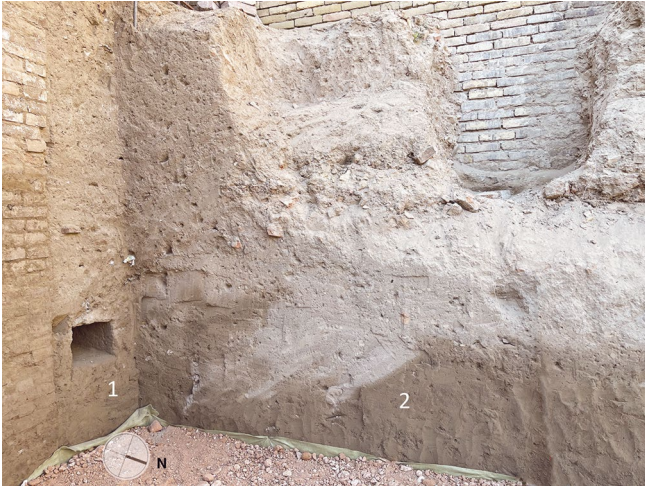
Fig. 8: Profiles 1, 2, late during excavations. In the profile modern infilling with ancient clay below. The fallen bricks from the collapsed section of the west wall were removed. At the bottom, recent green geotextile and infilling of reddish sand, clay and gravel. 28 February 2022

20 The western section is c. 15.4 m wide and 4 m high (c. 29 MASL to 33 MASL) and mainly consists of c. 2–3 m of soil in front of the mostly reconstructed remains of the south-north wall (Fig. 11 compared with Fig. 7 and Fig. 13). Due to the brick miners' activities, the German excavators found only parts of a thin façade preserved of the originally 5 m thick brick wall (for which see Profile 10 below). A c. 3 m wide section of the preserved façade had collapsed before the construction of the 1959 retaining walls and fallen down along with the top of the fallen wall at c. 29.8–30.3 MASL (Figs. 9. 35). The bricks in the collapsed section were removed and those still intact will be reused to repair the Ishtar Gate. The layer with brick fragments may also come from this modern collapse of the same wall. The bottom of the original wall was established during the German excavations as +5.68 or 31.18 MASL and the reconstructed part of the wall stands on a small concrete base, here marked as 31.0 MASL. Below these modern layers are ancient layers of clayey sand, sandy clay, and clay (Figs. 8. 11. 12).

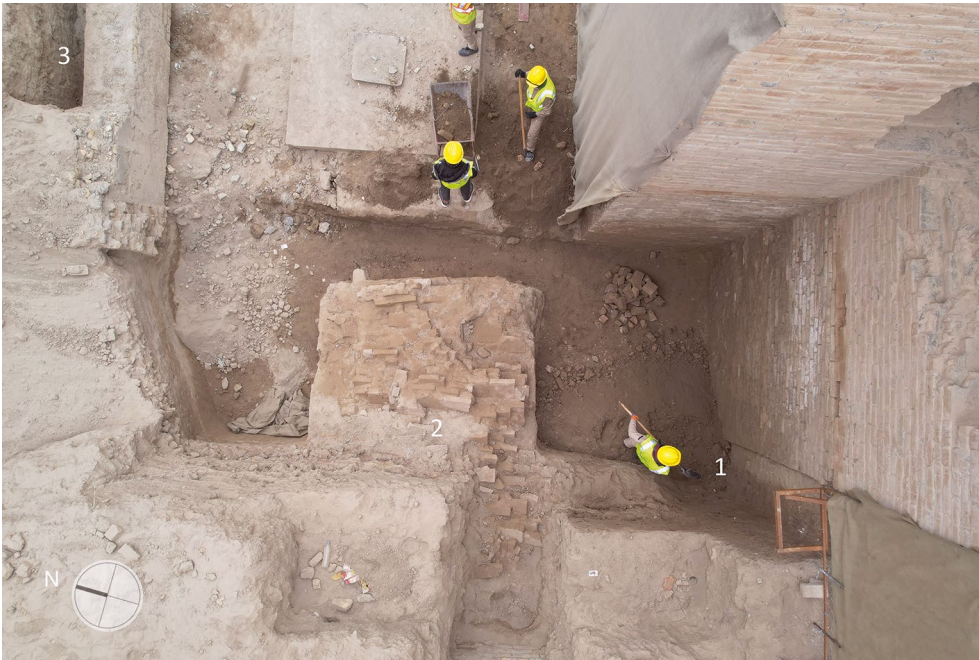
Fig. 9: Profiles 1–3 from above during the middle of the excavation. The fallen bricks from the 3 m wide collapsed section of the west wall are still in place, but numerous scattered brick fragments around it have been cleared away. Cf. Profile 10. 31 January 2022

36 The west wall as it now stands is mostly reconstructed with only minor original parts (Figs. 35, 36). The exposed part south of the 1959 retaining wall is 15.4 m long and c. 5 m high (c. 31 MASL to 36 MASL). Due to the brick miners' activities taking out most inner parts of the 5.0–5.6 m thick brick wall, the German excavators found only three sections preserved of a thin façade of the thick brick wall, for which compare Profile 2.¹⁴ The northern of the preserved sections had the top at +8.05 = 33.55 MASL during the German excavations and is now preserved to an almost flat height at 32.5 MASL. The middle section was much higher when excavated at +11.06 = 36.56 MASL, now it is only 32.7 MASL. The third section was standing even higher at the excavation, at +11.95 = 37.45 MASL, which is at most 6.4 m above the foundation at 31.0 MASL. That section, which had later collapsed and fallen in an eastern direction, was now excavated with the core up to 4.2 m from the original wall position and there were fragments even further away (Figs. 9, 35). The collapsed wall section had the top at c. 29.8–30.3 MASL.

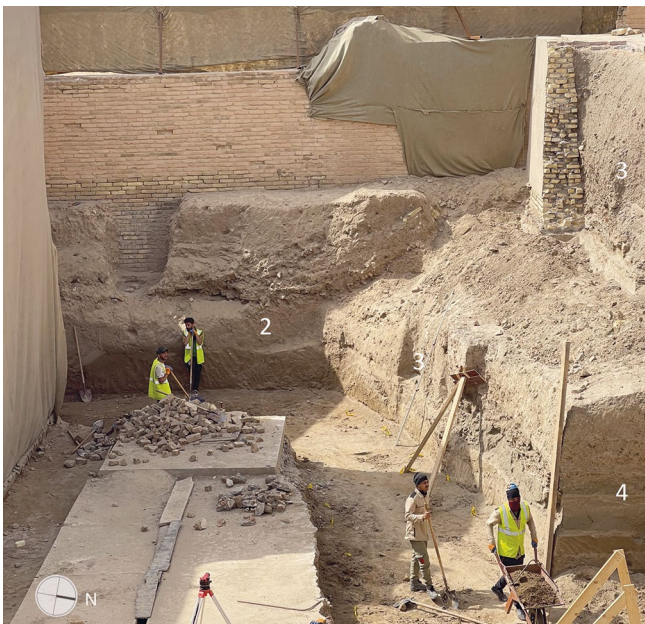
Fig.10: Profiles 2–4, late during excavations but before infilling of reddish sand. The mostly reconstructed west wall, with modern infilling in front and ancient layers below. The fallen bricks from the collapsed section of the west wall have been removed. 24 February 2022

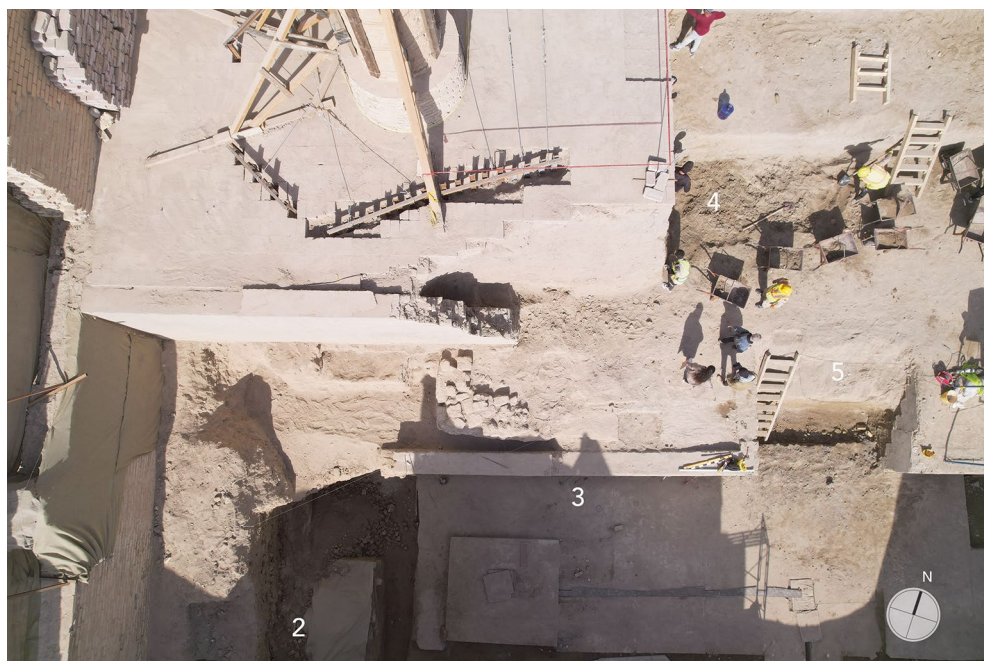
14

Fig. 14: Profiles 2–5, from above, early during excavations with only some of the retaining walls removed. In the middle of the photo between the retaining walls is the mudbrick wall with top at 32.2 and to the right of it the compacted layer. 24 January 2022

22 The west section of Profile 3 is c. 12 m wide and 7 m high (c. 29 MASL to 36 MASL), with the lower third c. 2–3 m in front of the upper two thirds (Fig. 13 compared with Fig. 19). The upper half of the profile is modern, probably a refilling from 1959 with loose sand, containing old and modern materials. In one spot, there is a small, much deeper pit with modern fill including modern brick fragments. There are several alternating sand and clay layers, in two places separated 2 m apart with thinner white layers. There are traces of a compaction layer at c. 31.7 MASL; the layer is rising in a western direction. The compaction layer was heading towards a mudbrick structure now removed due to the present construction work (Figs. 9. 10. 14. 15. 16. 17. 18).

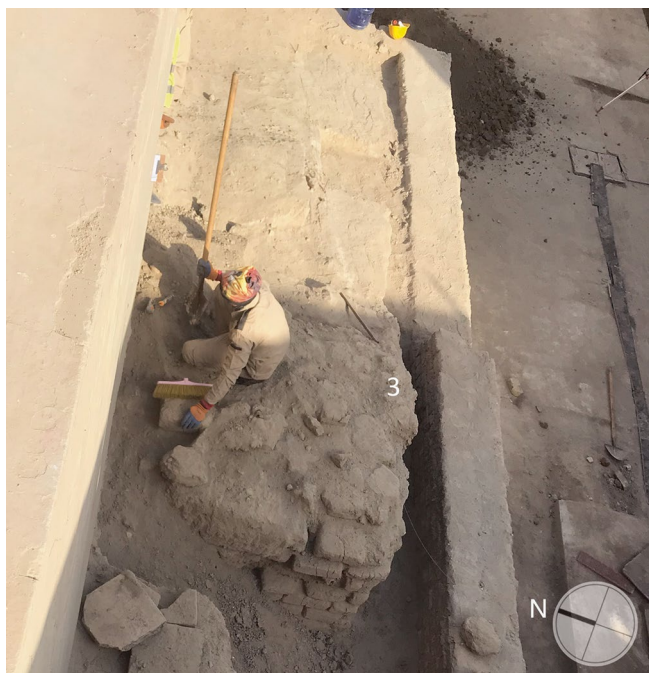
15

Fig. 15: Profile 3, middle levels, looking east, early during excavation. The mudbrick wall with top at 32.2 and the compacted layer behind; both were later removed. Remains of modern retaining walls later removed. 23 January 2022

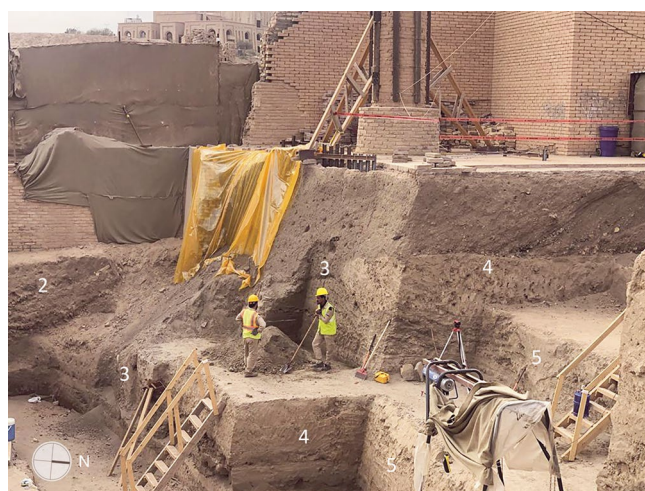
16

Fig. 16: Profiles 2-5, late during excavations. Additional excavations after collapse of modern upper fill in order to make space for an extra protective brick wall. In the lower level (at 3) is a brick and mudbrick wall over the wooden support. 6 March 2022

25 The west side of the south-to-north stair profile is 7 m high (c. 29 MASL to 36 MASL) and up to 13 m wide (Figs. 16. 19. 20. 21. 22). It shows essentially the same levels as Profiles 3 and 5 (Figs. 13. 23), but from another perspective. We can see the upper modern infilling, the clay and sand layers, and the compacted layer at 31.7 MASL. Noticeable is the change in the lower third when passing in a northern direction; the four different layers stop and are replaced with clay alone. In Profile 5 the unified clay structure is even clearer.

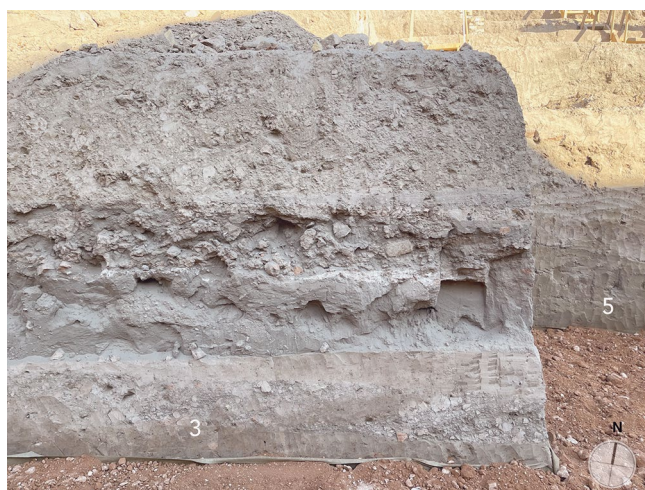
18

Fig. 17: Profile 3, middle level, late, after additional excavations in a northern direction for the extra protective wall. The first half of it has been constructed to the right, the old retaining wall is to the left. The space between was soon covered by the new protective wall. On the top is modern 1959 sandy infilling, below ancient sand, compacted clay, and sand. Top of red bricks at 31.9, thin white layer about 32.2. The removed mudbrick wall was situated about 1.5 m in the front of the depicted remains. It had the top at 32.2 and continued in southern direction. 8 March 2022

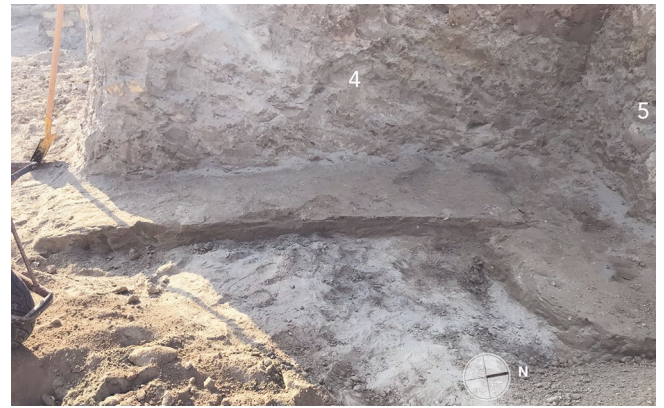
21

Fig. 21: Profiles 4, 5, middle level, early during excavations. Compacted layer at 31.7, later removed. 24 January 2022

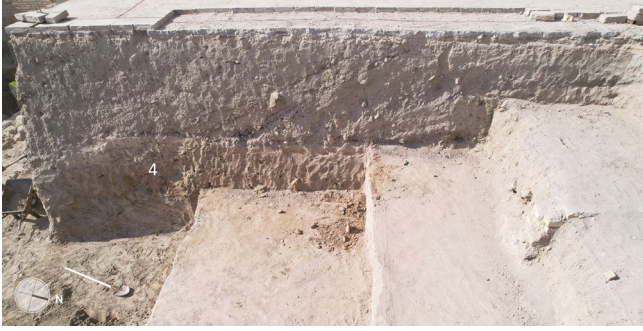
22

Fig. 22: Profile 4, upper levels, early during excavations. Left part later removed. Modern fill and ancient fill of clay below 33.8. 24 January 2022

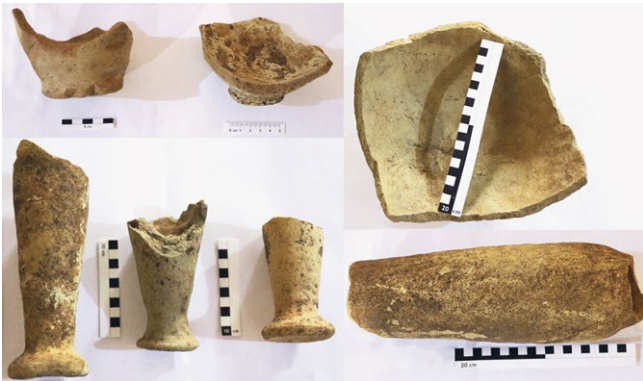
Fig. 24: Profile 5, upper levels. Neo-Babylonian pottery fragments from the upper, modern, probably 1959 infilling. January 2022

26 This profile shows the central section of the 32 m wide profile of the Processional Street in the area north of the Ishtar Gate façade; for the other two sections see Profile 3 and Profile 7. The section is c. 7 m high (c. 29 MASL to 36 MASL) with its lower third c. 7 m wide and the upper two thirds c. 9 m wide. Due to the modern staircase, this section is situated north of Profiles 3 and 7 and is stepwise retracting up to 13 m at the top (Fig. 23 compared with Figs. 19. 26). The upper third consists of modern refilling probably dating to 1959, with a mix of ancient material including seven broken Neo-Babylonian clay pots and two glazed brick fragments as well as some modern brick fragments and other material (Figs. 24. 25).

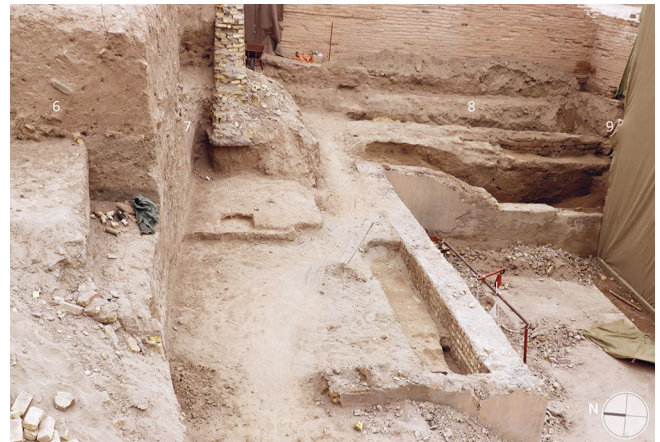
28

Fig. 28: Profiles 6-9, middle level, looking east, early during excavations. Compacted layer 31.7 under remains of the upper 1959 retaining wall. Compacted layer at 31.1 more to the right, to the left of the lower retaining wall. 11 January 2022

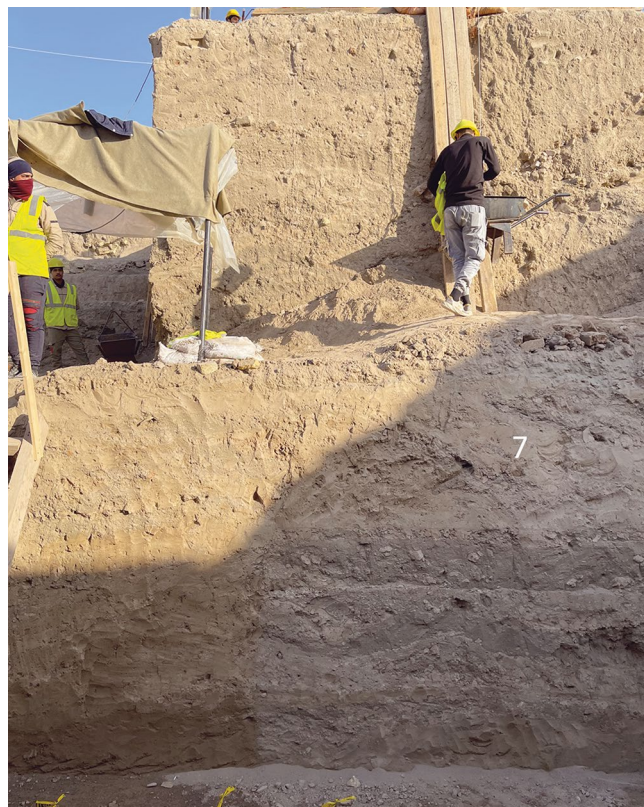
Fig. 30: Profile 7, late during excavations. Lower levels left are clay; lower levels right are various clay and sand layers including a thin white layer at 29.9. 23 February 2022

31 This section is c. 12 m wide and 7 m high (c. 29 MASL to 36 MASL) with its lower third c. 2–3 m in front of the upper two thirds (Fig. 29 compared with Figs. 26. 31). It shows the east section of the 32 m wide main west-to-east profile of the Processional Street; for the west and centre parts see Profile 3 and Profile 5. The upper approximate third is modern infill probably dating to 1959 when the retaining wall was constructed. Various layers of clay and sand follow (Fig. 30). In the exposed lower third, there is also a thinner, up to 6 cm white layer. There are two compacted layers (Fig. 28), a lower one at 31.1 MASL and an upper one at 31.7 MASL somewhat rising in an eastern direction where it is connected to a 3.3 m thick mudbrick wall built from the Ishtar Gate in a northern direction, as seen in Profile 8.

32 This section is c. 15.4 m wide and c. 4 m high (c. 29 MASL to 33 MASL) and situated c. 2–5 m in front of the ancient brick wall (Fig. 31 compared with Fig. 29 and Fig. 34). On the eastern side of the exposed area there are traces of two compacted layers near the Ishtar Gate at 31.4 MASL and 32.4 MASL. It seems reasonable to assume that these are the same layers as attested elsewhere at slightly lower elevations, given there is a slight slope downwards from the gate in a northern direction and also a slope downwards towards the centre of the street from the east, especially for the upper layer. Layers of sand and clay are discernible, but the details are not so clear. A c. 75 cm high mudbrick wall was built in a north-to-south direction on the lower compacted layer. At least in the south, the second compacted layer was on top of the mudbrick wall (Figs. 28. 32. 33).

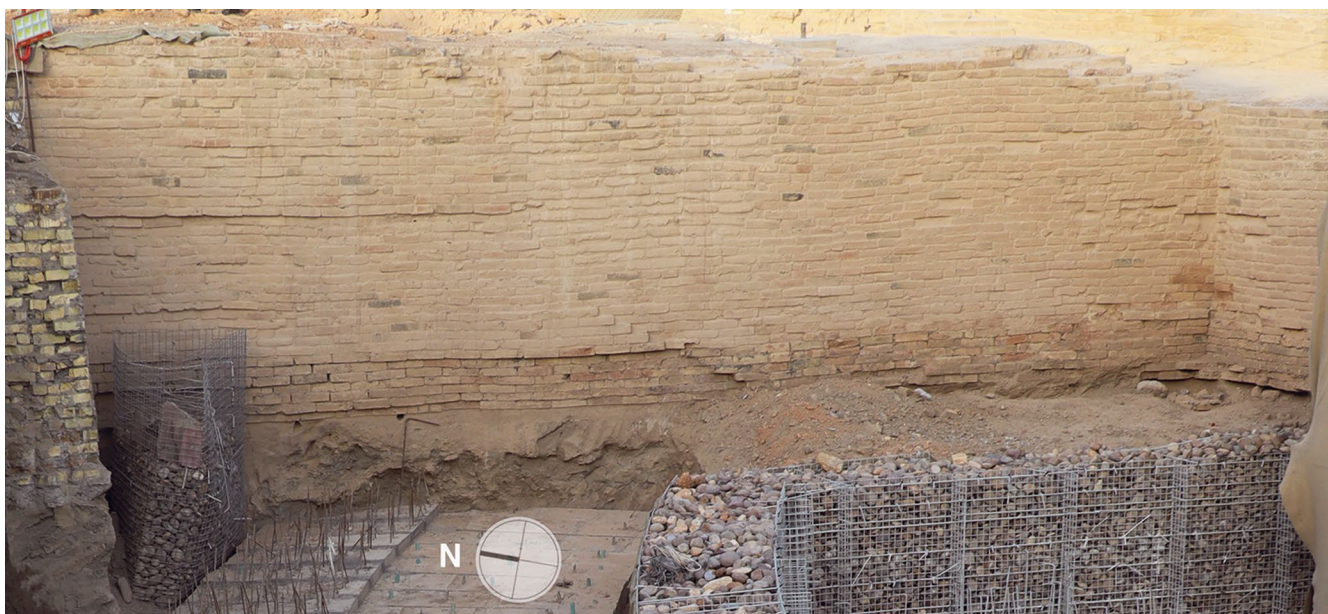
38

Fig. 37: Profile 11, wall east of the Ishtar Gate. Compare Figs. 31-38. The ancient wall itself is still standing after the German excavations. The complete wall was later reconstructed slightly higher up to 35.9. Under the wall there are compacted, sandy, and compacted layers. Modern fill and a new precast concrete foundation are at 31.48 (green) for the new retaining wall immediately in front of its façade. A new surface will be constructed at 32.44 (green)

earth. This rather sloppy work gives the impression that it was a foundation never meant to be seen. There are two less apparent surface irregularities in the northern part of the wall at 33.3 MASL and 34.2 MASL.

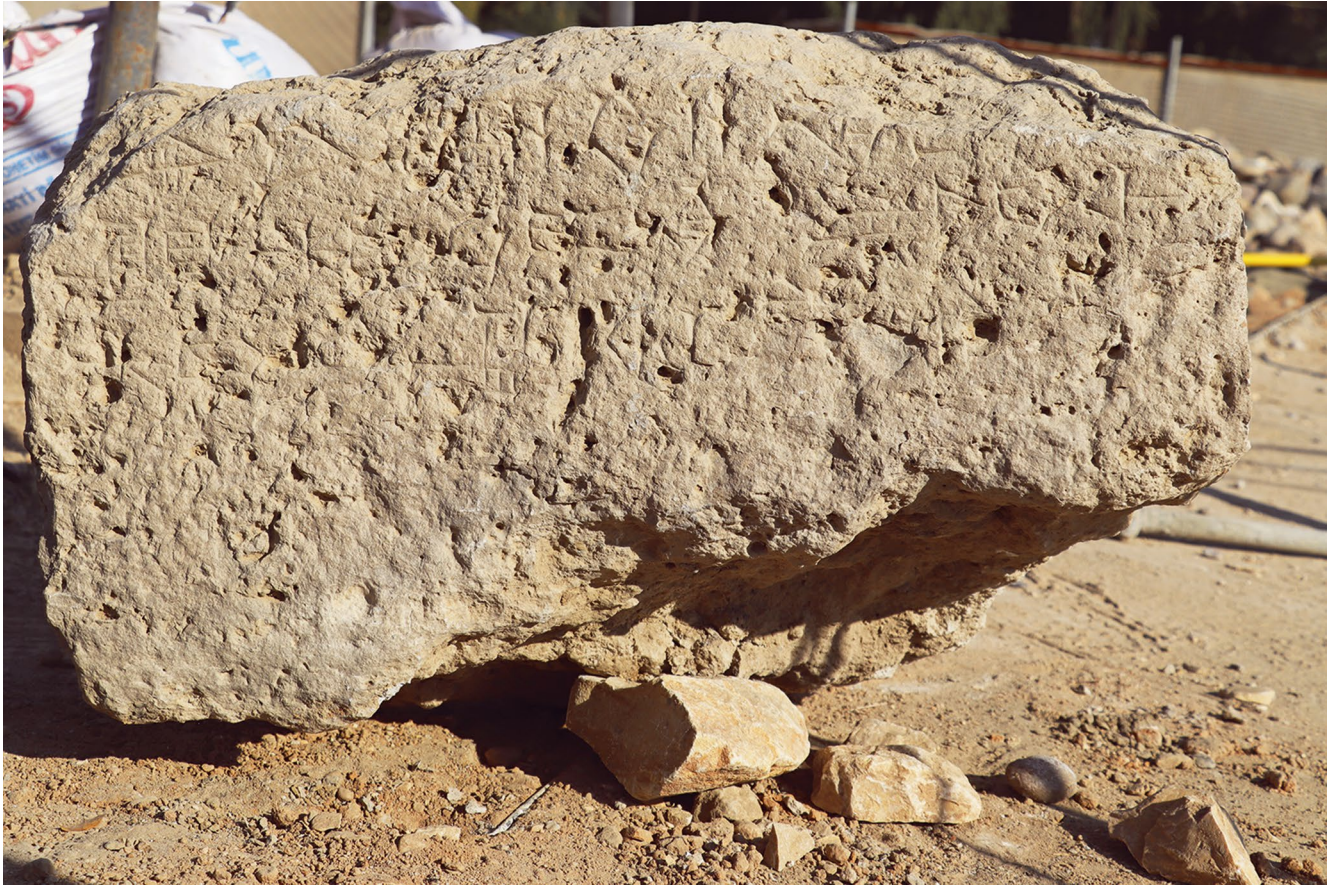
39

Fig. 39: Large fragment of limestone block, 57 × 40 × 35 cm, in a secondary context, with an inscription about the Processional Street. 19 December 2022

49 The more complete of the texts (Fig. 39) found at the Ishtar Gate is here recorded in transliteration with the missing parts added:

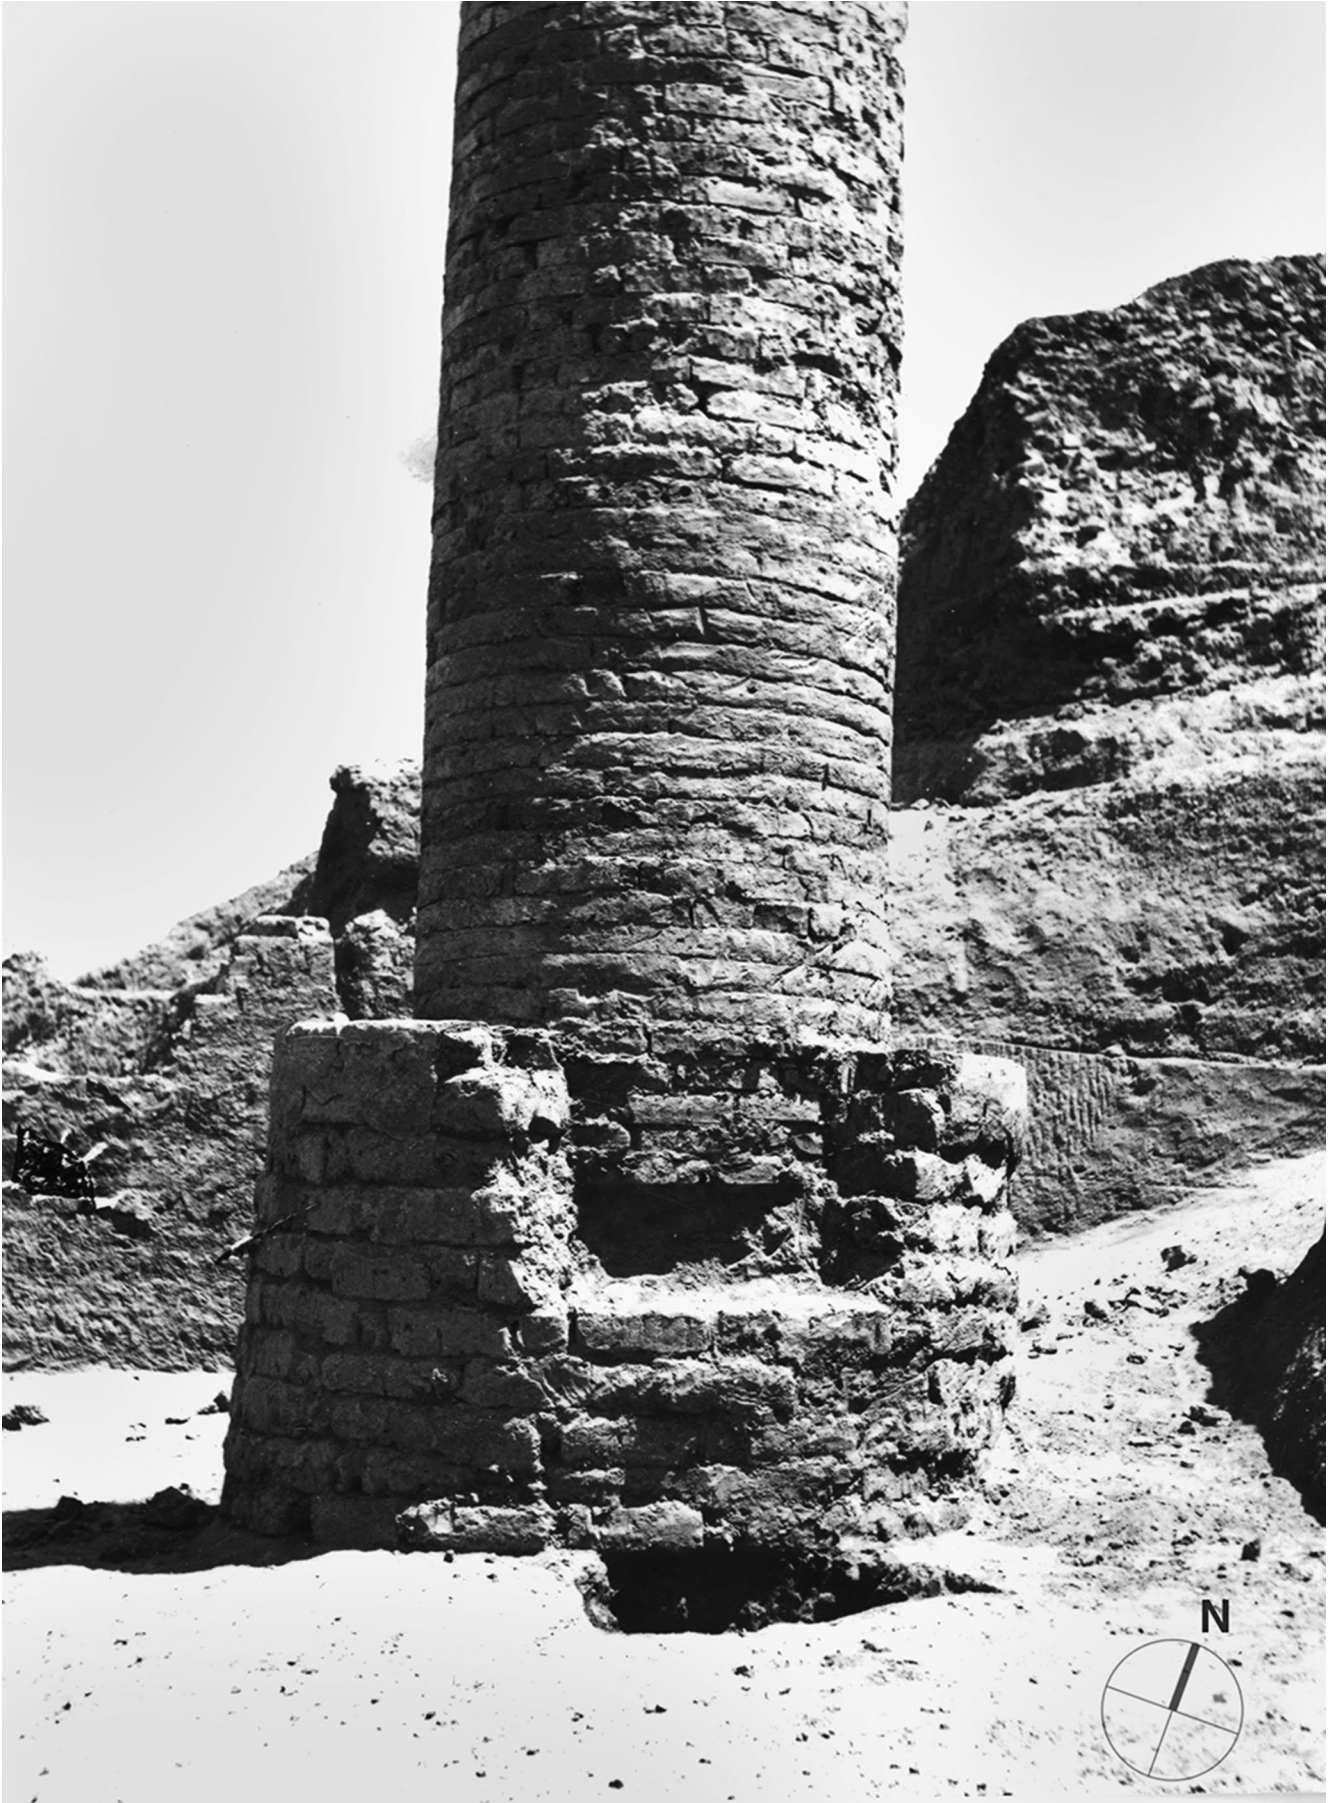
41

Fig. 41: The remains of the round pedestal with a diameter of 140 cm, excavated in 1902. The mudbrick mantel around the base has been opened in order to show the bottom of the baked brick cylinder. The uppermost brick layer of the pedestal is missing on the photo. 1902

54 The well-known western round pedestal was unearthed by German archaeologists in connection with the Ishtar Gate in 1902 and has since then been a landmark due to its preserved height and unusual cylindrical shape. The preserved round remains of the pedestal may have served as a foundation for a pedestal in connection with street Level 2 and Level 1, or even Level 0, but is now exposed together with street Level 3. The cylinder is standing on soil at +11.20 = 36.80 MASL c. 70 cm above the Level 3 street. It has a diameter of 140 cm. The top under current conditions is at +14.57 = 40.07 MASL, with 42 brick layers or 367 cm height. At the excavation, the three lowest brick layers of the cylinder and the soil below were surrounded by a c. 1.4 m high, one brick thick, unbaked mudbrick mantel (Figs. 41. 42). What looks like minor changes and disturbances at the approximate street Level 2 may be seen on old photos (Fig. 41), but after recent cleaning and repointing this is no longer certain (Fig. 42). Until the Level 1 street was removed in 1958, the connection with the Level 1 street was easier for visitors to understand; the pedestal now standing as a separate monument on the Level 3 street is hardly possible to understand correctly without an explanation. The mudbrick mantel at the base was replaced over the years with modern bricks, and recently they have again been replaced with ancient baked bricks, some of them even with Nebuchadnezzar inscriptions, nice looking, but giving an impression of visible monumentality and secure dating for a construction originally rough and always underground and without secured dating.

63 The remains of the round pedestal were already exposed by the German excavations. It consists of a 367 cm high baked brick cylinder with a diameter of 140 cm standing on soil c. 70 cm above the Level 3 street. Not standing on or grounded for that street level, it served as a foundation for a pedestal on Level 2, Level 1 or Level 0. What type of possible continuation there may be downwards to lower street levels has not been proven, but there was probably a pendant to the east pedestal also during earlier periods. The round form is more common in later periods, but a Nebuchadnezzar construction cannot be excluded. The rough construction indicates that the cylinder served as a foundation for a better shaped pedestal at higher levels.

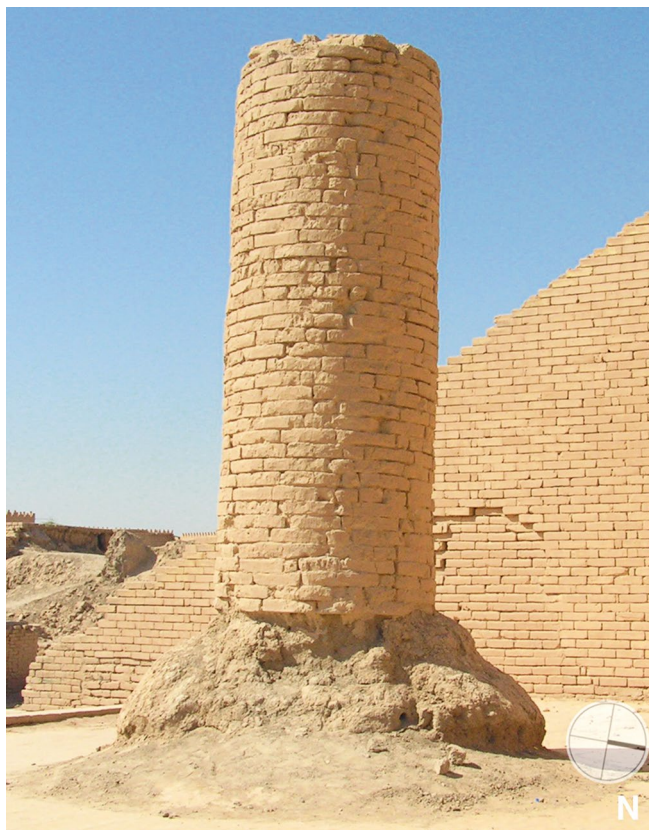
Fig. 42: The remains of the round pedestal, 42 brick layers high in 2016 before conservation. The mudbrick mantel around the base of the baked brick cylinder is mostly eroded. There is earth and some traces of the mudbrick mantel under the cylinder. August 2016

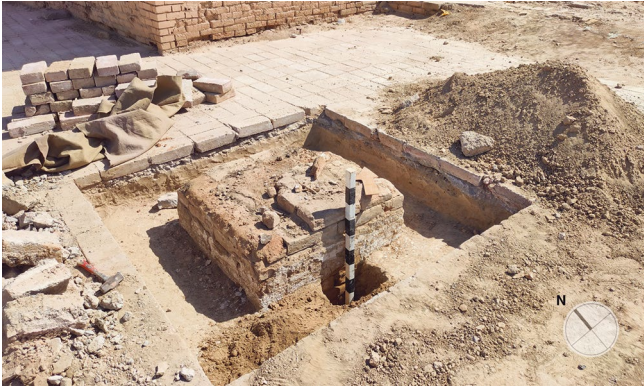
43

Fig. 43: The reduced remains of the square pedestal, about 105 × 105 cm, as re-excavated in 2021. The single topmost brick is *in situ* at +10.43 = 35.93. 25 June 2021

2 of the Processional Street.³⁴ The structure may have been exposed in 1958 in connection with the Iraqi lowering of the Processional Street from Level 1 at +15.5 = 41.0 MASL to the now exposed Level 3 at +10.6 = 36.1 MASL (Figs. 3. 4). There is a possibility that the exposure may have occurred earlier, but so far, no documentation about that has been found. The square pedestal was excavated in connection with street Level 3 but continues down to lower levels, as was recently established during the present work (Figs. 43. 44).

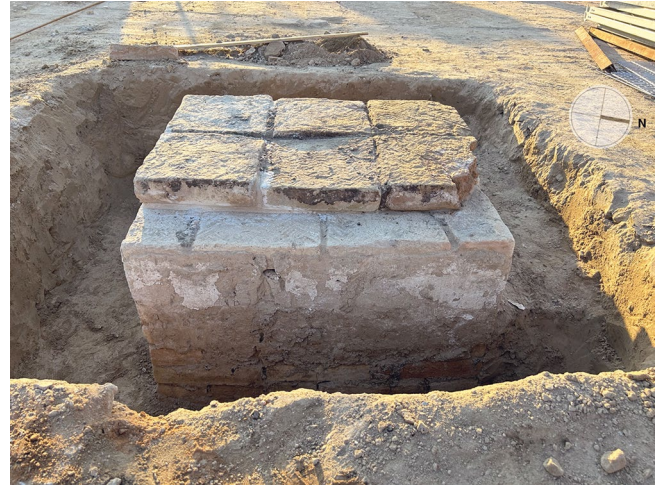
44

Fig. 44: The square pedestal as re-excavated in 2022 after cleaning and repointing before reconstruction. On four upper brick layers there are remains of mud plaster covered by white lime-gypsum. 11 January 2023
