## **Pergamon, Turkey. Monument Conservation and Capacity Building. The work of 2020 and 2021**

## PERGAMON, TURKEY Monument Conservation and Capacity Building

The work of 2020 and 2021

**Istanbul Department of the German Archaeological Institute**

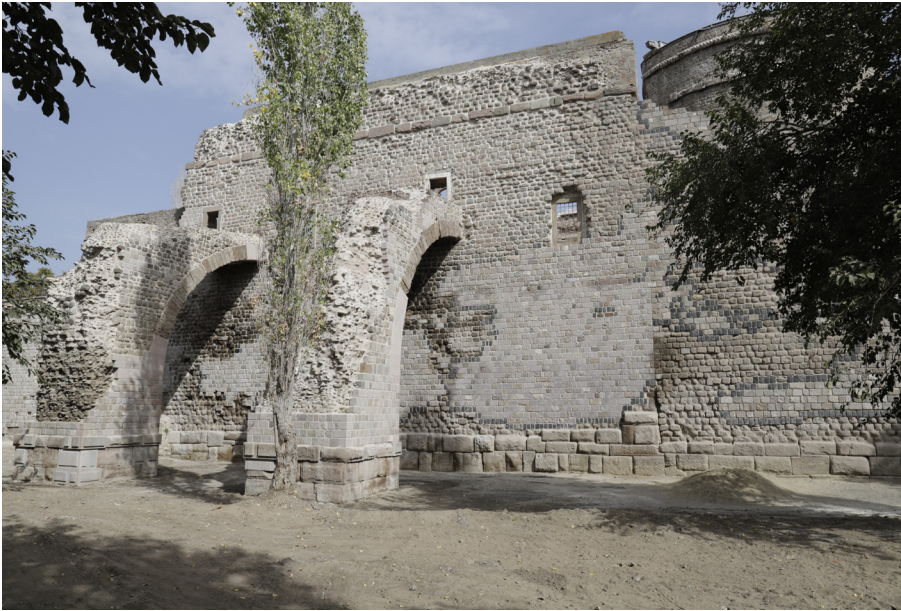
1 Pergamon, Turkey. Red Hall. Southern temenos wall and two supportive buttresses after consolidation. (Photo: Ulrich Mania)

- 2 During the period of the above-mentioned works, the south-eastern retaining wall of the ancient building complex was consolidated in several steps (Fig. 1). The stones that form the outer shell of the wall were mostly looted and had to be reassembled in order to ensure the stability of the wall. After this work was almost completed in 2019, the upper wall zones and the two buttresses leaning against the retaining wall were restored in 2020. Here, a total of 40 arch stones that were missing on the outer shell of the buttresses

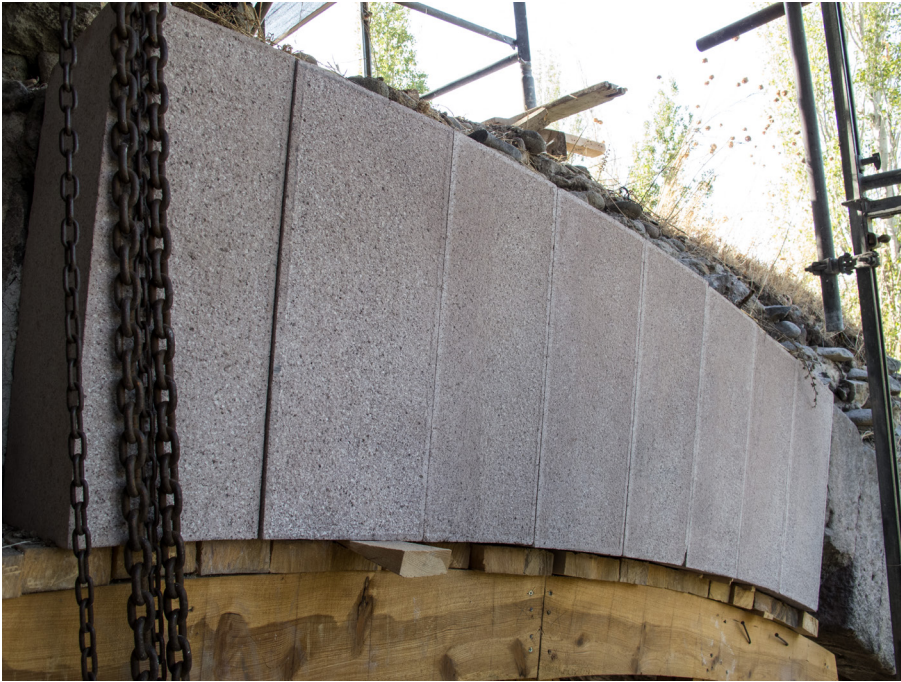
2 Pergamon, Turkey. Red Hall. Addition missing archstones on the western buttress of the southern temenos wall. (Photo: Seçil Tezer-Altay)

had to be replaced, due to static concerns (Fig. 2). All new arch stones were manufactured as part of the stonemasonry training programme (see Capacity Building).

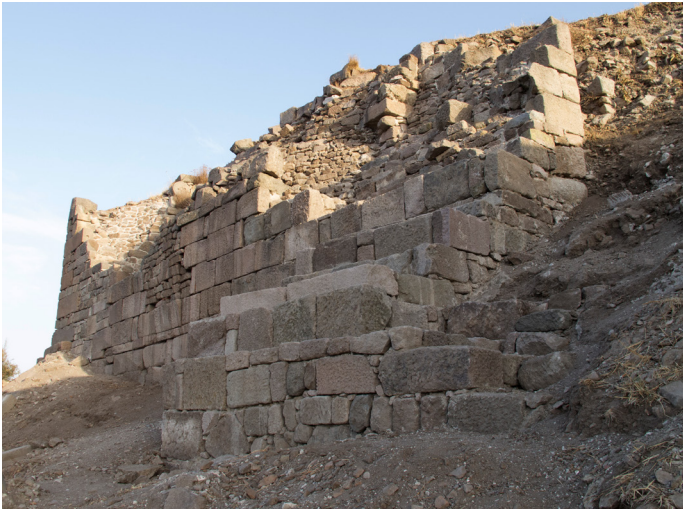
- 5 During a scheduled site visit in the winter of 2019/2020, it was noticed that a section of the wall posed an acute danger to the road that leads to the Acropolis and to the adjacent living quarters in the historical town of Bergama at the skirts of the hill. The loss of the outer wall shell here was not due to stone robbery, but to the fact that the wall had probably been built in great haste due to a dangerous situation. However, as a result the outer wall shell had been placed on the sloping rock, instead of being placed on a foundation, which later led to the slipping of the lower stone courses of the wall.

3 Pergamon, Turkey. So-called Goths' Wall. Southwest section of the fortification after conservation measures are applied. (Photo: Seçil Tezer-Altay)

were to be used. The defects in the wall, which was built of spolia and rubble, were closed carefully with a rough masonry of mortar and rubble (Fig. 3).

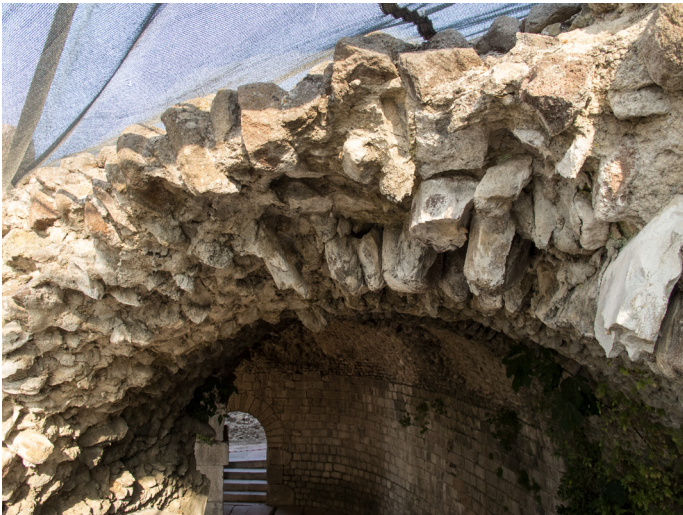
4 Pergamon, Turkey. Southern Rotunda, Asklepieion. Close look on the edge of the vault. The inner vault shell in particular has suffered a high degree of material loss. (Photo: Seçil Tezer-Altay)

8 The basement floor of the Rotunda is covered by a vault system, that is formed by two concentric barrel vaults. This covering of the basement has already largely collapsed. Recently the preserved parts of the vault have become looser, especially at the edges by erosion (Fig. 4). In order to preserve the structure from further deterioration and to secure the visitors, the weakened edges of the vault had to be stabilized. For this purpose, in 2020, loose parts were carefully removed and then a wooden formwork was placed under the vault. On this formwork, the inner vault shell was subsequently reconstructed (Fig. 5). This work continued in 2021, focusing on remains of the vault, with a huge loss of the cohesive mortar. Here, over a length of approximately 20 m, the vault has been consolidated by filling the joints with lime mortar.

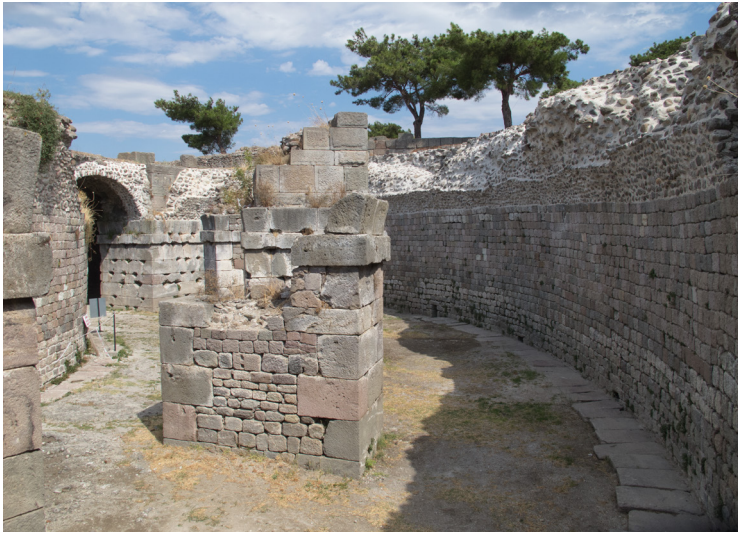
5 Pergamon, Turkey. Southern Rotunda, Asklepion. Consolidated edges of the vaults and upper parts of the walls in the eastern part of the building. (Photo: Seçil Tezer-Altay)

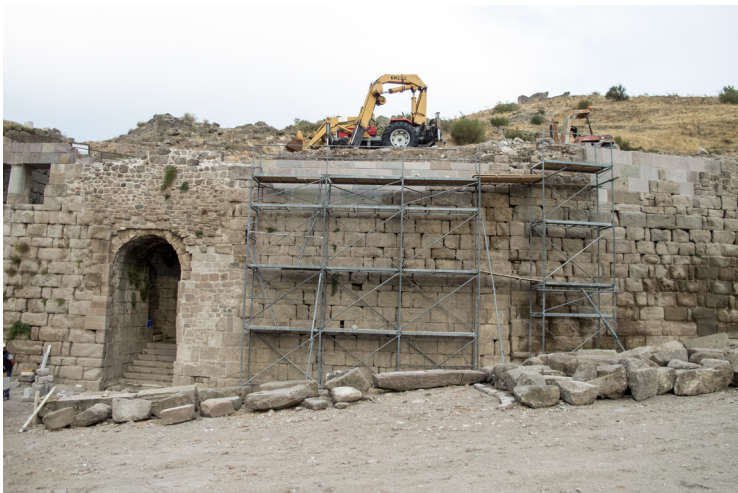
6 Pergamon, Turkey. Gymnasion. Southeast retaining wall, which is restored as part of the stonemason training programme. (Photo: Seçil Tezer-Altay)

- 11 The focus of the works in the Gymnasion in 2021 was to finalize the ongoing conservational interventions on the southeastern retaining wall of the large building complex. Part of the works have been completed in the framework of the stonemason training program, in which trainees have prepared large-size andesite blocks to replace missing steps in the eastern entrance gate, and also for the retaining wall of the Gymnasion terrace (see Capacity Building). This wall was partly under threat of collapse, since a number of stones of the outer shell were missing, whereas remaining ones were partly loosened from the core of the wall. Along the restoration of this wall, a part of the ancient road has been uncovered from the former excavations' debris in order to be presented along the visitor route. The finalization of these works not only protects the remains of the Gymnasion, but also provides a more secure access and increases the attraction of the site (Fig. 6).

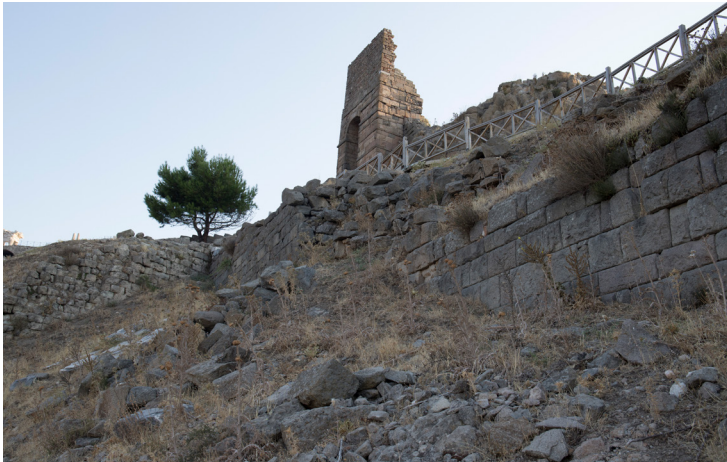
- 12 The Hellenistic Theatre is located on the western edge of the highest plateau of the ancient city hill. Owing its reputation to sitting on a steep slope, the theatre itself covers a height of approximately 40 m, whereas the rest of the slope is terraced by walls built in different levels and stages. In 2020, the terrace walls were documented, after the damaged areas had gotten particular attention and it was called for action since the visitor route was directly threatened (Fig. 7).

7 Pergamon, Turkey. Theatre Terrace. Collapsed part of the terrace wall, threatening the visitor path on top. (Photo: Ulrich Mania)

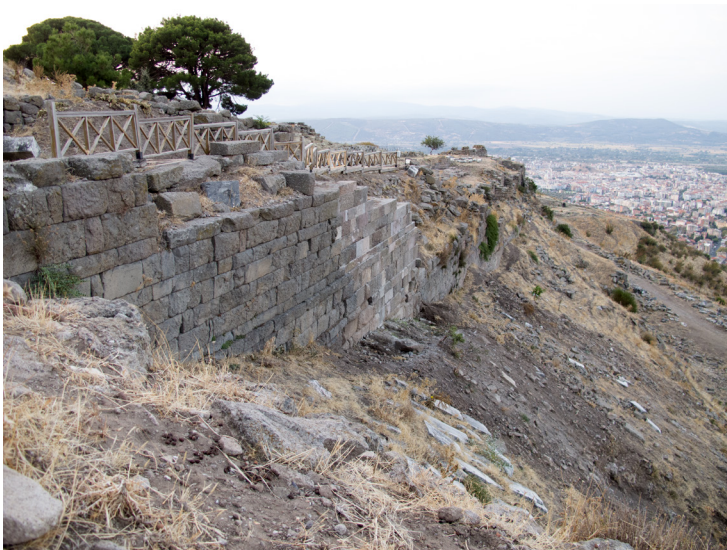
8 Pergamon, Turkey. Theatre Terrace. The terrace wall after restoration. (Photo: Seçil Tezer-Altay)

- 13 On the retaining walls of the theatre terrace, three spots were identified to be restored. In 2021, a first collapsed wall section which is supporting the level of a visitor path was rebuilt. A great effort was necessary in order to set up the construction site, by building a road for a huge crane and collecting ashlar from a steep slope, which had fallen down from the retaining wall. All these actions took place in the middle of a touristic spot with respective cautions. After the wall was freed from the loose parts around the damaged area, the collected ashlar could be replaced on the wall (Fig. 8).

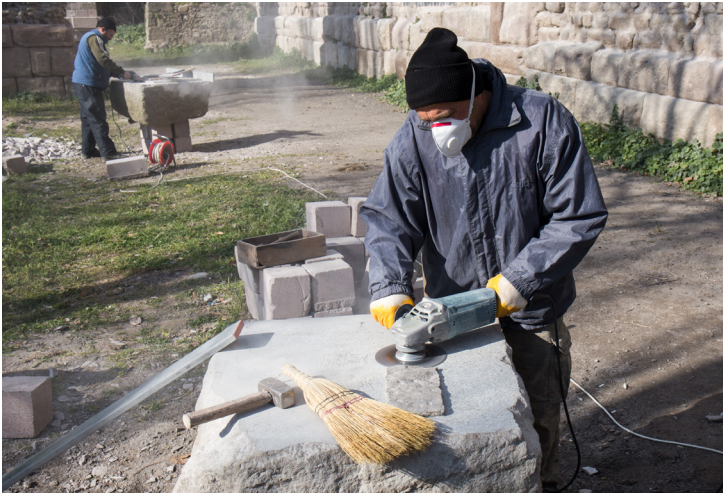
9 Pergamon, Turkey. Capacity Building. Stonemason trainees cutting and dressing ashlar blocks for the consolidation of the buttresses of the Red Hall. (Photo: Ulrich Mania)

- 15 Within the stonemasonry training program, ten young, unskilled craftsmen from Bergama have been trained. As part of the program, they learned to work rough andesite or marble stones into dimensionally accurate ashlar, arch stones, or profiled blocks (Fig. 9). These worked stones were eventually used in various restoration projects in the ancient city. As a journeyman's piece, each graduate made a profiled building block from marble.

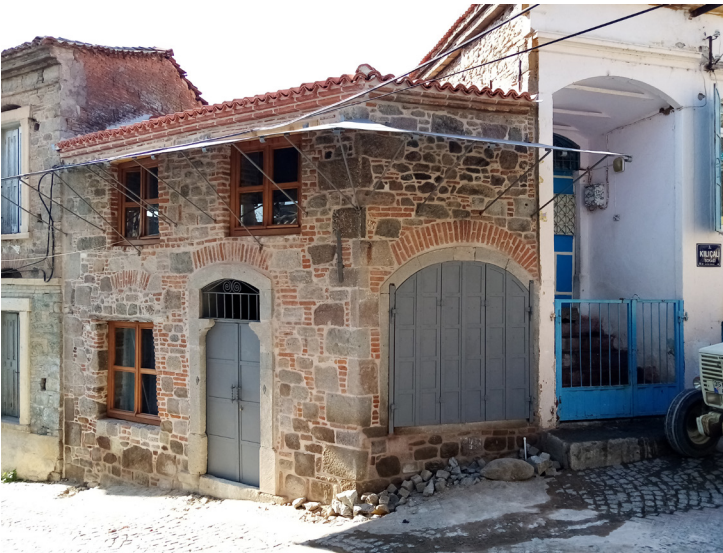
10 Pergamon, Turkey. Capacity Building. The old house was restored in order to function as a community house. (Photo: Ilgin Kemaller)

Pergamon Excavation and Bergama Municipality had been signed, the restoration could begin (Fig. 10). While the work was still in progress, an open forum was to be organized for the residents, to give them the opportunity to discuss possible functions of Mahalle Evi. However, due to the ongoing COVID-19 pandemic, meetings had to be avoided. Instead, a neighborhood survey was conducted. The result clearly showed a desire to use the house for various purposes, with a focus on artistic education for children. The result and the conditions of use were discussed with the responsible *Muhtars* (the elected head of a neighborhood), who will possibly be responsible for the house. The long-term goal is that the local community takes lasting responsibility for the house, for the benefit of the common good. The Pergamon Excavation keeps supporting this process with consultancy and public relations activities.
